O. Gökgöl  
Messerschmitt-Bölkow-Blohm  
Unternehmensbereich Hamburg

This study discusses the crack-free and cracked life of the fuselage including the fin box of the Airbus A 300 B and the problems involved.

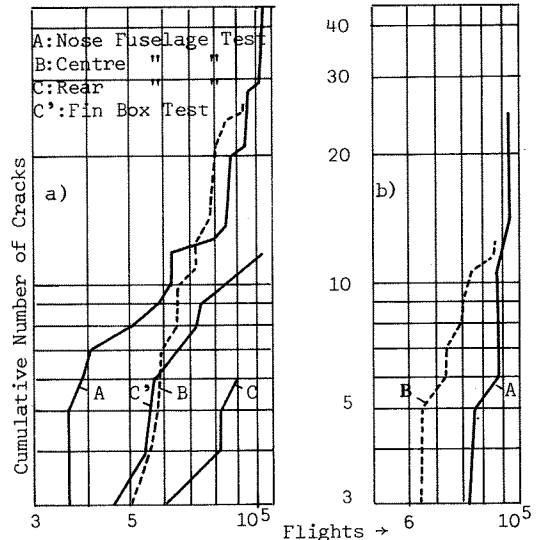
Figure 18a) Fatigue Cracks Starting at the 1st Rivet Row at Fitting (Doublers) Ends

b) Frame Cracks on Fitting Ends between Str. P40/41 (P'40/41)

The damage at the last rivet of the fitting run-out between str. 40/41 on the RH- and LH-side of the fuselage occurs relatively frequent and can be regarded as typical. Almost all frames in the centre wing box area failed in the course of tests at this runout (Fig. 19b). Figure 19a shows the same design in the case of the "Britannia" typ 100, where it failed after 6616 cycles of the full scale

test. An extension of this fitting with a tapering carried out at the same time, increased the service life in that location to 38571 flights.

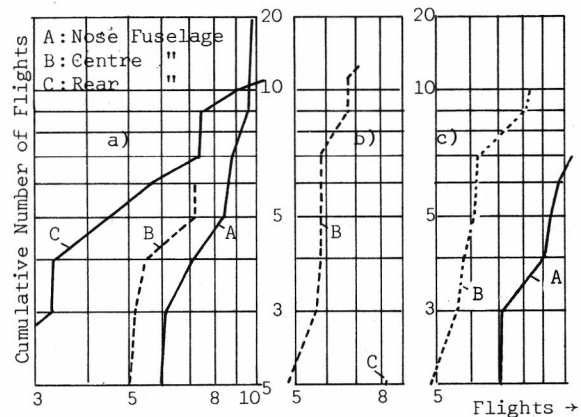
Figure 21 a) Cracks in Frame-Clips  
b) Cracks in Stringer Couplings  
c) Frame-Cracks Starting at Tooling Holes and from Continuous Riveting

Figure 21c shows that in contrast to the frame damages shown in Fig. 19b relatively few fatigue cracks in the frames occurred at tooling holes and continuous riveting.

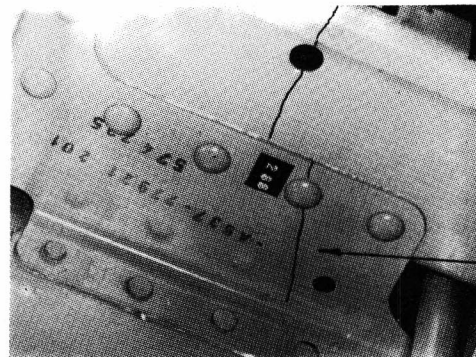
Photo for Figure 21c) Cracked Clip as Succession Damage

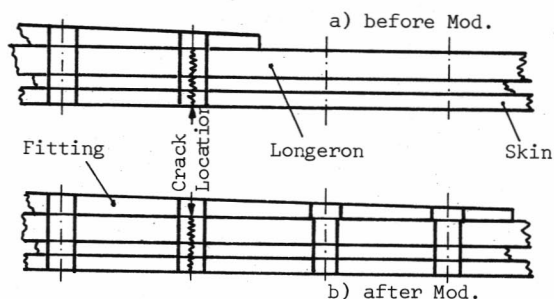
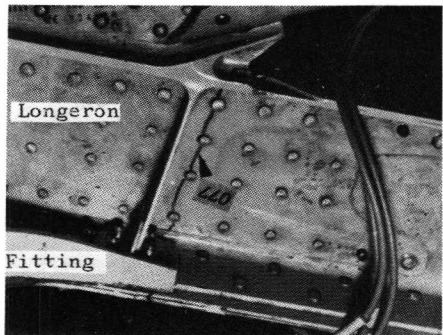
Figure 28. Modification of the Fitting Runout on Horizontal Stabilizer Cutout (Fuselage)

Photo for Figure 28a Skin, Bracket

- in case of the last two rivets of the runout the load is transferred not via bearing pressure but only by frictional closure. By this measure load transmission and additional bending stress are reduced at this location.
- the location of fatigue failure is displaced inward for at least two rivet rows. In the case of the centre rivet rows, load transmission as well as additional bending stress are also small. This warrants a considerable increase of the crack-free service life. A possible crack at one of the centre rivets of the new type would be held together by the intact fitting located above. Crack propagation would then be considerably slower.

The fitting, the longeron and the reinforcement bracket were provided with 38 strain gauges (partly flexa gauges). For the purpose of comparison stress measurements for the different flight phases were performed with a short fitting at first and then with the new type. It showed that the nominal stress at the location A is reduced by about 30% and the additional bending stress at the new type of runout becomes smaller. In the further course of the full scale test up to 106000 test flights no failure could be observed at this location.

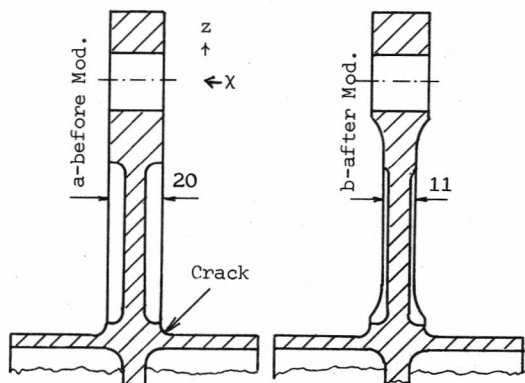
Figure 29. Modification of the Frame Heads on Cargo Door (Frame 60-63)

Further weak points are the frame heads of the cargo doors which failed in the course of centre parts of fuselage full scale test after about 48000 test flights and after 15000 test flights in the nose fuselage test. In spite of the fail-safe design of these door hinges (7-point suspension) the service life had to be increased.

Shotpeening of the failure-endangered blend radii brought about no life improvement. The application of strain gauges at these blend radii showed that the  $E \cdot \epsilon$  - values at this location by far exceeded the yield strength of the material. It is understandable that the effect of compressive stress, which is built up by shotpeening at the surface of the notch is lost at this high tensile strains.

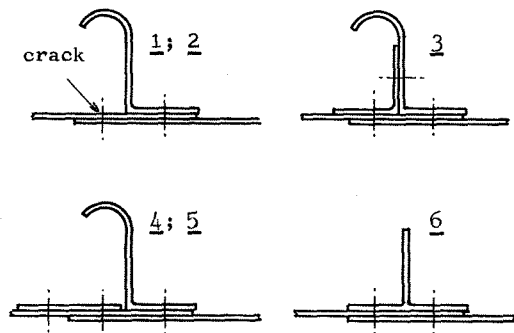
Figure 30. Measures to Improve the Fatigue Strength of the Longitudinal Skin Splice (Frame 73; Str.51) of the Pressurized Cabin

Version	related Life
1. basic type	1.0
2. basic type with DPS ringcoining	1.17
3. basic type with supporting angle	1.84
4. basic type with pre-connection 1.2 mm thick	1.52
5. as under 4. above, pre-connection 0.8 mm	1.57
6. with T-type stringer	>1.84

The supporting angle version was selected as retrofit solution for the already constructed aircraft and for the test cells. Stress measurements carried out for the purpose of comparison prior to and after the retrofit of the test cells showed a reduction of the maximum stress (tension + bending) in the case of an internal pressure load case by 15%. Thereby the aim of service life was achieved.
