MECHANICAL FAILURE ANALYSIS AS A MEANS OF IMPROVING QUALITY ASSURANCE IN THE
AERONAUTICAL INDUSTRY

M. Kendler and E. Makevet

Israeli Air Force

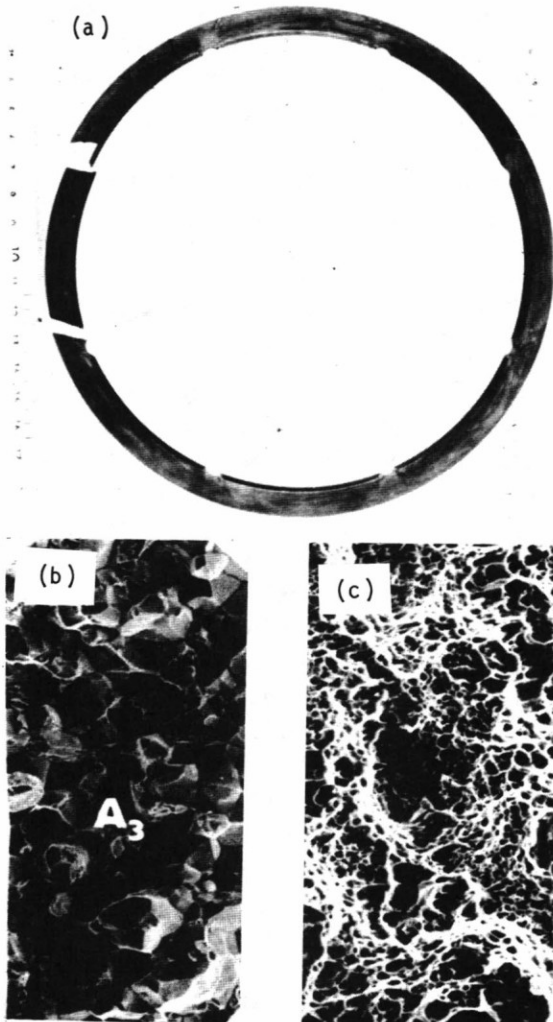
A large number of jet engine retainer-lock rings were reported to have failed upon assembly during overhaul operations. One fractured ring was received for laboratory examination (fig 1-a).

SEM (Scanning Electron Microscope) fractographic inspection revealed the fracture surfaces to be completely intergranular (fig 1-b). Material composition conformed to AISI-410 stainless steel while hardness was found to be 37-38[Rc]. The manufacturer's specification is the standard region of 30-36[Rc], whereas the next standard hardness region for that particular steel is 40-46[Rc]. The microstructure of the ring was indicative of quenched & tempered martensitic steel.

suspected that defective heat treatment had induced material brittleness⁽¹⁾. Thus a segment of the ring was re-treated according to MIL-H-6875 : preheated, quenched (austenized) and then tempered at $550 \pm 8^\circ\text{C}$ (1020°F). The resulting hardness was 32-33[Rc]. An overload test produced a ductile, dimpled fracture (fig. 1-c), as expected. The segment was then re-treated once more in order to reconstruct the defective processing, tempering being performed at 475°C (885°F). This produced 38[Rc] hardness, the same as the hardness of the failed ring.

It was concluded that the repeated failures of the rings were the result of temper embrittlement which reduced the ductility and the flexibility of the rings. The effect of tempering temperature on the brittleness of AISI 410 steel is depicted by fig. 1-d.

Fig. 1: a) The fractured retainer-lock ring, as received (x0.35). b) An intergranular fracture surface (x150). c) A ductile dimpled fracture surface produced by the overload test (x400).

For the restoration of defective rings, the IAF laboratories devised a restoration procedure consisting of thermal re-treating and of re-plating. This procedure was successfully applied to the rings at the overhaul depot.

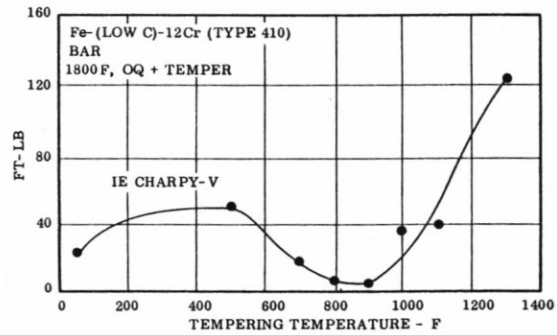
(d) EFFECT OF TEMPERING TEMPERATURE ON IMPACT PROPERTIES OF TYPE 410.

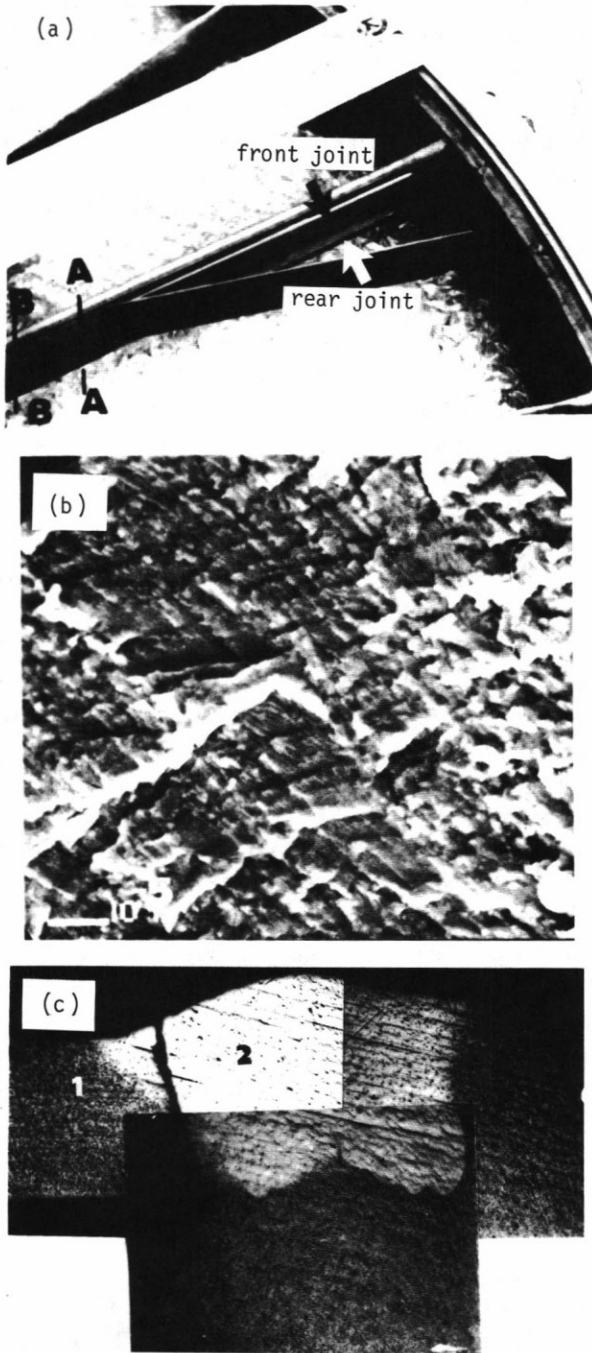
Upon regular inspection it was noted that a welded metal strip had partially separated from the strut of a jet engine inlet-case (fig. 2-a).

The separation of a 15 cm strip segment occurred along the two longitudinal EBW (Electron Beam Welding) seams on both sides of the strip. Macroscopic examination of the fracture surfaces, followed by SEM inspection, indicated that HCF (High Cycle Fatigue) cracks had initiated along the rear welding seam (fig. 2-b). Cracking then progressed transversely, towards the front seam.

Material composition of the strip and of the strut conformed to Ti-6Al-4V alloy. Hardness measured 31-33[Rc]. Metallographic cross-sections taken through the welding seams near the fracture area, showed partial joining or no joining of the strip and the strut along the front seam. This was due to a deviation of the welding beam from the joint, as indicated by the location of the heat-affected spot (fig. 2-c).

It was therefore concluded that an HCF failure of the strip resulted from a manufacturing error. The operator had partially missed the front joint of the strip along some 15 cm while electron-beam welding. Thus, the loose joint caused increased vibrations around the welded joint at the rear side of the strip.

Fig. 2: a) Strip separation at the inlet-case strut. The metallorgraphic cross-sections are indicated by dashed lines (x0.3). b) HCF striations at the fracture surface (x750). c) Section A-A showing no joining of the strip (1) and the strut (2). The heat-affected spot is light colored (x20).

Corrective action taken by the manufacturer consisted of the introduction of a wider

(defocused) beam and improved fixturing. Through these modifications, improved weld coverage and penetration were obtained. It is worth noting that no more failures of this type have been reported since then.

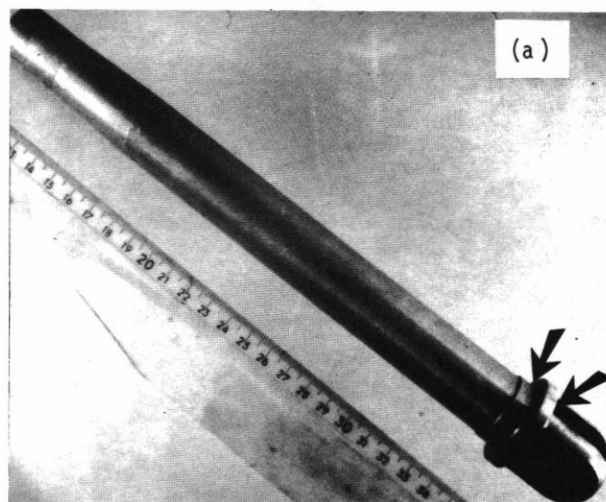
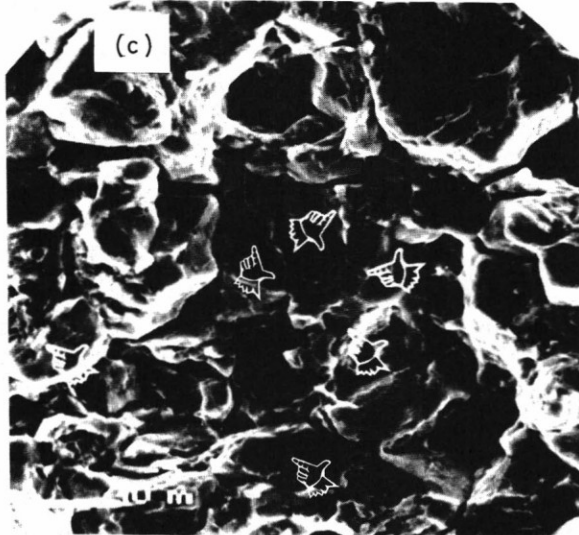
A gearbox mount bolt of a helicopter (fig. 3-a) was found broken following 15 operating hours in the course of two months since its installment. This bolt and another bolt from the same gearbox were received for failure investigation.

The failed mount bolt had fractured at the lugs (fig. 3-b) with visible fracture origins distributed along the circumference of the main fracture surface. SEM inspection showed the fracture surface to be predominated by an intergranular structure (fig. 3-c). Micro-pores and fine hairline features were observed on facets of some of the grains⁽²⁾.

The failed bolt material composition conformed to AISI-4340 steel. The bolt was Cadmium plated in accordance with specification QQ-P-416 as required. However, hardness measured 48-49[Rc] and tensile strength measured 268 KSI, while specification was 40-43[Rc] (180-200 KSI). The hardness of the other bolt was 48-50[Rc]. No further metallurgical anomalies were detected.

The above findings led to the conclusion that the bolt had failed in a hydrogen embrittlement mechanism due to the deviation in its hardness. The application of QQ-P-416 Cadmium plating is limited to steels of tensile strength lower than 240 KSI, because of the susceptibility of high-strength steels to hydrogen embrittlement even after being properly "baked" (see QQ-P-416, section 3.2.1).

Fig. 3: a) A helicopter gearbox mount bolt with the failure location indicated (x0.75). b) The fracture surfaces of the failed bolt (x1.6). c) SEM micrograph showing the intergranular structure of the fracture. Micro-pores and hairline features, characteristic of hydrogen embrittlement, are indicated (x1125).

The defective bolts were eventually traced to a batch that was not produced by the helicopter manufacturing company. Consequently the bolt was re-defined a "flight safety" item in order to ensure procurement through the original manufacturer only.

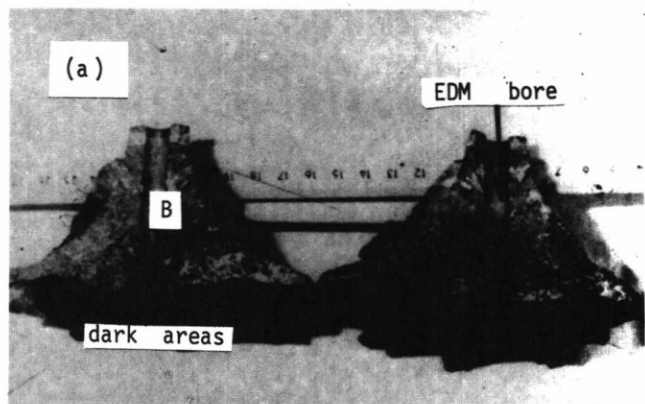
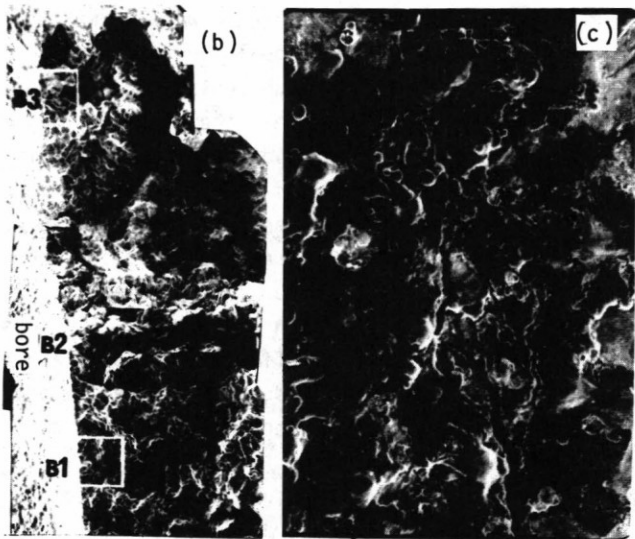
A jet starter engine exploded during start-up, following some 200 operational start-ups. Initial investigation revealed that the turbine wheel was broken across its center into two halves, thus bisecting the central bore longitudinally (fig. 4-a). This bore was manufactured by EDM (Electro-Discharge Machine) process.

Two dark areas, coarse in macroscopic appearance, were observed at the fracture surface on both sides of the EDM bore (fig. 4-b). Numerous short cracks, 0.2 mm long, were detected at the bore surface (fig. 4-c).

The microscopic fracture features of the dark areas, as observed by SEM, were characteristic of time-dependent crack propagation. The initial mode of propagation was intergranular, eventually changing into a mixed intergranular - transgranular mode. Fatigue striations were discernible on crystallographic planes up to 0.25 mm from the bore surface, and crack origins were identified along the bore's edge. Striation density was estimated at 300-800 striations/mm, probably indicating LCF (Low Cycle Fatigue).

The turbine wheel material was Inconel 713 casting of hardness 34-35[Rc]. Metallographic inspection revealed an EDM recast layer, 2.5-70 microns deep, at the bore surface, as well as intergranular cracks traversing from this surface. Micro-hardness testing of the recast layer indicated 54[Rc] hardness.

1) The turbine wheel failure occurred in a high stress, high temperature fatigue mechanism related to the number of engine start-ups.

2) Cracks were formed at the bore surface during the EDM process or during the initial turbine runs. Due to the hard and brittle recast layer, the crack initiation process was essentially completed by the beginning of the turbine's operational life. This resulted in a severe reduction of the fatigue life of the turbine wheel.

Fig. 4: a) The two halves of the failed turbine wheel (x0.35). b) A magnified view of area B, near the EDM bore (x7.5). c) Cracks at the bore surface (x75).

The occurrence of this failure, as well as several similar cases brought to the manufacturer's attention, impelled the manufacturer to make the following modifications: as a first step, a bore of smaller diameter would be formed by EDM. Then, the bore would be mechanically machined to its final dimensions, thus eliminating the recast layer problem.

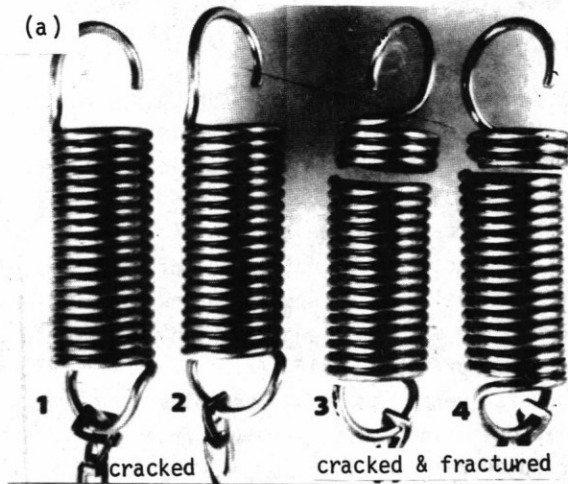
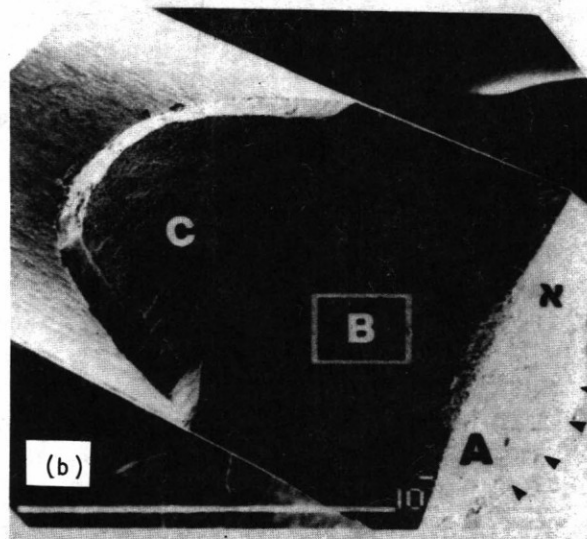
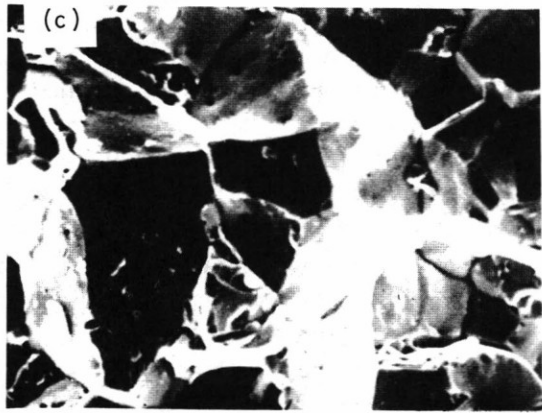
Following the failure of a number of helical springs during handling before assembly, numerous other springs from the same batch were found cracked in storage.

Visual examination of a sample of springs revealed a multiplicity of transverse fractures and cracks in the coils (fig. 5-a). Metallurgical inspection showed the springs to be made of AISI-6150 steel, heat treated to 48-52[Rc] and Cadmium plated in accordance with QQ-P-416, as required. The surfaces of the fractures and cracks, as observed using SEM, were intergranular (figs. 5-b & 5-c). Penetrations of Cadmium plating were detected by EDX analysis at the edges of these surfaces.

The fractographic findings as well as the occurrence of such failures in storage suggested that hydrogen embrittlement, induced by the electrolytic plating, might have contributed to the failure process. A qualitative hydrogen embrittlement test was performed, in which a cracked spring was subjected to a sustained load of 10.6 kg, this being the spring's upper design load limit. That spring failed after 11 hours at the location of one of the cracks.

The failure of the springs was attributed to defective manufacturing, the cracks having occurred during plating or prior to the electrolytic Cadmium plating process. The stress relief treatment as reported by the manufacturer, was deemed ineffective, for it was reasonable to assume that the failure resulted from high residual stresses combined with hydrogen embrittlement⁽⁴⁾.

Fig. 5: a) A sample of failed springs (x0.5). b) A characteristic fracture of a coil. Areas A, B are intergranular. Cadmium penetrations were detected along the arrowed edge (x15). c) SEM micrograph of the intergranular structure of area A (x4000).

Following the investigation corrective measures were taken by the IAF Q/A facilities to ensure the manufacturing of these springs according to specification requirements.

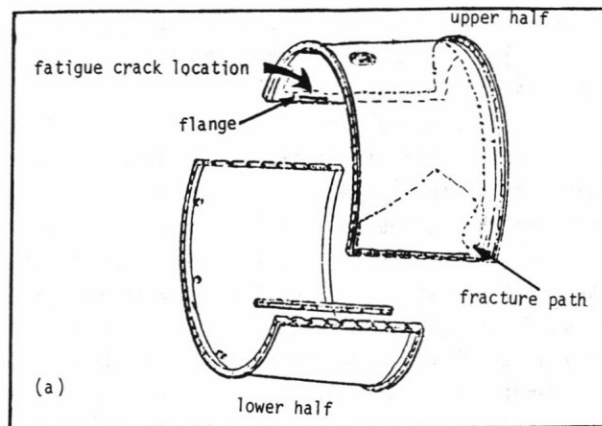
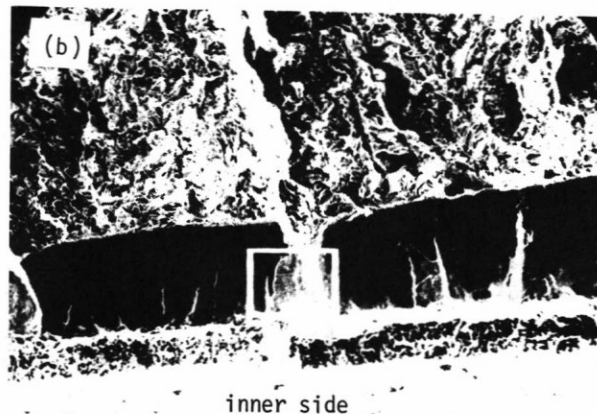
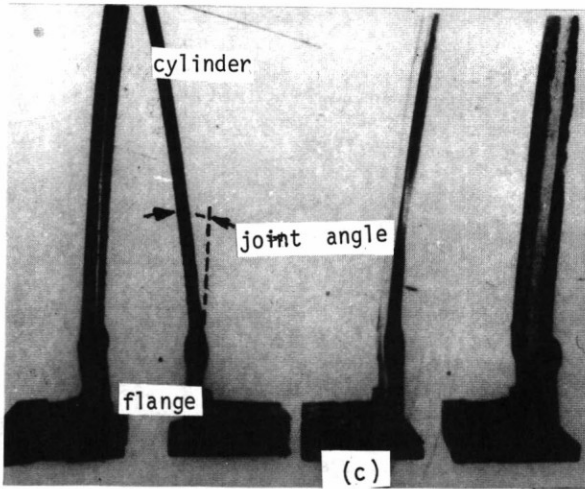
During a jet aircraft training flight a sudden explosion occurred, resulting in an engine shut-down. It was discovered that part of the combustor duct was blown off.

The duct was constructed of two semi-cylindrical halves. The upper and lower halves were attached by mating flanges, which were welded to both sides of each half (fig. 6-a). All welded components were made of Chromoloy. The duct had been in operation only a small fraction of its expected operational lifespan. This particular duct had been manufactured by a sub-contractor and not by the original manufacturer.

- 1) A fatigue crack was generated at the inner side of the weld joint of the upper half. The crack initiated at numerous origins and progressed radially outward to form a semi-elliptical through-crack, 83 mm long, in the cylinder wall. The rest of the fracture surface was characteristic of ductile overload. No surface irregularities were observed at the origins.
- 2) Secondary fatigue cracks were generated at the same location in the opposite joint of the upper half (fig. 6-b).
- 3) A considerable deviation from the specified joint geometry was measured at the failed side, i.e. 1.6 mm mismatch as compared with the max. allowable 0.8 mm, and approximately 13° joint angle as compared with the max. allowable 7°. Similar deviations were measured at the other joints as well (fig. 6-c).

Finite element stress analysis established that the dimensional deviations at the failed joint had increased the tensile stress level at the inner side of the joint by a factor of at least 2.5. Using fatigue crack growth analysis it was determined that the deviation in the joint angle had a major effect on the reduction of the fatigue life of the duct (the effect of the mismatch was secondary).

Fig. 6: a) A schematic drawing of the failed duct. b) SEM micrograph of secondary fatigue cracks (dark in color) penetrating from the inner side of the cylinder wall (x40). c) Transverse sections through the duct depict the geometric deviations at the joints .

The IAF required the sub-contractor to re-qualify for the manufacture of the combustor duct. Hence, the flange welding process was modified so as to obtain better control of the joint geometry. The joint inspection technique was also improved. Furthermore ,each duct had been given individual documantation for data of manufacture as well as depot operations.
