Huey D. Carden*
NASA Langley Research Center
Hampton, VA

Abstract

Failure behavior results are presented from crash dynamics research using concepts of aircraft elements and substructure not necessarily designed or optimized for energy absorption or crash loading considerations. To achieve desired new designs which incorporate improved energy absorption capabilities often requires an understanding of how more conventional designs behave under crash loadings. Experimental and analytical data are presented which indicate some general trends in the failure behavior of a class of composite structures which include individual fuselage frames, skeleton subfloors with stringers and floor beams but without skin covering, and subfloors with skin added to the frame-stringer arrangement. Although the behavior is complex, a strong similarity in the static/dynamic failure behavior among these structures is illustrated through photographs of the experimental results and through analytical data of generic composite structural models. It is believed that the similarity in behavior is giving the designer and dynamists much information about what to expect in the crash behavior of these structures

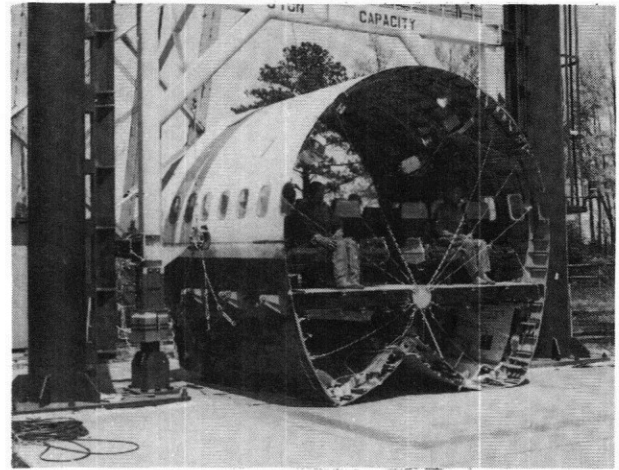
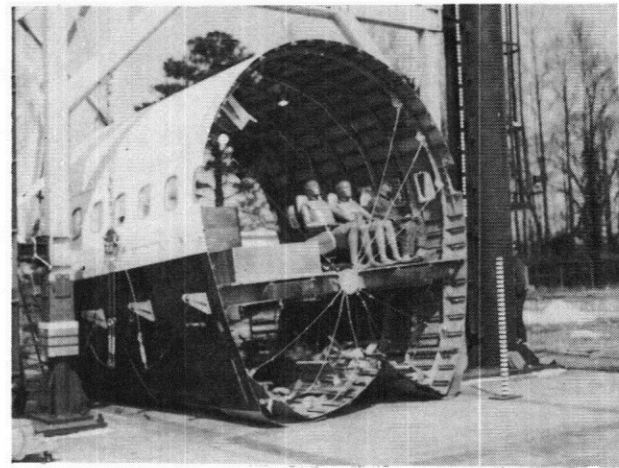
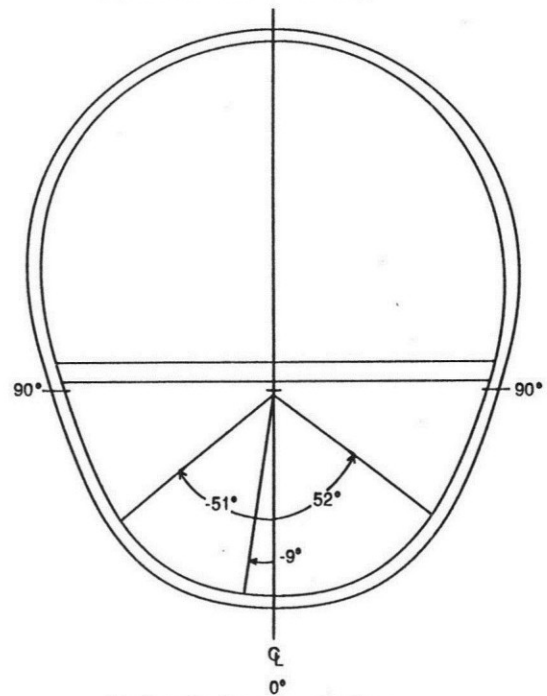
Figure 8. - Structural damage to metal aircraft structures resulting from impact tests.

Dynamic tests.- Structural damage of the transport aircraft structures resulting for the 20 ft/s drop tests is shown in figure 8(a) and (b). The damage to the transport sections was confined to the lower fuselage below the floor level. Under the vertical impact of 20 ft/s, all seven of the frames ruptured near the bottom impact point. Plastic hinges formed in each frame along both sides of the fuselage about 50 degrees up the circumference from the bottom contact point (See figure 8(c)). The crush of the lower fuselage was approximately 22-23 inches at the front end and 18-19 inches at the rear for the section taken from forward of the wing location (figure 8(a)) whereas for the aft section (figure 8(b)) the crushing was about 14 inches in front and 18 inches in the rear. Although the aircraft structures are metal and the failures discussed above involve plastic deformations with some tearing of the metal rather than brittle fractures, the general observed failure pattern and locations for the transport fuselage sections will be shown to be quite similar to the results of the composite frames and subfloors discussed later.

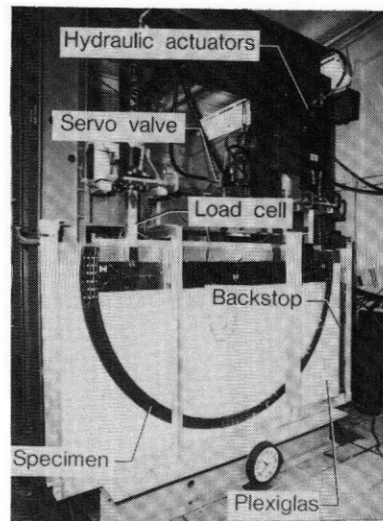
(a) Static test apparatus.

Static tests.- Results from the static test of a semi-circular frame with a Z cross-section²⁷ are presented in Figure 11. A photograph of the static test apparatus in figure 11(a) shows that the splice plate was at the load point. Consequently, the frame failed just outside the doubler splice plate area by a complete fracture across the Z-section. Load-deflection data and the location of failures of the frame are shown in figure 11(b). The load-deflection data show a saw-toothed behavior of loading and unloading. The load increased linearly until initial failure, then falls off to under 600 pounds force. Subsequent loading of the frame after initial failure was at a new, reduced stiffness. Second and third fractures occurred up the side again at about 54 and 58 degrees under continued loading as may be noted in the sketch at the right of figure 11(b). Photographic data in figure 10(c) shows that the initial failure was induced by a local buckling of the frame which occurred at about 18 degrees from the bottom loading point outside the splice plate area.

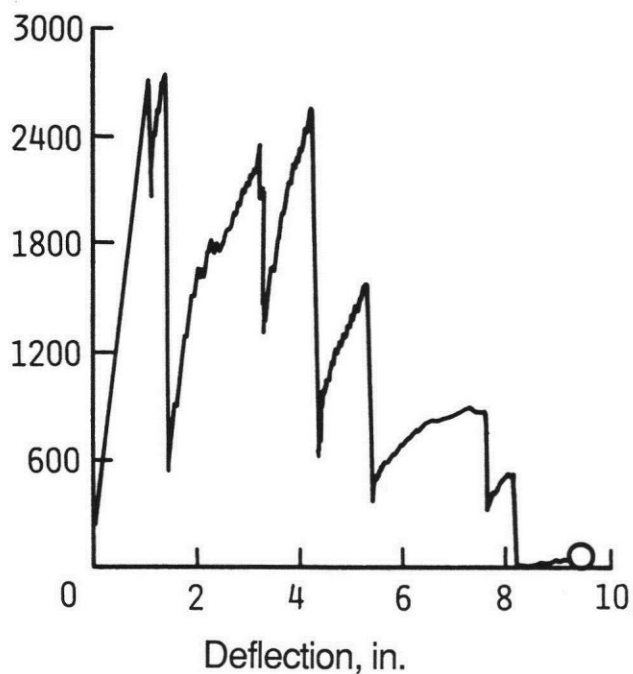
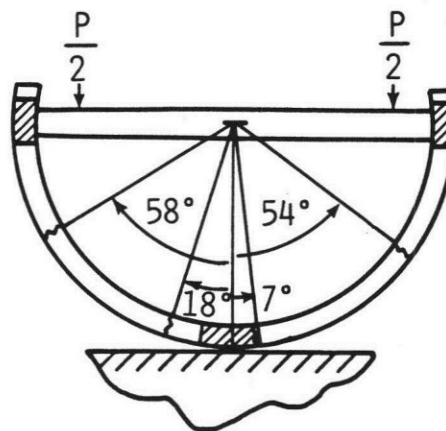
(b) Load-displacement and failure locations.

Furthermore, a comparison of the analytical cases (figure 12(a)) with the actual static load-deflection of the Z-section (figure 11(b)) indicates very similar load-deflection behavior patterns as discussed above. Although the Z-frame had no skin, if the ends jam together (as they did in several cases), the boundary is effectively between the skin stiffened case and a guided boundary. Thus, the predicted maximum moment location in the simple beam-frame model at about 50 degrees (See figure 12(b)) agrees well with the 54 and 58 degree failure locations in the experiment with the Z-section frame.

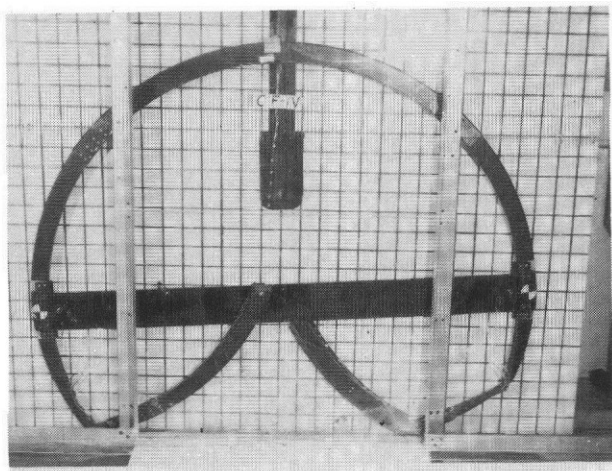
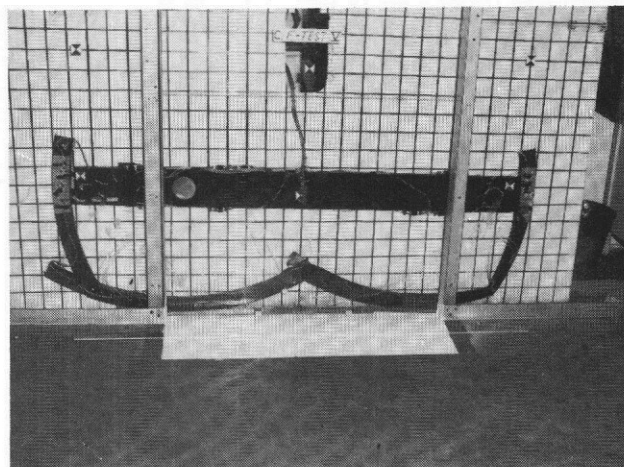
(a) Photographs of failed frames.

Dynamic tests.- Results from reference 29 on the dynamic studies of the response of composite frames are shown in Figure 13. Photographs of the failed Z-frames in the drop apparatus are shown in Figure 13(a). It should be noted, the splice plates joining the segments of the frame are 45 degrees up the circumference from the point of impact. As shown in figure 13(b), complete failures (fractures) of the Z-section frames occurred at the bottom and approximately 60 degrees from the bottom. It appears that the presence of the splice plates moved the top failure points up a few degrees (to about the 60 degree locations).

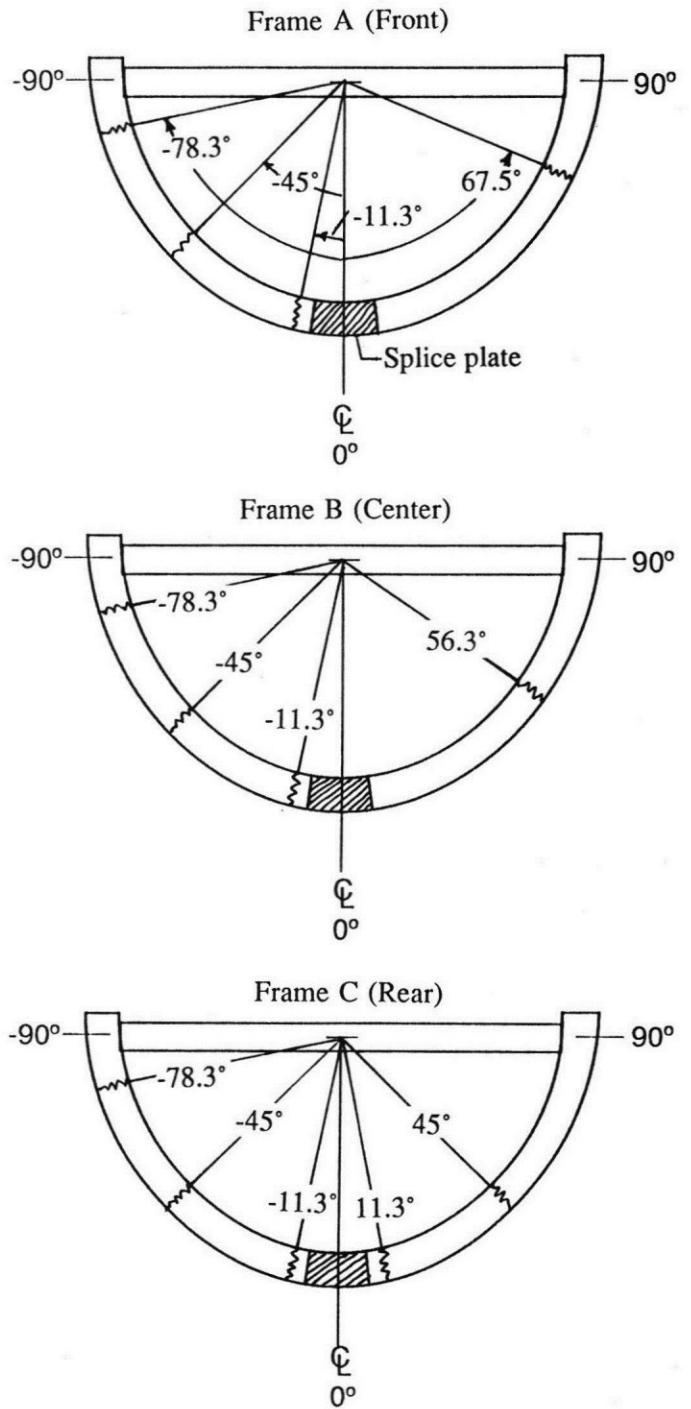
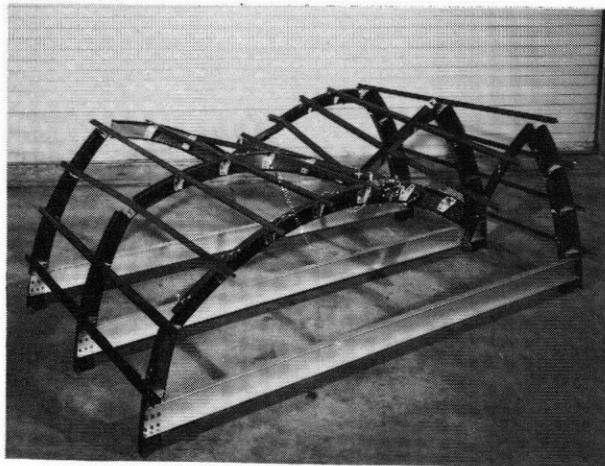
Figure 14. - Behavior of composite skeleton subfloor under static loading tests.

Static tests.- Experimental results³⁰ of the skeleton subfloor specimen following a static test are shown in Figure 14. As noted in figure 14(a) and (b), failures on the three Z-section frames occurred at 13 discrete locations. Unlike the unnotched single Z-frame, the failures in this specimen occurred at notches (which served as stress risers) in the frame through which the stringer passed. However, as shown in figure 14(b) the failures were still near the point of load application (approximately 11 degrees) and at other circumferential locations of approximately 45 to 67 degrees. In the absence of skin material, twisting and bending out-of-plane occurred with the frames. The stringers had only a minimal effect on the subfloor response and that was to maintain the lateral spacing of the three Z-frames.

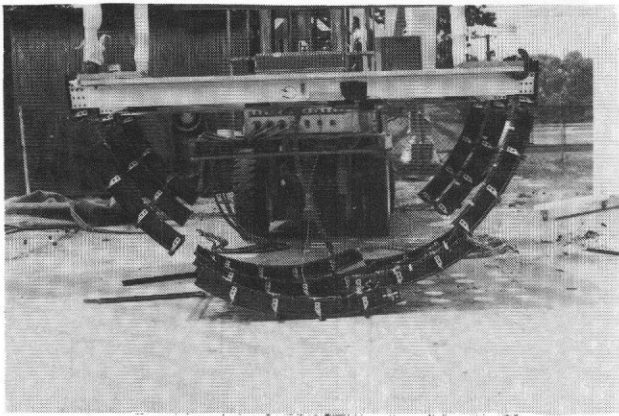
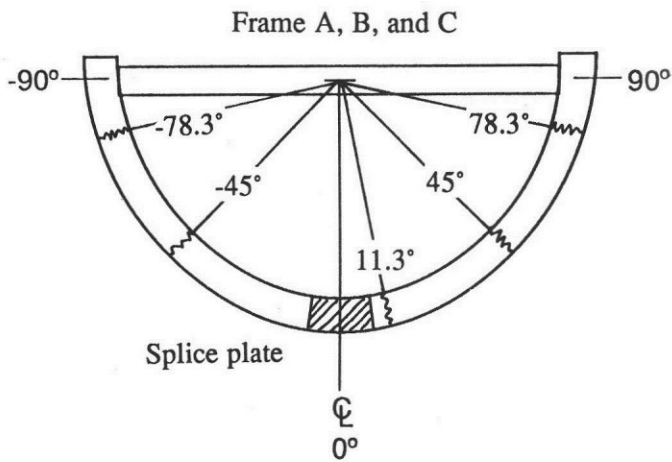
Figure 15. - Behavior of composite skeleton subfloor under dynamic loading tests.

Dynamic tests.- A photograph of a skeleton subfloor after an impact test onto a concrete surface at 20 feet per second is shown in Figure 15. In the dynamic test of the skeleton subfloor, fractures were produced at notches in the frames (Figure 15(a)). The locations, shown in figure 15(b), were also near the point of impact (about 11 degrees because of the splice plate) and at three other locations up the circumference of the frames (55 degrees and 78 degrees) totalling 15 fractures for all three frames. The impact energy exceeded the energy absorbed by the local fractures and the floor bottomed out during the impact. The normalized circumferential strain distribution measured on the flange of the front frame during the dynamic test just before first failure is shown in Figure 15(c). A comparison of the measured distribution to the predicted moment distribution of Figure 12(b) and (c) shows essentially identical shape between the single frame and skeleton frame distributions. Maximum values at 0 degrees and at approximately 50 to 55 degrees for the experiment agree well with the analytically predicted locations on the frame.

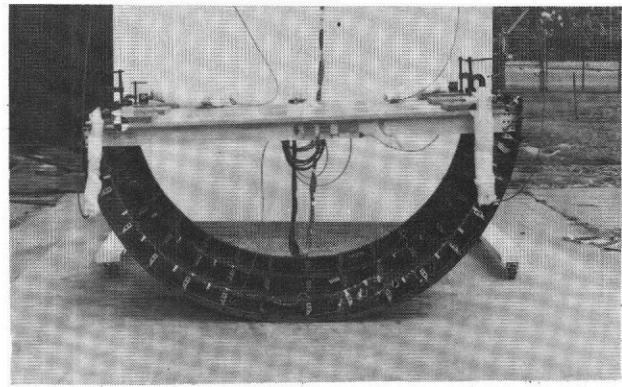
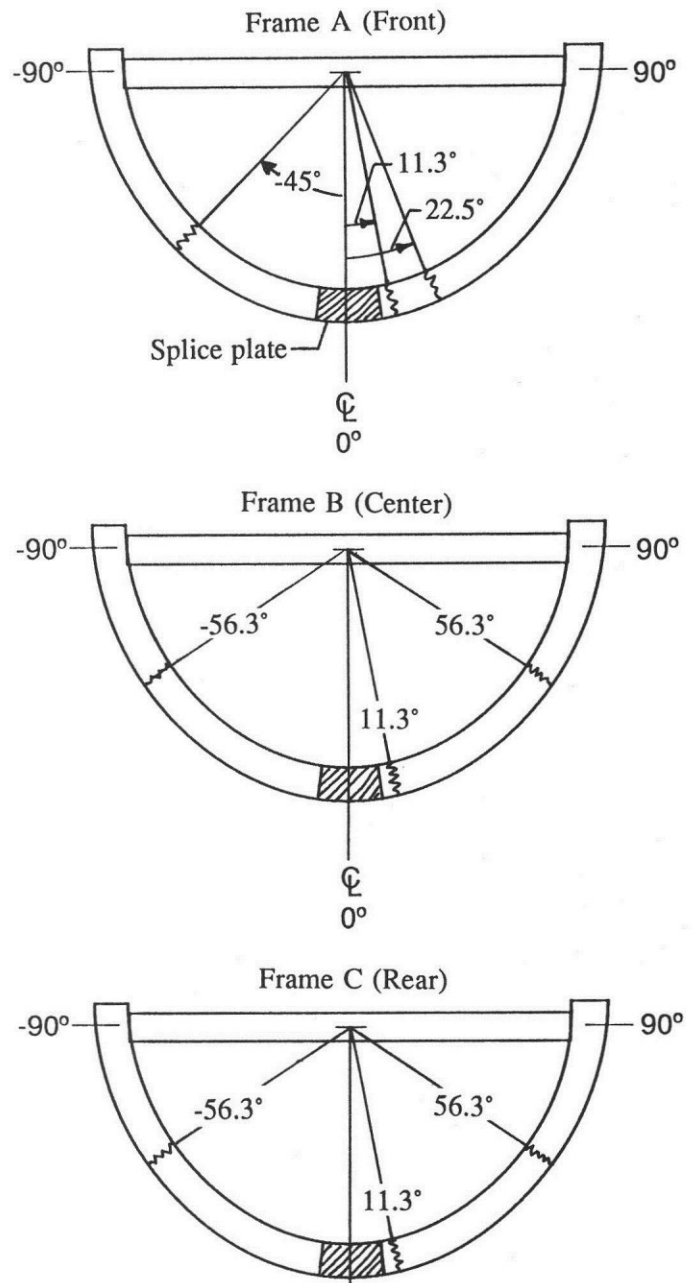
Figure 16. - Behavior of composite skinned subfloor under dynamic loading tests.

Impact results for the subfloor with skin after an impact of 20 feet per second are shown in Figure 16. A photograph of the subfloor specimen after the test is shown in Figure 16(a). Points of failure of the frames in this specimen are indicated in figure 16(b). Again the points of failure are at or near the impact point (within 12 degrees) and circumferentially at about 56 degrees up both sides of the frame on the middle and back frame and 45, 12 and 22.5 degrees on the front frame. It was observed that the subfloor impacted first on the front area which possibly explains the 12 and 22.5 degree fractures being different from the other locations. Again all three frames were involved in the failures. Some delamination of the frames from the skin was evident but the skin remained intact. Normalized strain distribution (just prior to first failure) measured on the skin at the location of the front frame during the dynamic test showed essentially identical shape as the single frame and skeleton frame distributions. As was the case for the skeleton subfloor maximums at 0 degrees and at approximately 50 to 55 degrees for the experiment agree well with the analytically predicted locations on the frame.
