THE FRETTING DAMAGE AND EFFECT OF TEMPERATURE IN
TYPICAL JOINT OF AIRCRAFT CONSTRUCTION

ICAS-92-5.2R

T.Z.Tian
Shenyang Aircraft Institute
Shenyang, Liaoning, P. R. CHINA

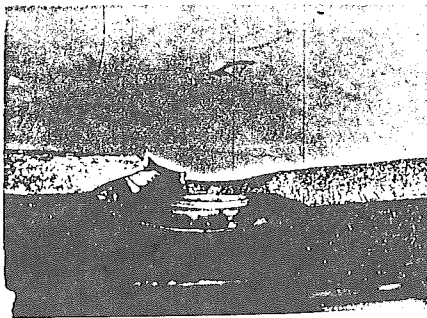
The clamping pressure of countersunk rivet joints is lower, the transmitting load must therefore go through the rivet rods and the rivet holes where fretting occurs. Fretting fatigue cracks initiated along the diameter perpendicular to the load direction. The stress concentration caused by fretting piles up, see figure 8 that of the sheets and the crack initiation. Therefore, the fatigue strength of this type of joints is the lowest.

Figure 8 Countersunk rivet joint fracture appearance of fretting scar

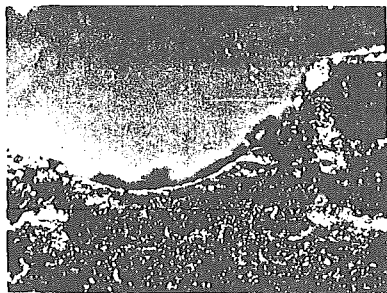
Interpretation of these situation see figure 10-11. Figures 10 and 11 compared fracture appearance at temperature 150°C or at room temperature. Both of them are experienced cycle 10^6 , figure 10 shows an example of this where anodised oxidation layer was clearly fragmented and churned up by the heavy scuffing action that developed in elevated temperature. Figure 11 shows a result of room temperature of where not only anodised oxidation layer presented, but also surface smooth and slighter fretting action.

Figure 10 fretting damage made oxidation accelerated LY-12 bolt joint at edge of washer 150°C . experienced 10^6 cycle, ($\times 10$)

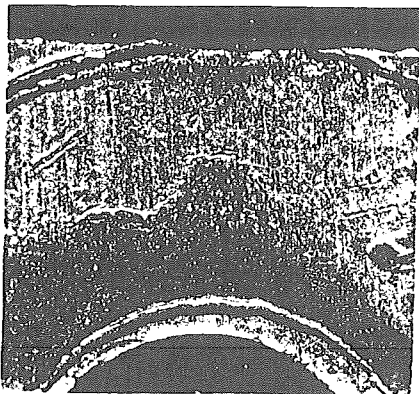
Figure 11 bolted joint It is experienced 10^6 cycle. surface smooth. oxidation slighter ($\times 10$)

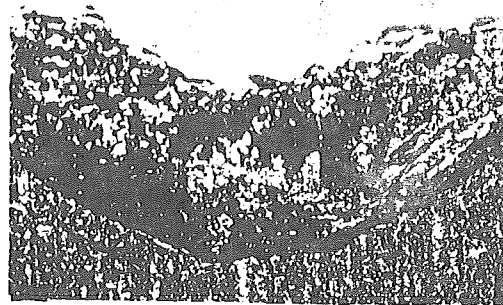
(2), Figures 8, 12 and 13 show cases of fretting fatigue in set-head rivet joint, countersunk rivet joints and bolt joints in aluminium alloy LY-12 aircraft skin stringer attachments where non-uniform closure conditions have existed and point breakdown has occurred both at the skin / stringer interface and under fastener heads and also where, by the design, local rubbing points exist at the edges of dimpled holes. There have been clad with relatively soft aluminium (alclad). This cladding, being soft, is particularly prone to stage 1 fatigue cracking produced early in the life of the part. Add to this reason, introducing such as fretting, temperature rubbing, oxidation, which also has the effect of producing early cracks, at the sometime oxygen infused new micro-cracks surface accelerated parent oxidation as if "awage" action. In addition, the softer coatings may be deformed and a large burr will form all these accelerated micro-cracks propagation.

Figure 12 Fretting or rubbing made breakdown contact surface, oxidation accelerated in LY-12 set-head rivet joint 150°C experienced 10^6 cycle ($\times 12$)

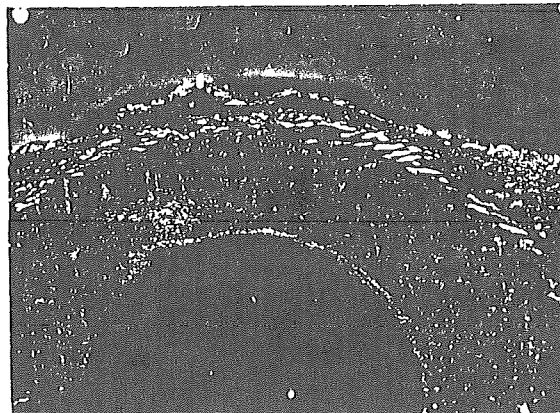
Figure 13 Non-uniform closure or rubbing oxidation made extrusion deformation in edge of washer, crack initiation was accelerated in elevated temperature in bolt joint, 125°C, 8×10^4 cycle ($\times 8$)

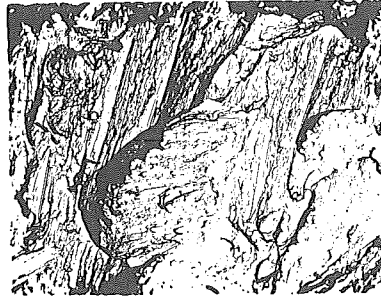
- Figure 16 shows phenomenon of grain slip in that was caused by elevated temperature or local soften.

Figure 16 Grain boundary slipping, folds, exhibited local softening. 150°C, (SEM × 4900)

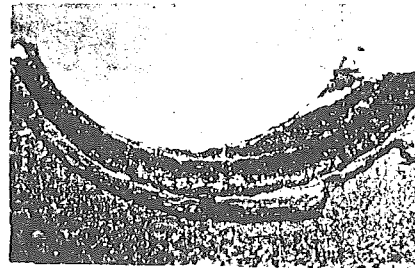
- Figure 17 shows fractures of fatigue test for set head rivet joint in 150°C. It can be seen that fretting surface was cleanly fragment and elevated temperature cause plastic deformation in contact surface between rivet head and dimple. It is evidence temperature to churn up by the heavy scuffing action and to accelerate action of elevated temperature.

Figure 17 Fretting between in set-head rivet and sheet made a edge of sheet roll up (×12)

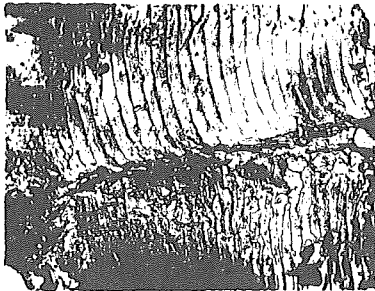
(3), Fractures appearance of aluminium alloy has been influenced more by elevated temperature than by room temperature. Figure 14 is one of room temperature tests in stable cracks propagation zone in where fatigue striation is clear and uniform. Figure 15 is one of elevated temperature in stable cracks propagation zone, in where exhibiting serious plastic deformation may indirectly cause distortion of fatigue striation and accompanying oxidation in also where fatigue striation is not clear, ununiform, or edge is not clear.

Figure 14 Fatigue striation is clear or uniform, Crack propagated from left to right. Middle is grain boundary. room temperature, (SEM × 4900)

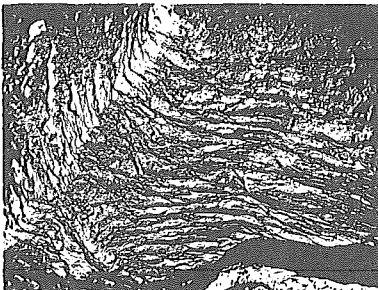
Figure 15 Plastic deformation made striation un-parallel and oxidized point can be seen in upper. LY-12. 200°C (SEM × 10500)

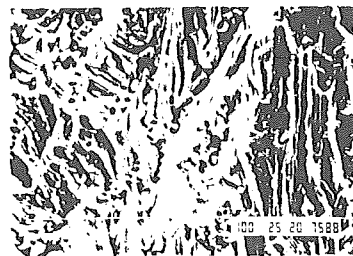
- Figure 19 shows the effect of elevated temperature on crack irregularly propagation in where there are small black pit of that Al₂O₃ come off remains

Figure 19 The effect of elevated temperature on crack irregularly propagation in where there are small black pit of that Al₂O₃ come off remains. 200°C (SEM × 375)

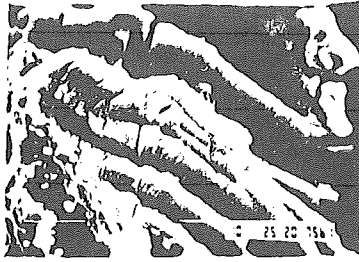
- Figure 20 shows stable propagation zone in where the plastic deformation cause fringe smooth

Figure 20 Stable propagation zone plastic deformation cause fringe smooth. 200°C (SEM × 1000)

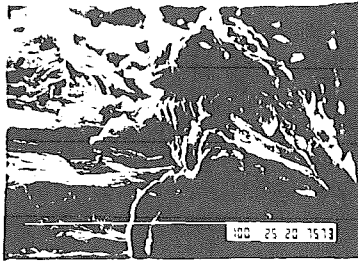
- Figure 21 shows of that plastic deformation under elevated temperature cause not only grain folds and pile up but also grain-boundary become fuzzy.

Figure 21 The plastic deformation under elevated temperature cause grain folds, pile up and grain-boundary become fuxxy, 200°C (SEM × 375)

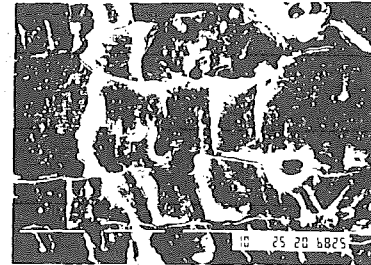
- Figure 25 shows fracture appearance of cracks propagation zone in room temperature, in where step evident to be similar to cleavage character lead to brittle fracture.

Figure 25 Cracks propagation zone in room temperature, step is evident to be similar to cleavage character lead to brittle fracture. (SEM × 750)

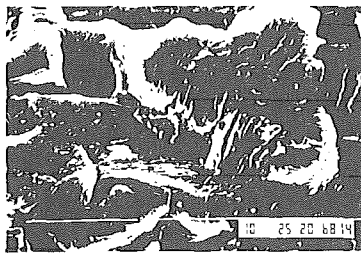
- Figure 22 shows plastic cracks in where two large grain has evidence plastic deformation.

Figure 22 The plastic cracks in where two large grain has evidence plastic deformation and fatigue striations, 150°C (SEM × 2000)
