BIRD IMPACT RESISTANCE OF THE SMALL TRANSPORT AIRCRAFT
Experience Gathered from Tests and Structural Changes

Ing. Ludvík BEDŘICH - Strength Department, LET a.s. Kunovice, Czech Republic

Ing. Vlastimil MERTL - Institute of Aerospace Eng., Technical University of Brno, Czech Republic

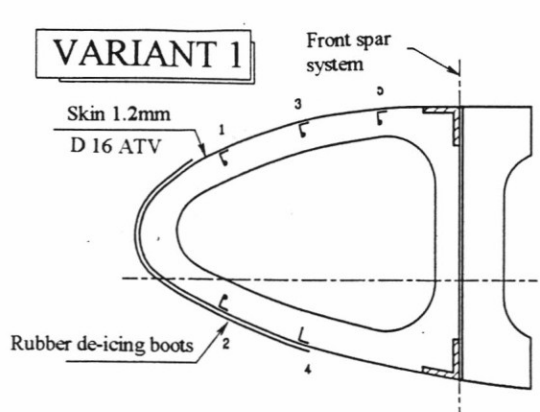
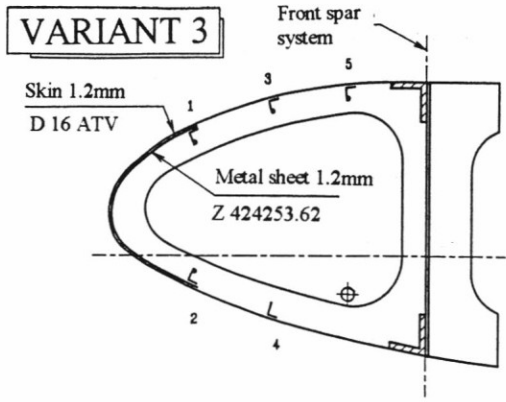
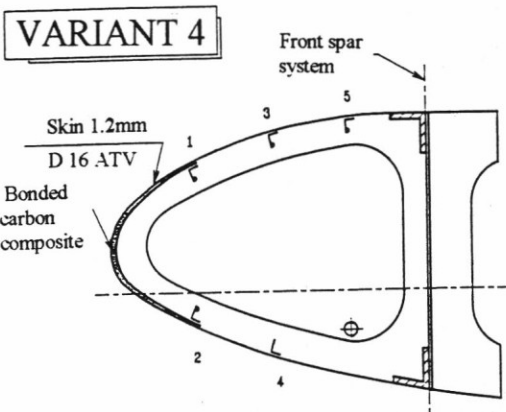
FIGURE 3 - Original Structure of a Wing and its State Following the Test

By no means can the tightness of the tank be jeopardised by loose rivet joints or defective beams or webs of the foremost spar. Damage to the wing's leading box does not prevent completion of the flight and is thus admissible. Wing specimens were used in the tests. The shots were fired at the centre of the leading edges between ribs or close to them. A wing specimen and its attachment are depicted in Figure 2. The original structure and its state following the test are shown in Figure 3. Damage was inflicted onto the wing's leading edge and the front spar's web. Other structural variants that were tested but did not conform to the requirements are shown in Figure 4. Figure 5 shows the final variant, which had minor damage evident on its leading edges. Its spar remained unharmed. This variant was applied on the aeroplane.

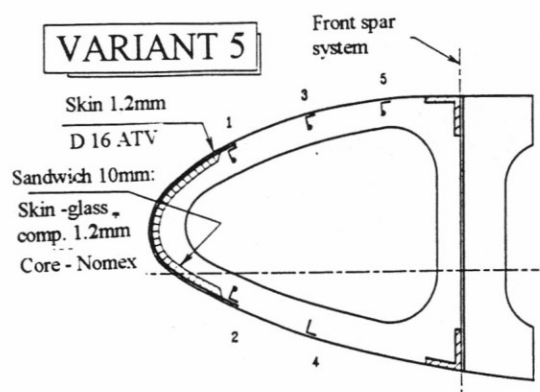
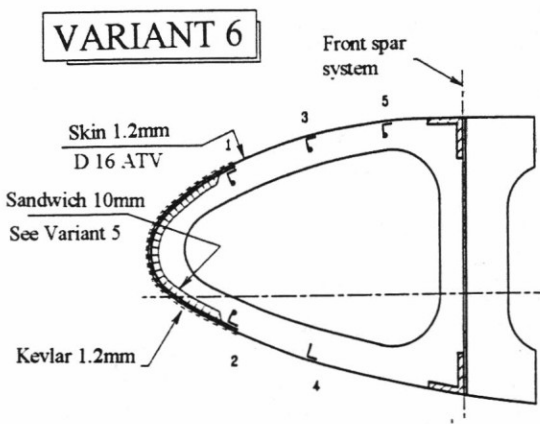
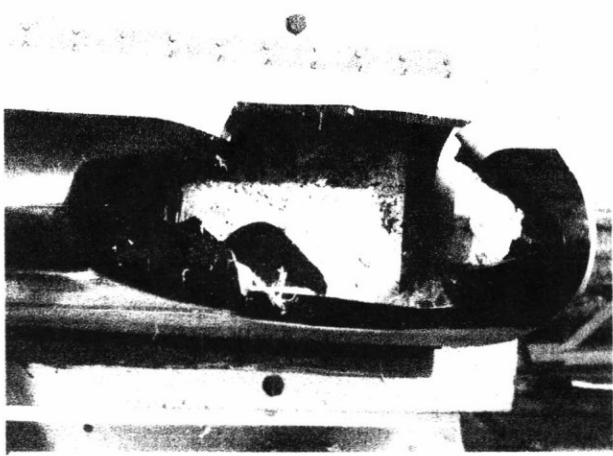
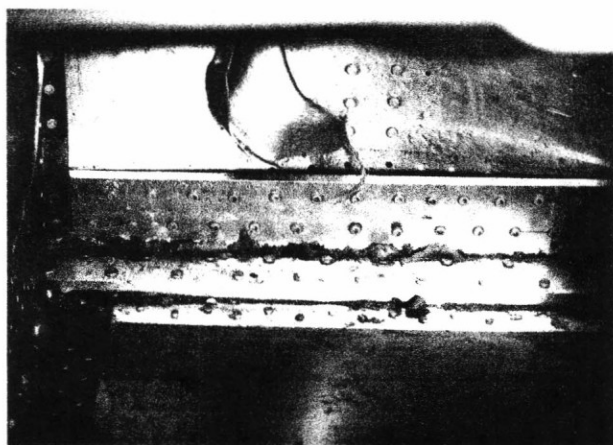
FIGURE 4 - Other Tested Structural Variants

The best type of structure is one that through local deformation deflects the bird across the wing. The destructive energy applied to the wing is substantially reduced. However, it is difficult to apply such a solution to a thick leading edge. It is possible though by strengthening the skin and supporting it. Even if the bird would not be deflected from its path, a substantial quantity of its energy would be absorbed and damage prevented to the front spar. However, the elements must be well attached to the structure. The final variant selected for the L 610 aeroplane conforms to all these principles.

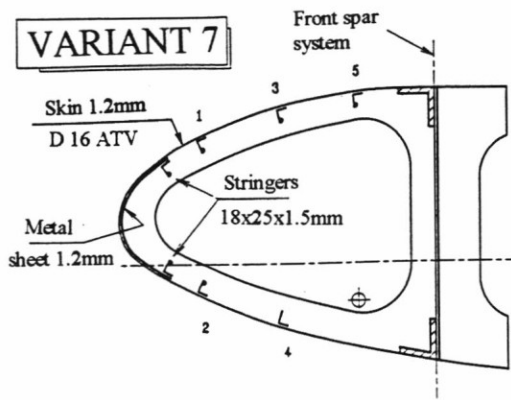
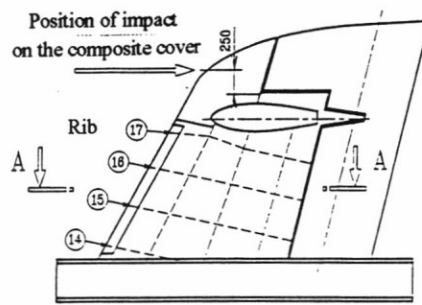
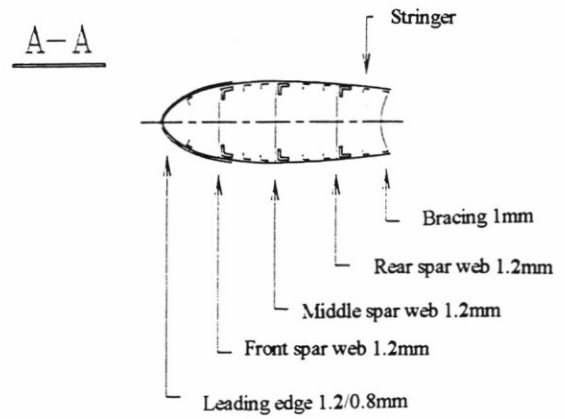
Oval openings of 150x240mm are included in the spar webs

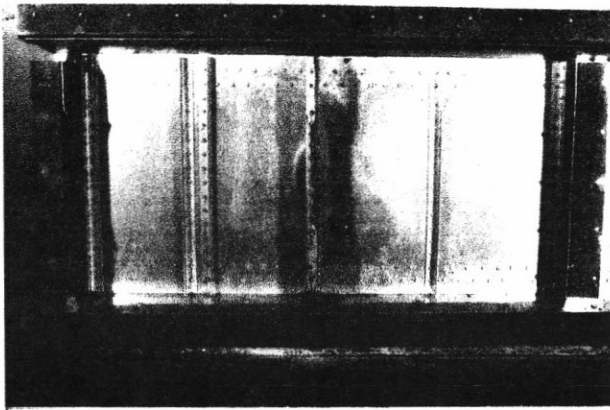
FIGURE 6 - Fin Specimen and its State Following the Tests

The impacts were directed to the composite section covering the connection of the stabilizer and fin and to the fin's leading edge located under this connection. The bird weighing 8 lb inflicted greater damage. The composite cover was damaged and the rudder's horn balance partially damaged. Despite this, it was possible to deflect the rudder in the range of 9.5 degrees. The web of the stabilizer's front spar (three spar structure) was deformed but the hinges were not damaged. The leading edge of the fin's bottom section, inclusive of the front spar web (three spar structure), was damaged. The slight deformation of the centre spar did not reduce its carrying capacity. The fin structure is still capable of completing a flight even if it has suffered such damage and therefore did not have to be altered. A specimen of the fin and the condition the structure was in following the test are shown in Figure 6.

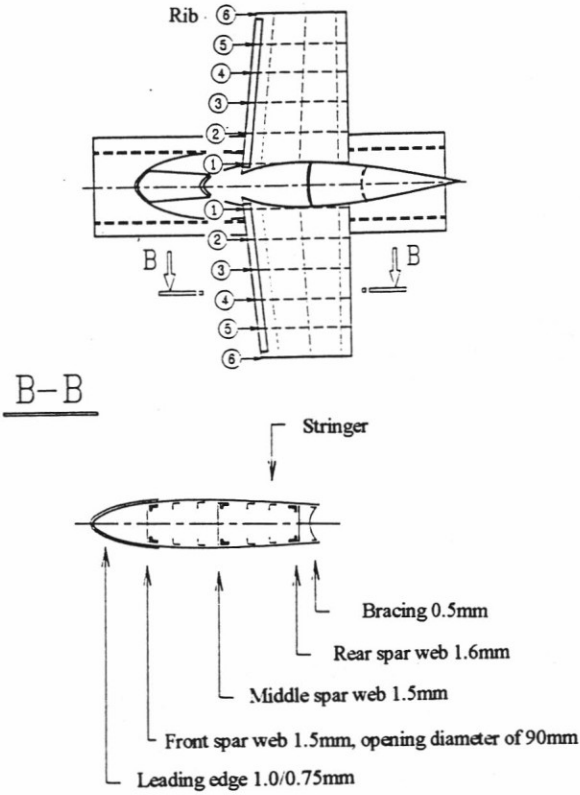
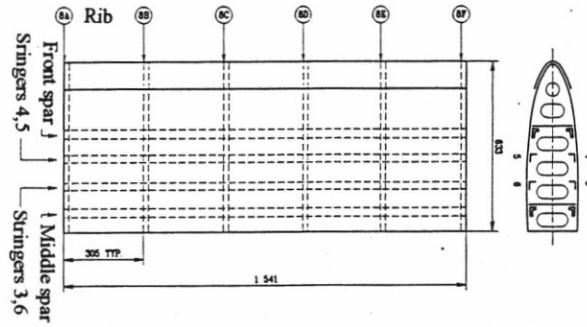
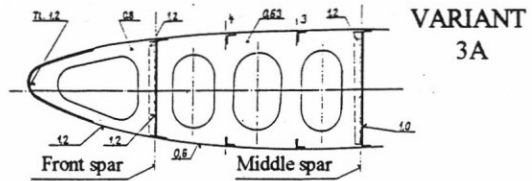
FIGURE 7 - Original Structure of a Stabilizer and its State Following the Test

The stabilizer was tested together with the mounted elevator. When tested on the original structure (Figure 7), the bird broke right through the leading edge and webs of all three spars, in the process deforming the elevator. Structural alterations were executed and variants A, B, C and D tested. The specimen and various variants are given in Figure 8. The leading edges of variant C did not break and thus did not significantly increase the magnitude of damage done to the structure. The structure deformed and the bird slid away, causing no more damage. Based on these factors, this variant was chosen as the final solution. The solidly shaped pipe, situated not far beyond the leading edge, allows it to deform without actually ever breaking. The deformation is sufficient to alter the bird's path. As a consequence of this the

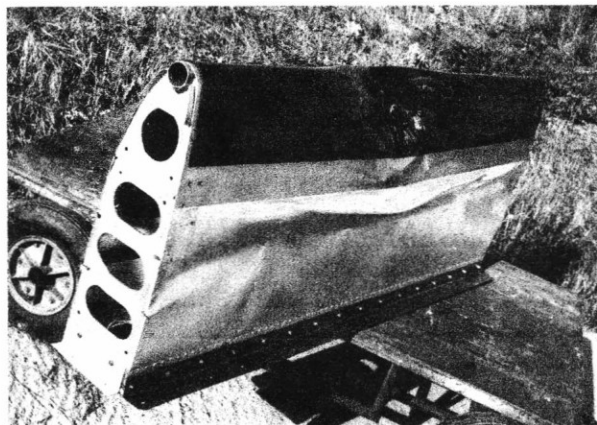
FIGURE 8 - Stabilizer Specimen for Testing of Structure Variants A,B,C,D. Final Variant C and its State Following the Test

structure only has to absorb a portion of the bird's energy, thus preventing any major damage.

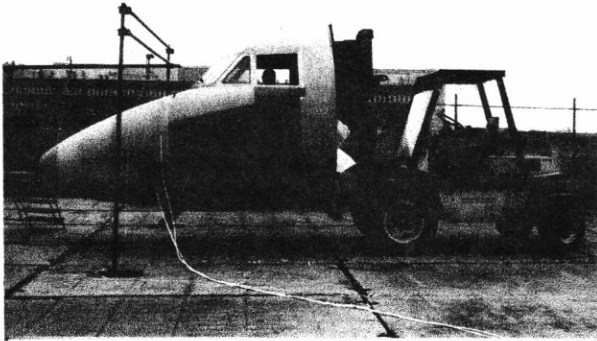
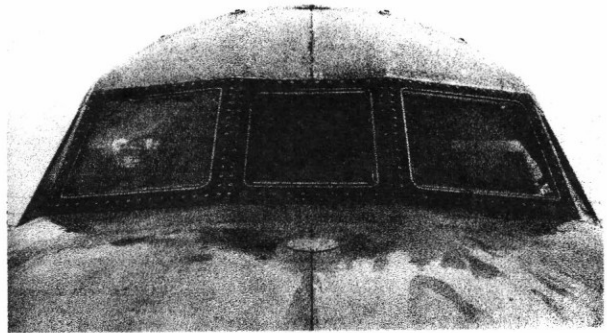
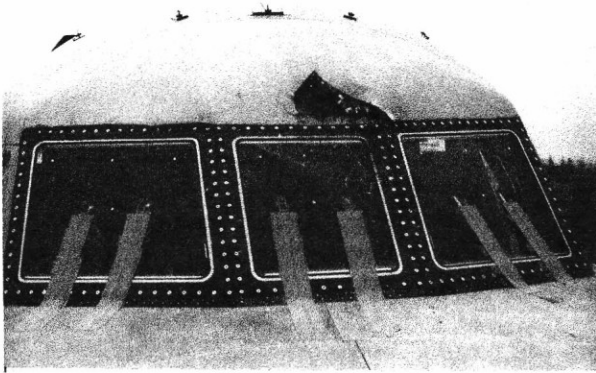
FIGURE 9 - Fuselage Specimen with a Pilote Dummy Repair of Skin Damage

The radome, made of a Nomex honeycomb structure 16 mm thick, first frame and front pressurised wall were damaged by the impact on the radome. The outer layer of the honeycomb structure was strengthened, whilst the first frame was strengthened by utilising a titanium sheet 1.2 mm thick. The ensuing shot was aimed at a point away from the nose landing gear. The radome was penetrated and although the titanium-strengthened first frame partially deformed, it withstood the impact of the bird, hence shielding the front pressurised wall.

The fuselage sections in front of and above the pilot windows are so inclined so that the bird only tore the skin and slid away without any serious consequences. The longitudinal skin joint had to be overlapped and the screws strengthened about the aeroplane's axis, above the windows, to prevent the projected birds from tearing the skin in the location of the joint. No major alterations were necessary. The original condition, how the damage was done and repair are illustrated in Figure 9.

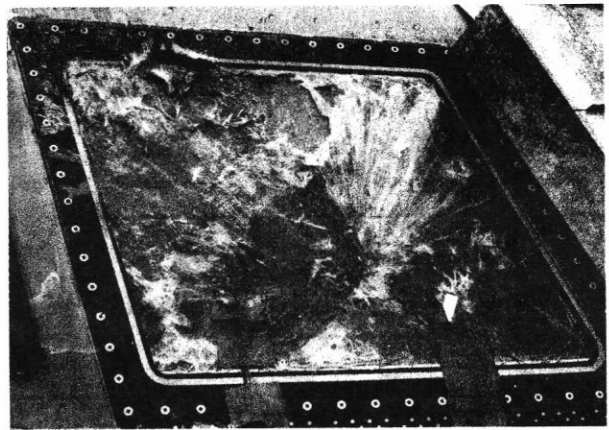
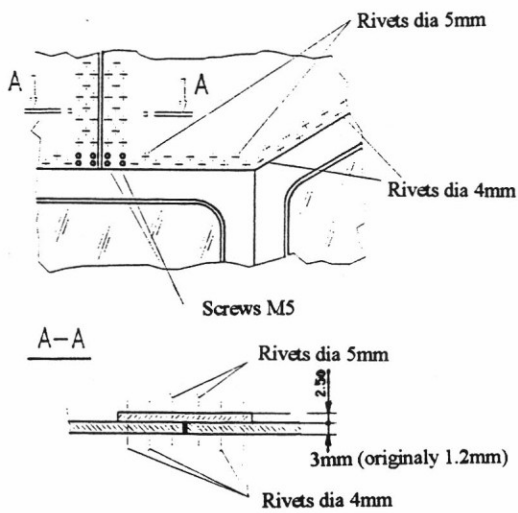
FIGURE 10 - Cockpit Windows and their State Following the Tests. The most Damaged Right Side Window

The tests involving the glass and frames of the cockpit were relatively extensive. The centre glass and the glass in front of the pilots were tested. The company Lucas Aerospace Ltd designed and produced the actual glass. A dummy pilot head covered with plasticine was placed inside the cabin in order to be able to assess any possible injury to pilots caused by glass fragments. However, no glass shattered within the cockpit during any of the tests and therefore the dummy was not injured.

glass heater installed for de-icing) and - 55°C (-30°C inside) corresponding to the drop in temperature measured for an aeroplane in flight. The cooling effect was achieved by applying carbon dioxide from a pressurised bottle placed under a cover fastened to the window. This was removed prior to the shots being fired. The positions selected for impact were in the centre and corners of the glass so as to test positions of various stiffness. Since all sections of the glass withstood impact, it was decided to weaken the centre glass by 5 mm and the glass in front of the pilots by 3 mm. Following impact with a bird, only a few small cracks were perceivable on the outer layers of the weakened centre glass, which remained transparent. The outer siliceous layers of the glass situated in front of the pilots fractured and fragments broke off resulting in the glass losing its transparency. The inner layers were also cracked but no fragments broke off.

When making a comparison of the test results obtained at various temperatures, it was obvious that the damage was greater to heated glass. Impact of the birds with the window frames did not damage or deform the frames. The condition of the windscreen following the tests is shown in Figure 10.
