PATCH REPAIR OF CRACKS IN THE UPPER LONGERON OF AN F-16 AIRCRAFT OF THE ROYAL NETHERLANDS AIR FORCE (RNLAf)

W.G.J. 't Hart, J.A.M. Boogers

National Aerospace Laboratory (NLR), the Netherlands, hart@nlr.nl

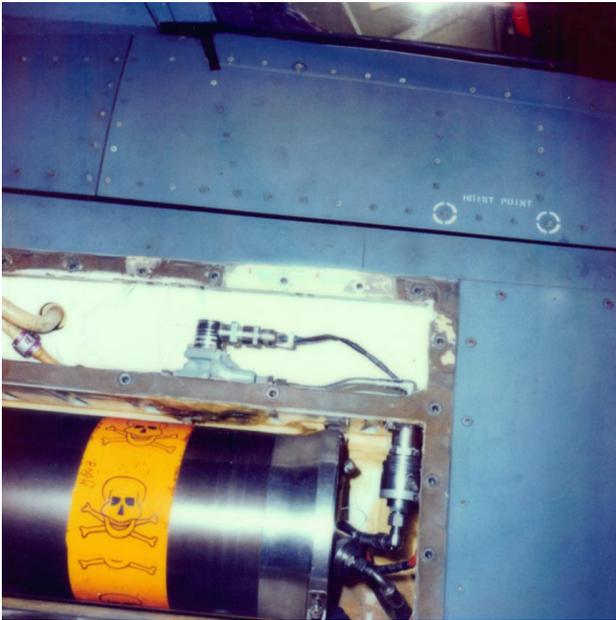
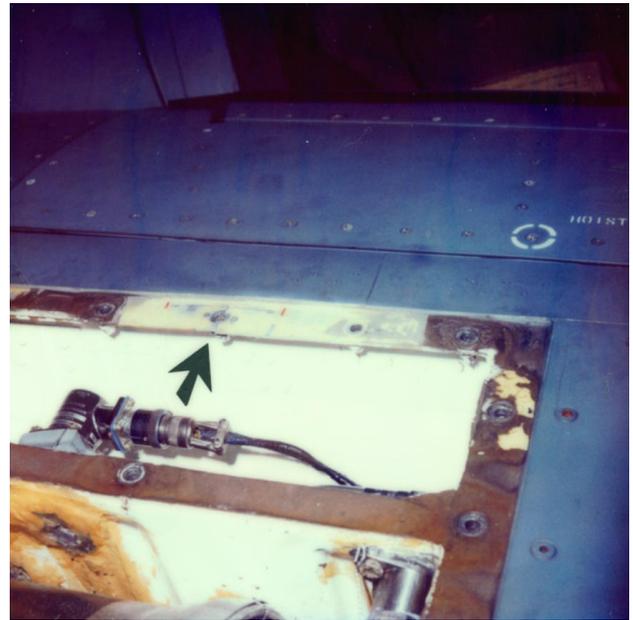
Fig. 1 Cracks in longeron 16B1111 at third fastener hole from the right (see arrow)

During a phase inspection of an RNLAf F-16, cracks were detected in the upper right longeron 16B1111-21, FS 186.90 – FS 247.89. The cracks occurred in the longeron flange for fixing the access panel 2408, at the location of the third fastener hole from the right of the panel, see figure 1. There were two cracks: one in longitudinal direction (outside the hole) and one transverse crack through the hole, see figure 2. The longitudinal crack length was about 70 mm and the transverse crack about 22 mm.

Location of access panel 2408

Arrow indicates location of cracks

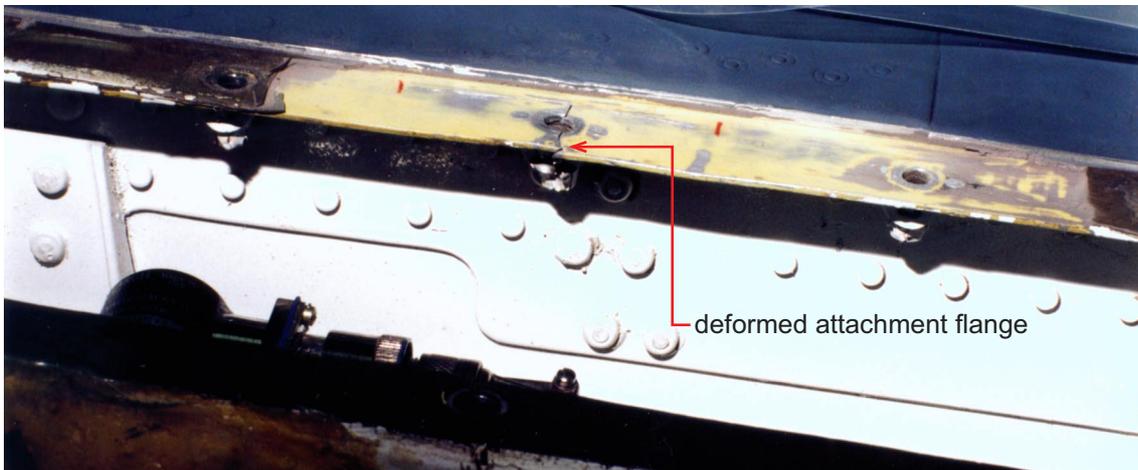
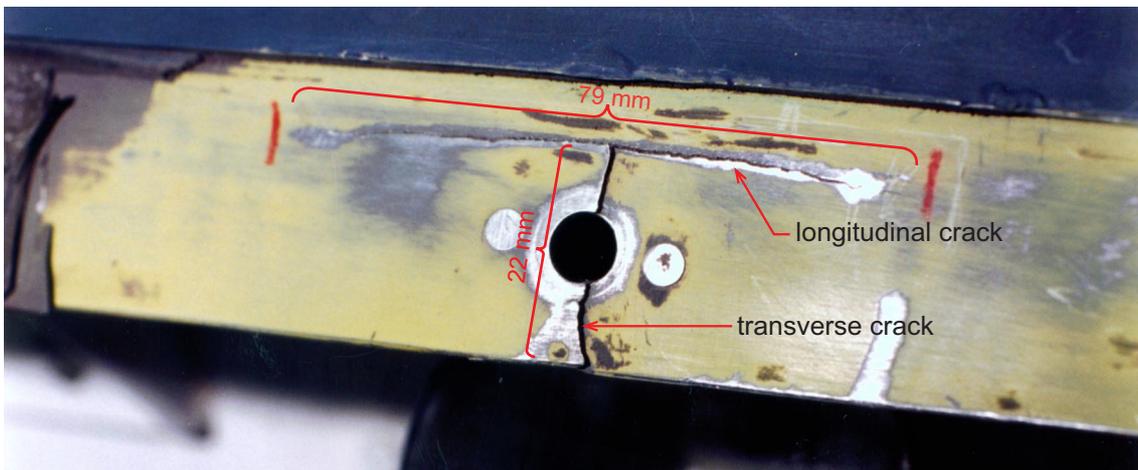
Fig. 2 Details of cracks in longeron

Figure 2 shows the main cracks that were found in the upper attachment flange. In the top view it is seen that the flange is somewhat deformed and the upper surface shows signs of rubbing. Further, it was observed that the nut riveted to the flange lower side had an oblique orientation. These discrepancies indicated a bad fit of the panel on the longeron flange.

Operational aircraft loads in combination with assembly-induced bending stresses most probably caused the longitudinal crack first. Subsequently, the transverse crack initiated

from the fastener hole owing to dynamic tensile stresses in the longeron.

Side view

deformed attachment flange

Upper view

longitudinal crack

transverse crack

The patch repair concentrated on restoration of the longeron strength in the longitudinal direction. However, a bonded patch does not remove the longitudinal crack. In order to prevent possible further growth of the longitudinal crack, stop drilling at the tips of the longitudinal crack was recommended.

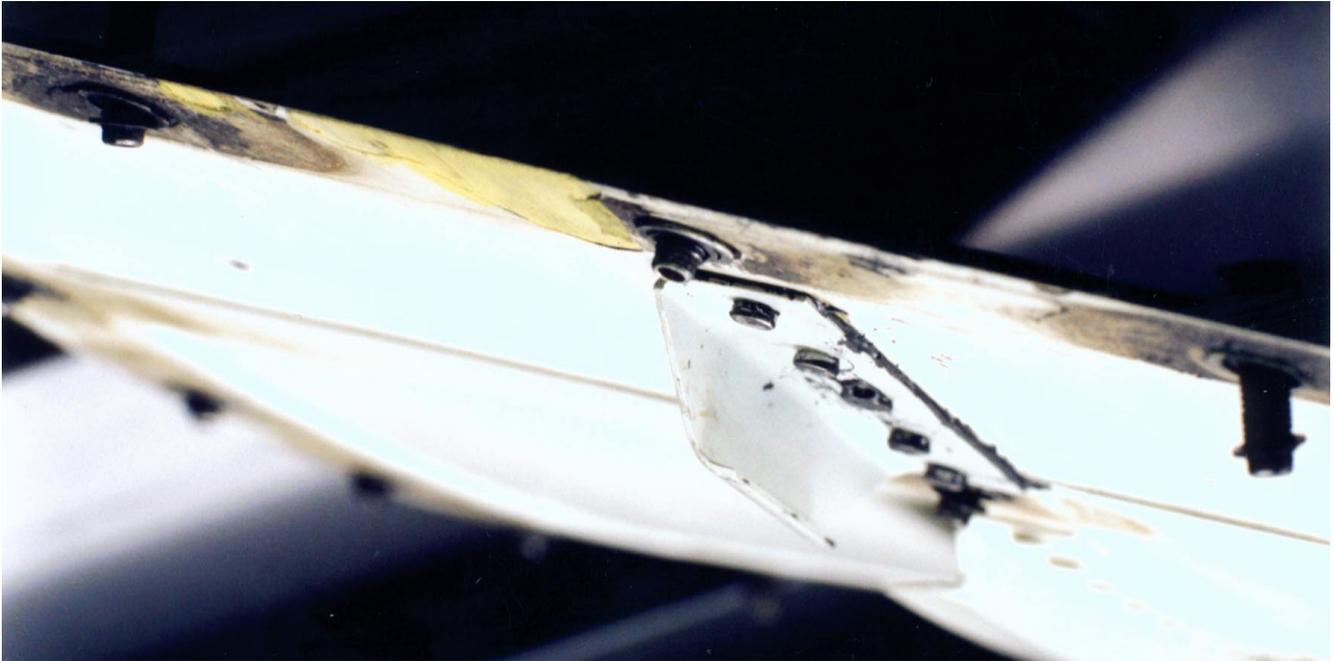
Fig. 3 Lower side of access panel 2402 with a stiffener repair

The specific access panel had been previously repaired with a relatively large stiffener that ended at the fastener hole where the cracks were found (Fig. 3). It is most likely that the access panel plus this large stiffener had introduced large static bending stresses in the flange owing to the bad fit.

In the present investigation cracks in the upper right longeron of an F-16 aircraft of the RNLAf were investigated. The main cause for cracking was the occurrence of assembly stresses due to an improperly repaired access panel 2408. Since a conventional mechanical repair could not be done, the OEM advice was removal and replacement of the longeron. However, because the aircraft would be retired from service after 400 flights hours, a cost effective bonded patch repair was evaluated and applied to the cracked longeron. Inspections during the remaining operational life did not show any damage propagation in the repair. Thus the present investigation has shown that adhesively bonded patch repairs can be very useful and cost-effective, especially when the repair has to be sustained only during a limited service life.

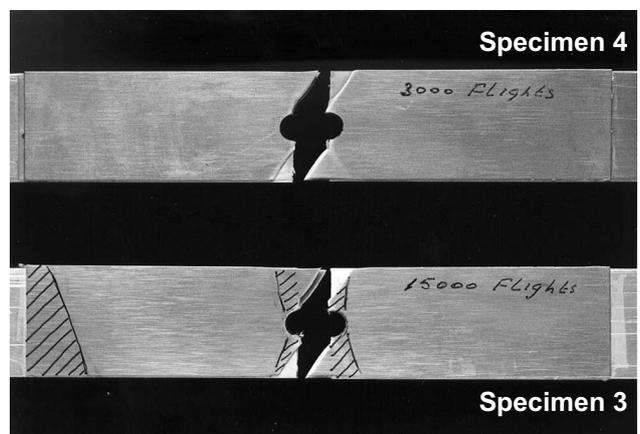
Fig. 8 Residual strength tested specimens after fatigue testing for 3000 and 15000 flight hours. (delamination after fatigue testing was only found for the specimen tested for 15000 flights)

Figure 7 gives the test results. The static failure load of the undamaged open hole specimen was 19.9 kN, specimen 1. Fatigue testing at 130 % LW-VAL resulted in a life of 14300 flights, specimen 2. Specimen 3 demonstrated that the repair survived 15000 flights after which a residual strength of 23.1 kN was obtained. NDI before residual strength testing showed local delamination at the edges of the titanium patches. Specimen 4 did not show signs of debonding after testing for 3000 flights. The residual strength was 25.3 kN. Figure 8 shows the failed repair specimens. Both specimens showed tensile failure of the

Titanium patches despite local fatigue induced delamination for specimen 3.

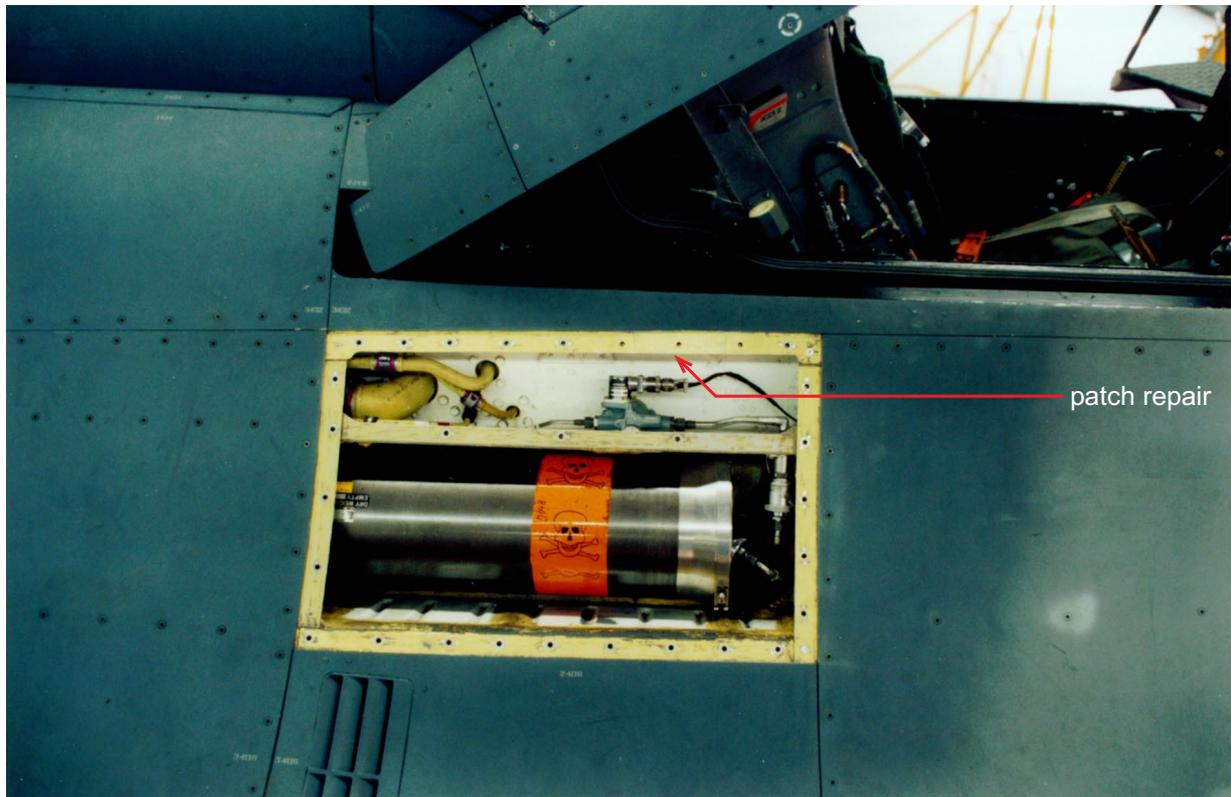
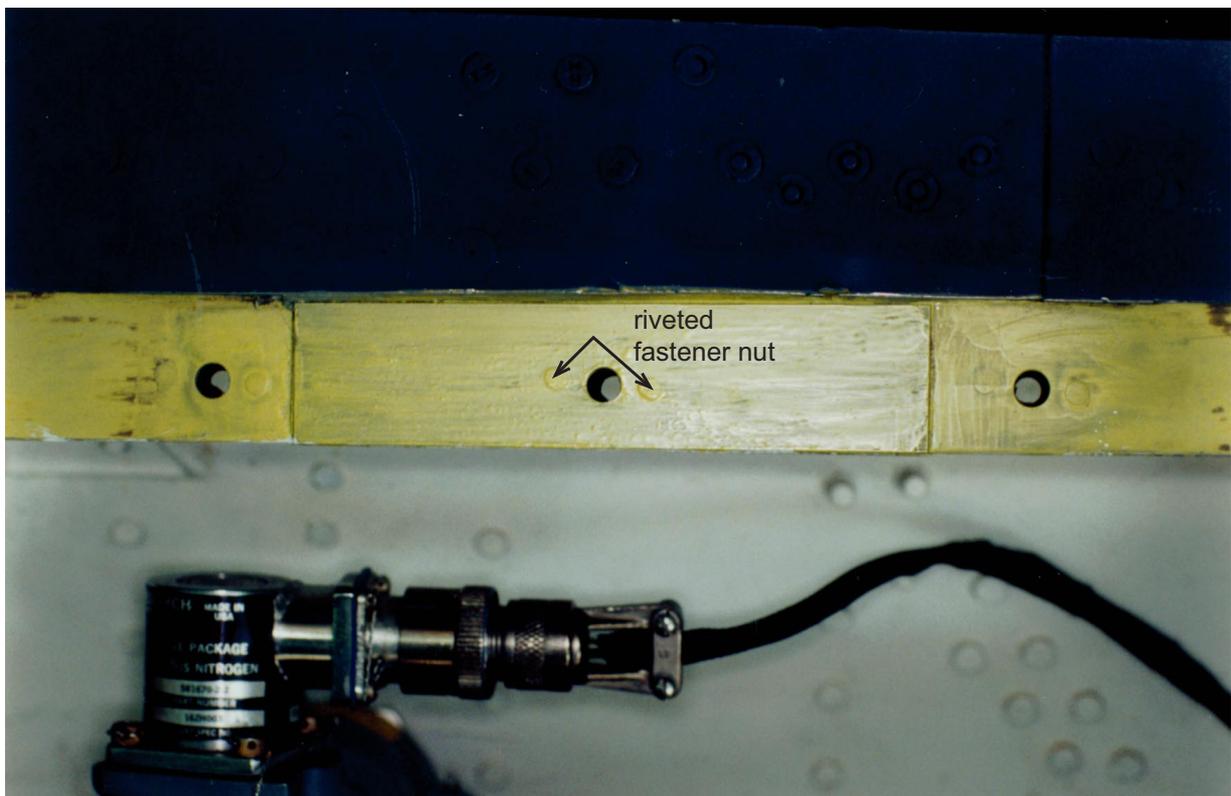
Fig. 9 Repaired longeron

Location of the repaired attachment flange

Detail of bonded patch repair

In March 1997 the cracked longeron was repaired. Before the Titanium patches were applied the deformed attachment flange was straightened to guarantee good contact between patch and flange. The surface pre-treatment consisted of abrasive blasting (Al_2O_3) of the Titanium patches and sanding of the aluminium flange. After bonding, the repair region was provided with the F-16 primer, FMS-3035, figure 9. A spare access panel was fixed to the structure using liquid shimming to compensate for the patch thickness.

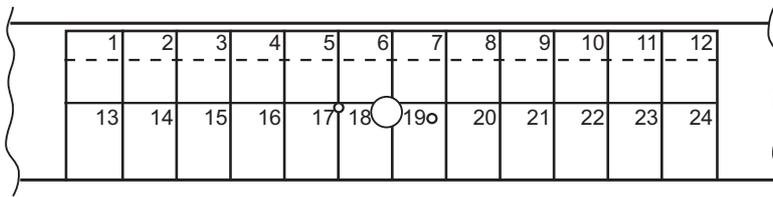
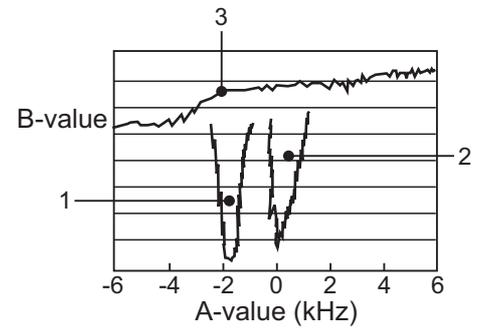
Fig. 10 Inspection set-up for Fokker Bondtester inspection

hours. No signs of paint cracking at the edges of the patches, debonding or crack propagation were found, and in 2000 the concerned F-16 aircraft was retired from service.

For checking on debonding the Fokker Bondtester Model 70 was used with transducer 1414 and coupling fluid. The patch surface was divided into areas of about 1 cm^2 , figure 10. The possible Fokker Bondtester responses are indicated in the same figure and were used as calibration signals during the periodic inspections.
