FATIGUE INITIATION AND CRACK GROWTH BEHAVIOUR IN GLARE FROM THE AIRBUS MEGALINER BARREL TEST

R.J.H. Wanhill, T. Hattenberg, P.H. de Haan
National Aerospace Laboratory NLR, Amsterdam, The Netherlands

Abstract

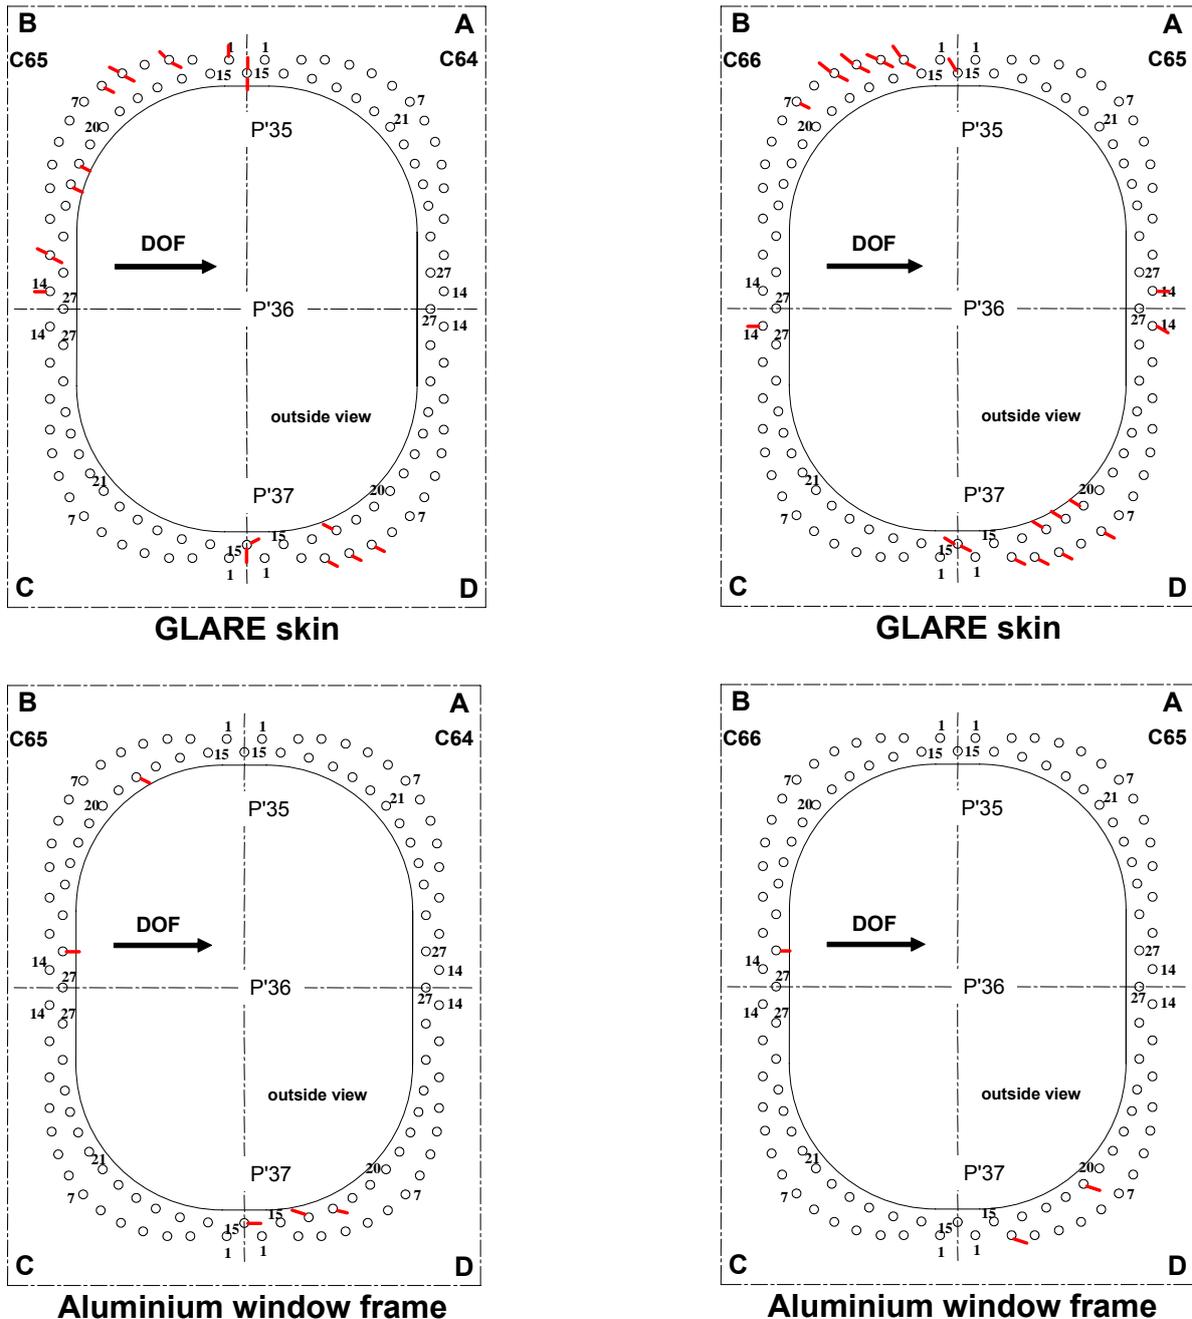
Fig.2. Overviews of the crack indications from NDI of the fully disassembled GLARE skin and aluminium window frames. **DOF** = Direction Of (simulated) Flight

crack indications than the window frames, mostly in the **B** and **D** quadrants. These were the quadrants largely subjected to shear loads during the MLB fatigue test.

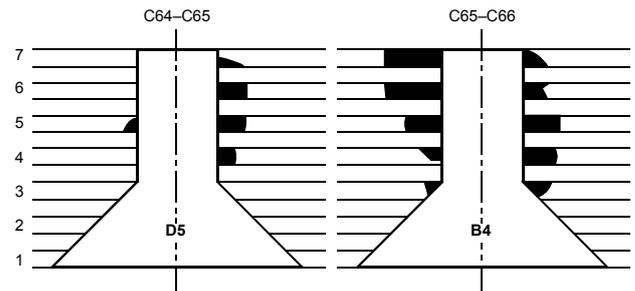
Fig.4. Examples of GLARE cracking

Figure 4 gives representative examples of the cracking patterns in the aluminium layers of the GLARE skin. Most cracks were in the fastener hole bores, the largest mainly in layer 5. Only a few cracks grew from the countersinks, and only in layer 3.

The R.H. example in figure 4 shows the fastener hole (B4, C65-C66) with the largest GLARE cracks. These were 0.91 and 0.95mm long. The crack in layer 6 was selected for detailed fractography.

The smaller cracks in figure 4 show that they began from one or both corners of an aluminium layer. This was also the case for all the other cracked fastener holes in the GLARE skin. Thus the most likely causes of fatigue crack initiation, besides the severity of the applied fatigue load spectrum, are the stress concentrations provided by these corners.

However, this does not explain why many more cracks began in the fastener hole bores (layers 4 – 7) rather than in the countersinks (layers 1 – 3), where there are so-called “knife edges”. It is possible that local secondary bending favoured fatigue initiation in the fastener hole bores.

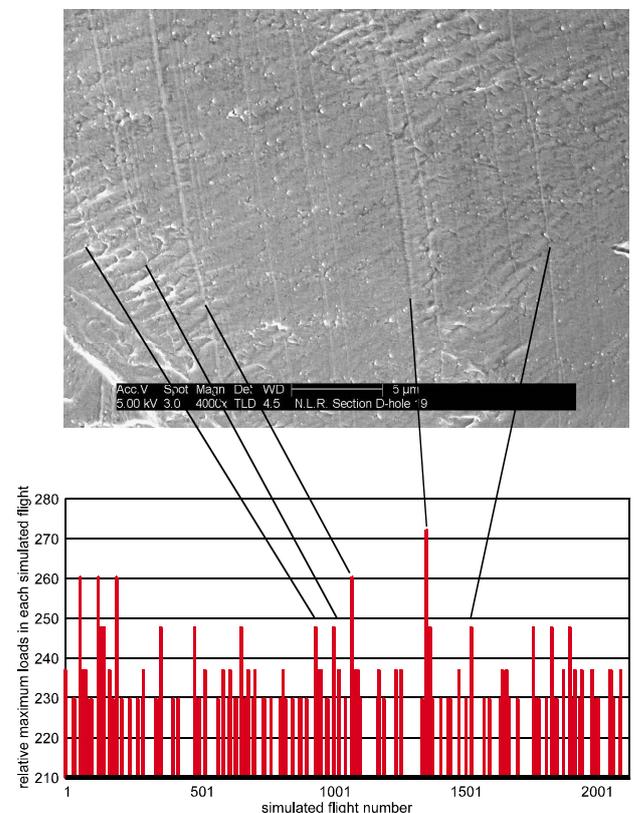
Fig.5. Example identification of severe flights from crack front markings by peak loads

Figure 5 gives an example of identifying the severe simulated flights, notably flight types **A**, **B** and **C**. The crack front markings from these flights were mostly sufficient for tracing fatigue crack growth back to a small crack length. However, the fainter crack front markings from **D** type flights helped in checking the numbering of **B** and **C** type flights. In general, the fractographic “readability” was excellent.

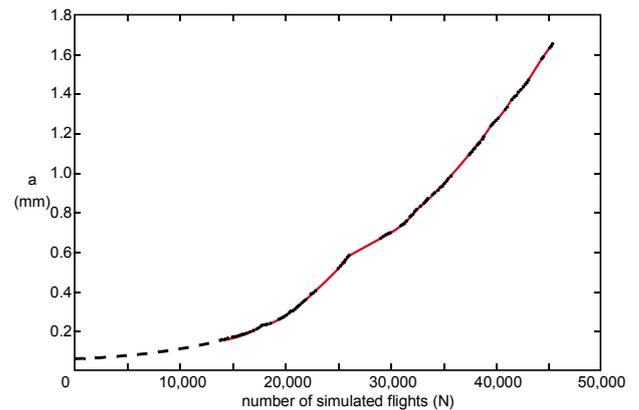
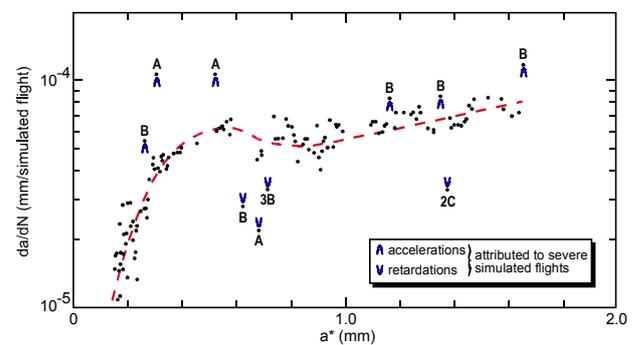
Fig.6. Window frame crack analysis

Figures 6a and 6b show the curves of a versus N and da/dN versus a^* , respectively. Both show the effects of severe simulated flights, pointed out explicitly in figure 6b. Most of these effects appeared to be transient.

However, beginning at a crack length of about 0.6mm there was a persistent retardation of fatigue crack growth. This could be due to termination of the “short crack effect”. This effect is well known, and is generally attributed to no fatigue crack closure in cracks smaller than about 0.5mm. Thus once the window frame crack grew beyond 0.5mm, closure-induced retardation due to peak loads in severe simulated flights would have become possible.

The a versus N curve in figure 6a suggests that the fatigue “initiation” life was zero, and that there was an initial crack size of about 0.06mm. In fact, the crack initiated from a fretting scar due to fastener movement against the bore of the fastener hole [2]. This explains the effectively zero fatigue “initiation” life [3] and also the indication of an initial crack size, which was most likely due to the fretting scar.

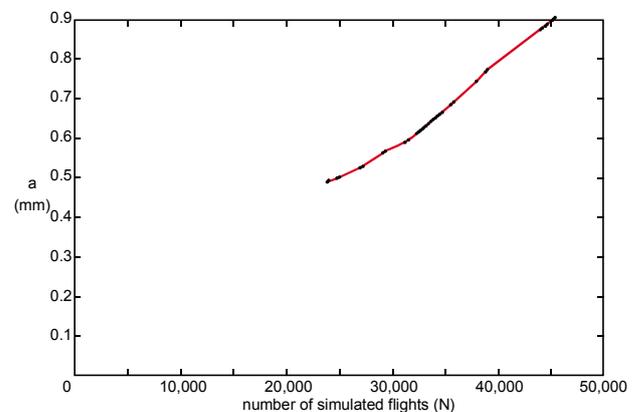
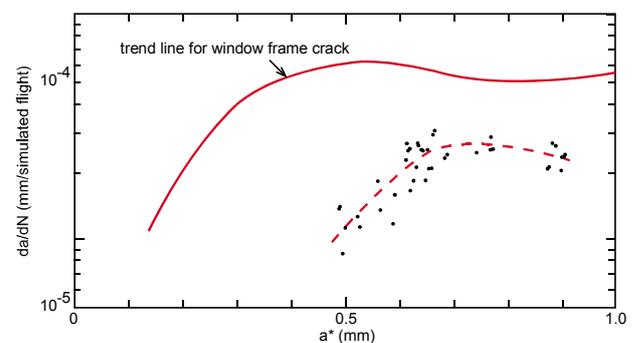
Fig.7. GLARE crack analysis

As stated in subsection 4.2, the selected crack was in aluminium layer 6 of fastener hole B4 in window area C65-C66. Figure 7 presents the same types of crack growth curves as those for the window frame crack. The data are limited, but enough to show a growth rate “plateau” at

about 50% of that for the aluminium window frame.

Back-extrapolation of the *a versus N* curve in figure 7a is unfeasible, owing to the limited data. The crack could not be traced back to less than 0.45mm, owing to too closely-spaced crack front markers. Hence an estimation of the fatigue “initiation” life is not possible.
