COMPOSITE REPAIR FOR METALLIC AIRCRAFT STRUCTURES DEVELOPMENT AND QUALIFICATION ASPECTS

G. Günther, A. Maier

European Aeronautic Defense and Space Company – EADS
Military Air Systems, Germany

This paper describes the development aspects of a repair-programme for a specific high load transfer area of a metallic engine inlet duct panel featuring a complex geometric contour in an integral fuel tank area of a fighter aircraft.

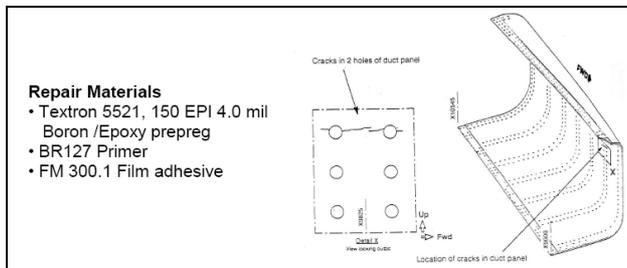
Fig 7-2 Repair location in engine duct

Access to the location is limited from inside the engine duct only, the location is close to the lower end of the upper radius of the duct structure. Target for the repair was test continuation for additional 1000 test hours with

no further crack growth during this period. Using boron epoxy bonded doublers, due to the curvature of the duct panel in circumferential direction and the change of radius in the longitudinal direction the patch geometry was limited to 9 plies with a 4 mm taper / ply.

Analytical investigations for the max. loading conditions indicated a circumferential stress level of 200 MPa at Design limit load (DLL) in the repair zone. In order to achieve no crack growth for the desired additional testlife, crack growth analysis indicated a reduction of approx. 50% in the substructure would be required.

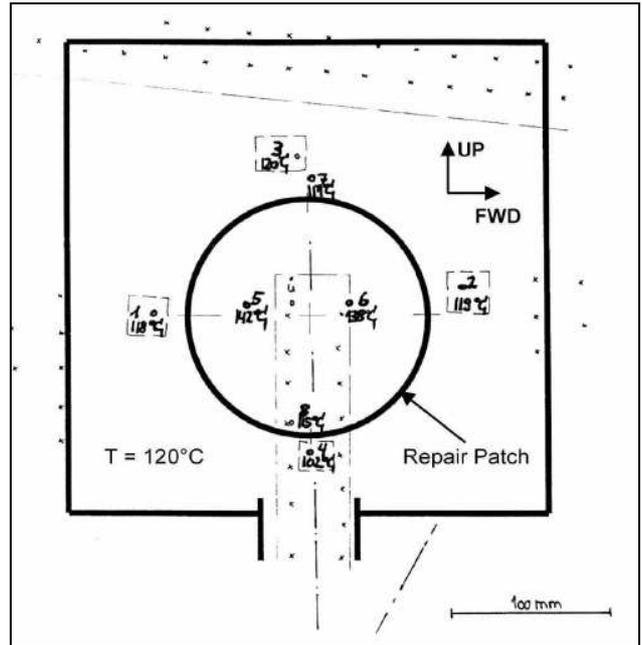
Fig. 7.2-4 Heat sensor elements during simulated bondline curing

While the min. temperature will determine cure cycle dwell time, max. temperatures need to be closely monitored in real aircraft applications in order to stay within limit of sealants for fuel tanks, cable looms or other equipment installed in the vicinity of the repair, especially when access is limited to single side

The final application process of the repair used a total cure time of 24 h and 120 °C, as shown in the a.m. Fig 7.2-4, the repair set up is shown in Fig. 7.2-5, the completed repair after debuging in Fig. 7.2-6

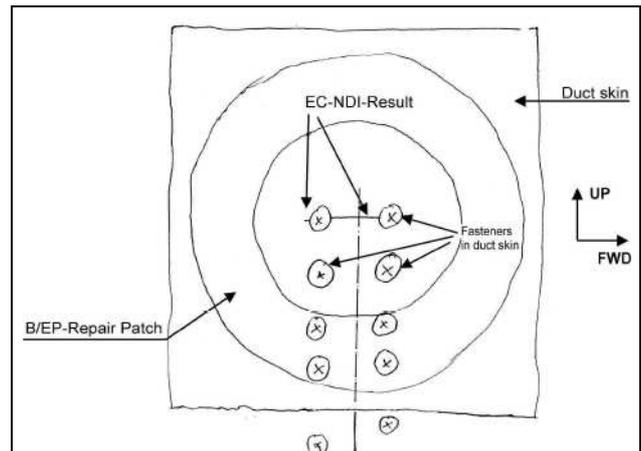
Fig. 7.3-1 EC-NDI Results at 500 Testhours

The bondline was inspected after curing using standard ultrasonic NDI and was considered free of delaminations and unacceptable porosity. The crack between two fasteners was detected through the repair patch using eddy current NDI, however, the two smaller cracks developing from the fasteners to either side opposite of the link-up crack could not be detected at this point in time. After restart of the test, NDI of the repair was performed after 500 test hours using identical techniques to indicate any changes [5]. No changes were detected for the bondline and eddy current (ED) showed the two smaller cracks LH / RH of the two fasteners missed before in the first inspection, original NDI plot see Fig. 7.3-1.

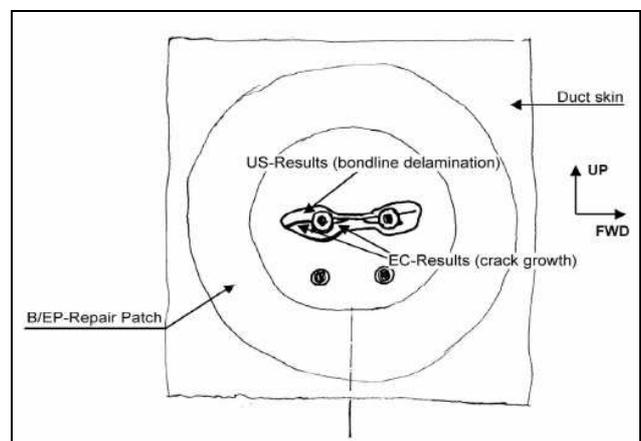
Fig. 7.3-2 EC-NDI Results at 1000 testhours

After 1000 testhours these two cracks increased in length and ultrasonic testing of the patch revealed delaminations in the bondline around the two fasteners and the crack location, Fig. 7.3-2.

Although the full "crack arrest target" was not achieved, the repair proved successful in slowing down the crack growth and enabling the full scale test continuation for add. 1000 test hours without unstable crack growth.

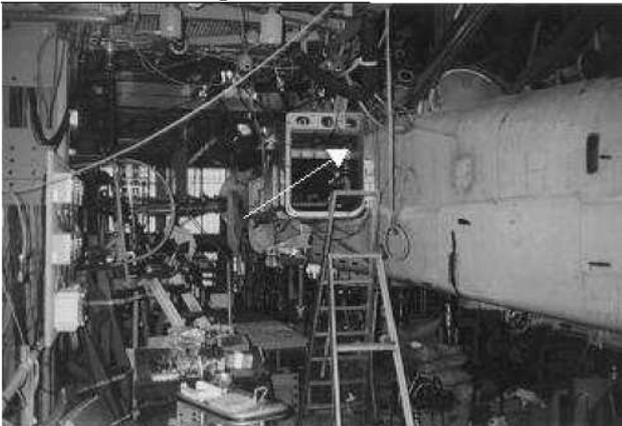
Fig. 7.4-2 Repair Location

Figure 7.4-2 shows the test article and the location of the repair.
