ANALYSIS AND COUNTERMEASURE ON AERO-ENGINE BLADE DEFECT

Zhijun Sun, Zijing Guo, Guoliang Liu
AVIC Xi'an Aero-engine (Group) LTD.

Abstract: A large number of finished turbine blades on aero-engine, which were made by deformation nickel superalloy, were found defects on their body, serration and shroud during the finished fluorescence inspection. And the defects were investigated by using macroscopic observation, microscopic observation, surface state analysis, fracture observation, and classification statistical analysis. The results show that the defects can be divided into three categories: 1. Local intergranular attack; 2. Intergranular thermal stress cracks caused by grinding and polishing; 3. Surface machining damage. And the formation mechanisms of the three types defect are analyzed. The qualified rate of finished turbine blade is improved to 95% by new proposed process optimization.

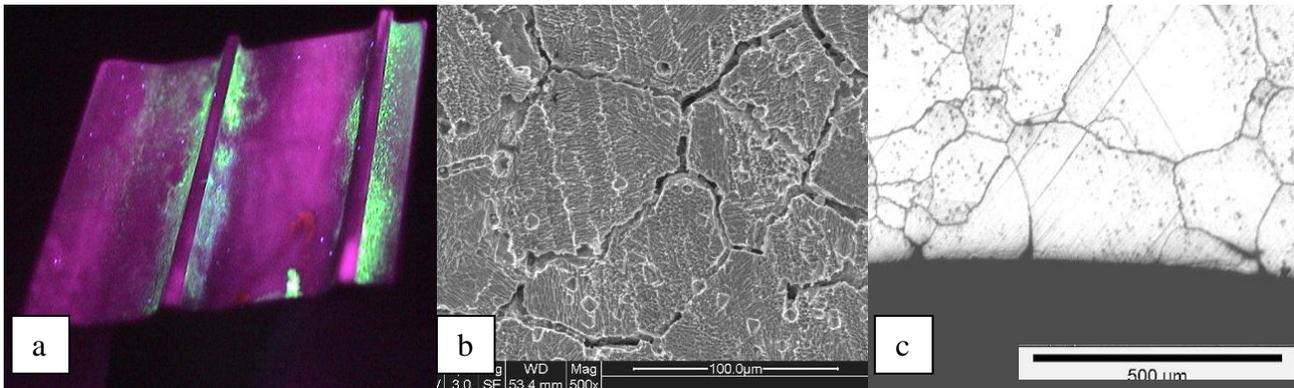
Figure 1 Morphology of reticular fluorescence displays at shroud

1) Reticular fluorescence displays: it is found that the distribution of fluorescence displays is clustered flake under fluorescent lamp. Using microscopic observation, there are clearly overstriking network grooves along grain boundaries. And the machining surfaces of grain are became rough with etch pits. Meanwhile it is found that there are tiny intercrystalline cracks extend into the matrix along the grain boundaries. These cracks have larges opens and blunt ends without material and metallurgical defects around them. Also, their length is 0.03mm to 0.06mm, as shown as in Figure 1.

a. Fluorescence displays at top surface of shroud b. Reticular grooves along grain boundaries
c. Metallographic morphology at profile

All fluorescence displays are belong to local intergranular attack.

This type of fluorescence displays is distributed at shroud, serration and trailing edge of body. And it accounts for 3% of the damaged blades. Grinding is used to manufacture the flank and top surface of shroud. Too large feed and inadequate cooling will lead to the local overheat on surface. If the incorrect polishing is used, it also lead to the local overheat. After the blades machining are finished, FeCl₃ etching will be performed for fluorescence inspection. Because of the local overheat on shroud and body, the electrochemical corrosion is inhomogeneous. Under the same etching medium and time, the overheat position caused by polishing will form the preferential intergranular attack. Therefore, at the prescriptive etching time, there has different etch state. At the overheat position, it is reticular overstriking grain boundaries and local intergranular attack. In adding, the displays on serration is related to poor protection.

i) To prevent local overheat and thermal stress cracks, the grinding feed is decreased and the coolant flow of grinding is increased;

ii) During polishing, increasing the feed frequency with the decreasing of feed, to prevent the local overheat and thermal stress crack caused by excessive polishing;

iii) Using rubber to protect the serration during etching.

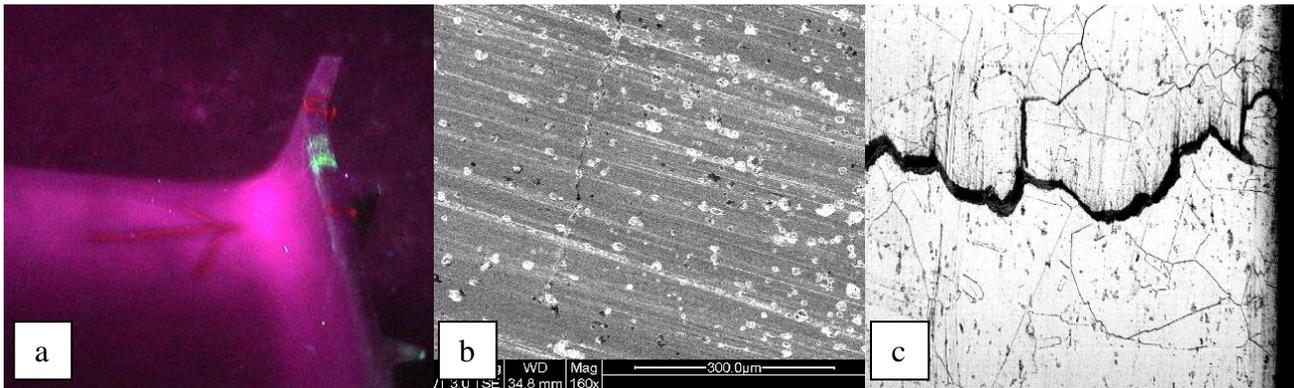
Figure 2 Fluorescence displays morphology at flank of shroud

2) Linear fluorescence display: they are single-strip or parallel multi-strip, and with the length from 3mm to 7mm. The fluorescence displays are cracked along the reticular grain boundaries, and perpendicular to the grinding directions. Also, the machined surface has lots of spalling. Observed by using metallographic observation, it is shown that the cracks are reticular and tiny intercrystalline cracks with fine end. Meanwhile, there are secondary cracks

with slight oxidation. The length of cracks is 0.2mm to 0.5mm. Especially, individual cracks throughout the shroud with the length of 1mm, as shown as in Figure 2.

a. Linear fluorescence displays b. surface morphology of cracks c. metallographic morphology of profile

These types of fluorescence displays belong to the grinding cracks.

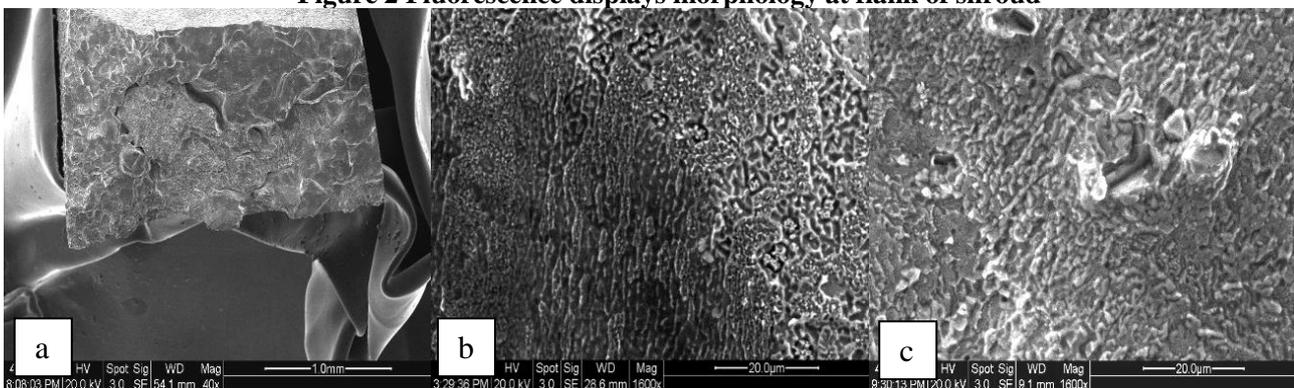
Figure 3 Fracture morphology of shroud cracks

Observed the whole fracture after opening the cracks, its characteristic is intergranular fracture. The original crack is black grey with slight oxidation. Its fracture feature is intergranular fracture with dimple. The biggest distance from the cracks to surface is 0.8mm. The photographs are shown in figure 3.

a. Morphology of the whole fracture b. Micrograph morphology of crack fracture

c. Micrograph morphology of artificial fracture

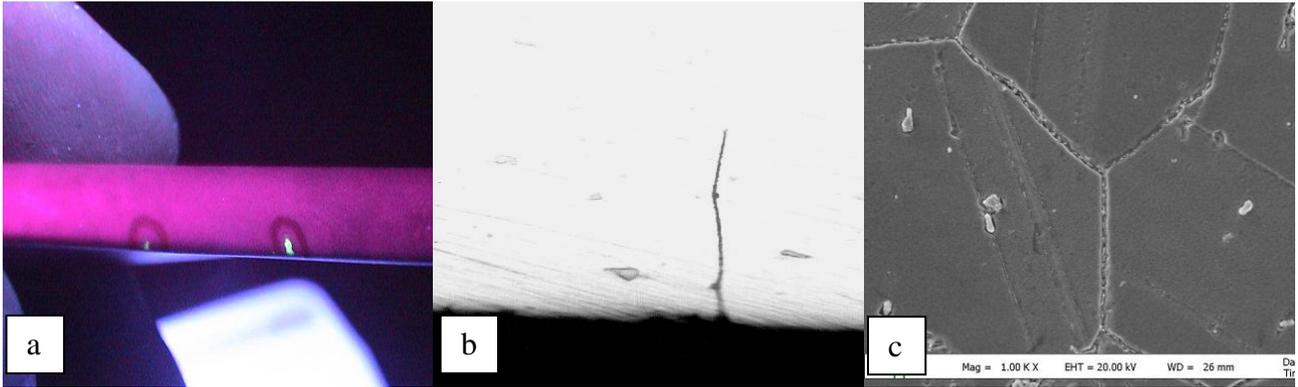
Figure 4 Fluorescence displays on body

1) Thermal stress cracks caused by grinding or polishing: the fluorescence displays are intercrystalline cracks by using microscopic observation. Metallography observation indicates that there are lots of tiny, grayish black intercrystalline cracks with fine end and the length of 0.17mm. And there are chain carbides precipitated on the grain boundaries. Compared the crack fracture with artificial fracture, the

crack fracture is dark brown, and the artificial fracture is sliver gray. There is a obviously boundary between both of them. In additional, the crack fracture is similar to the grinding crack in 2.1(Figure 3b), and its fracture feature is the intergranular fracture with dimple.

All of these fluorescence displays belong to the thermal stress crack caused by the grinding or polishing overheats on body.

a. Linear displays b. Morphology of crack profile c. Chain carbides precipitated on the grain boundaries

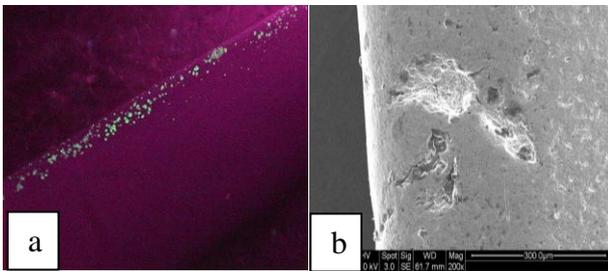
Figure 5 Fluorescence displays on bodie

3) Machining damage on body surface: there are obvious flake peeling on the body. Meanwhile, there are lots of micro-pits on the surface. Both of them are caused by machining, as shown as in figure 5.

a. Reticular or densely punctate b. Machining damages

Machining damages of body: these damages can be solved by using high frequency and low feed in grinding and polishing.

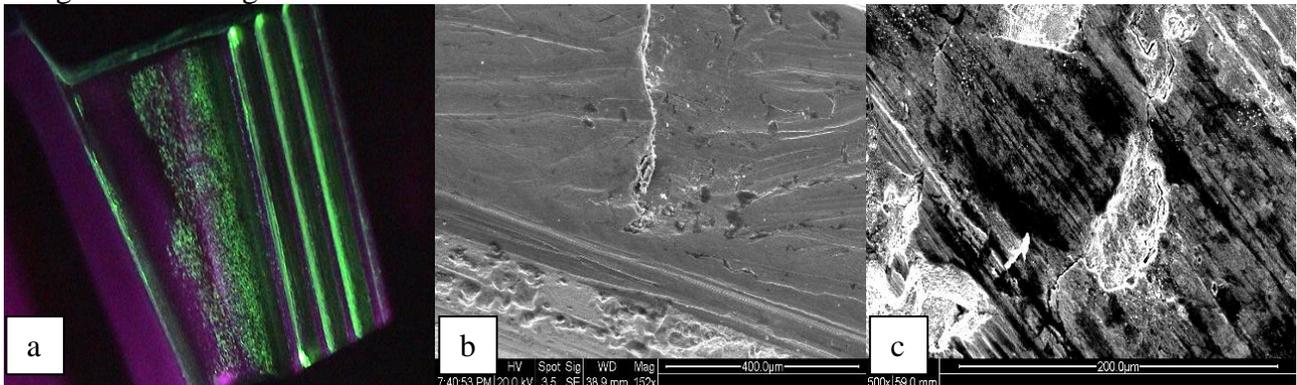
Figure 6 Fluorescence displays on serration

2) Machining damages on serration surface: The fluorescence displays on serration are densely punctate in most of blades. Microscopic observation results show that these damages are machining mark, flaking, peeling, step, surface micro-pit, or laps, which are damages caused by the broaching or grinding, as shown as in figure 6. All of these displays belong to the machining damage on serration surface.

a. Fluorescence Displays b. Step c. Peeling

According to the above mentioned analysis, this problem was solved by modifying the front angle of broach, improving the sharpness of tools, increasing the cooling medium flow, and determining the tool service life (acceptance amount of broaching blade).

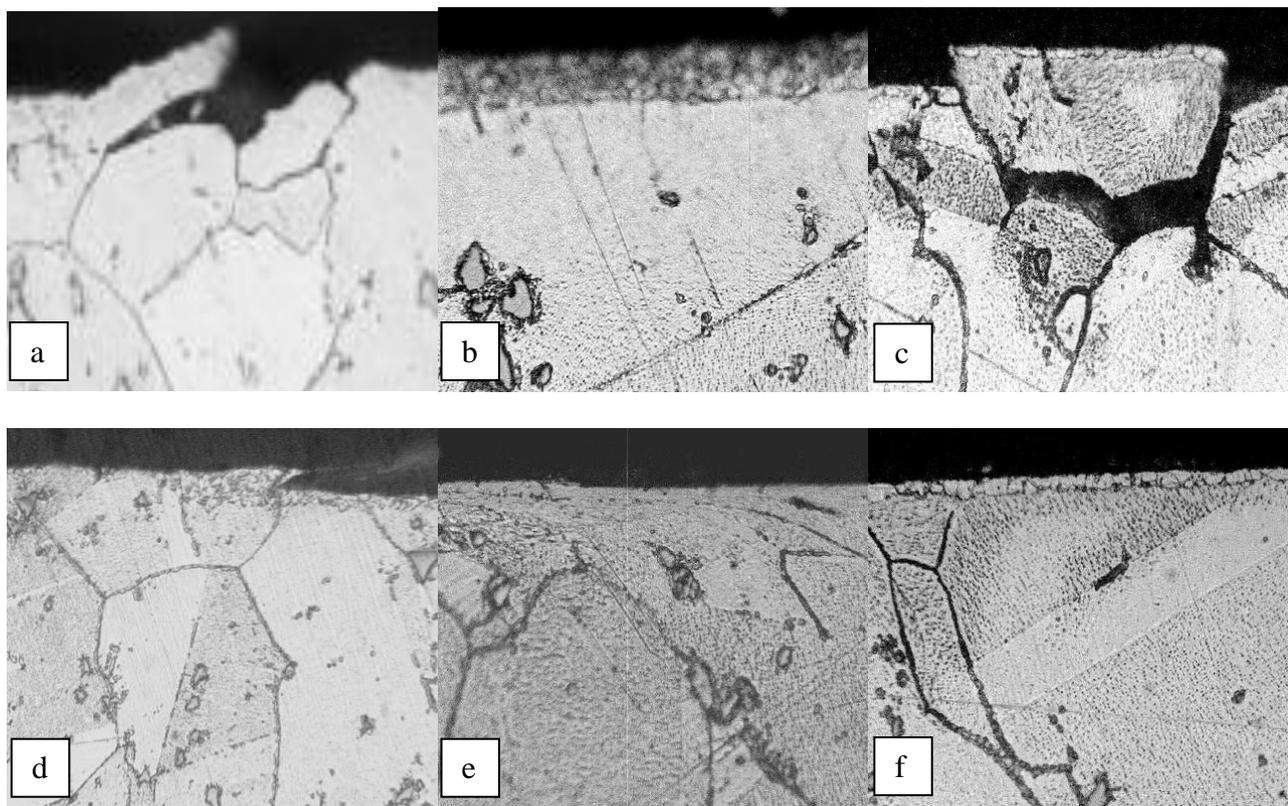
Figure 7 Machining damage on serration surface

The testing results show that the existences of work hardenings are distributed on the whole machining surface of serration. And local or individual positions exist the re-deposited layer, plucking, laps. Especially, there are grain loosening or peeling in individual positions, as shown as in figure 7.

The discontinuity of surface, which was caused by re-deposited layer, plucking, laps and grain loosening on the serration surface, leads to the fluorescence displays. And the machining hardening and recrystallization not only show the surface damage degree, but also show the quality of machining parameters.

a. Plucking b. Re-deposited layer c. Grain peeling
d. Laps e Working hardening f. Recrystallization
