# Failure Analysis on Rear Gearbox Output Gear of Helicopter

**Abstract:** A tooth of a rear gearbox output gear in a helicopter fractured after service for a period. The failure mode and causes of the gear were analyzed by macro and micro observation, hardness and carburized depth testing, microstructure examination, roughness and round angle measurement. The results show that the fracture surface exhibited fatigue fracture characteristics. It is concluded that the gear failed by fatigue fracture. The crack initiated from the working face of the dedendum round angle. The working face round angle of the gear is smaller than required, resulting in stress raisers, which is the main cause for the fatigue fracture of the gear. It is recommended that the manufacturing processes of the dedendum round angle should be concisely controlled.

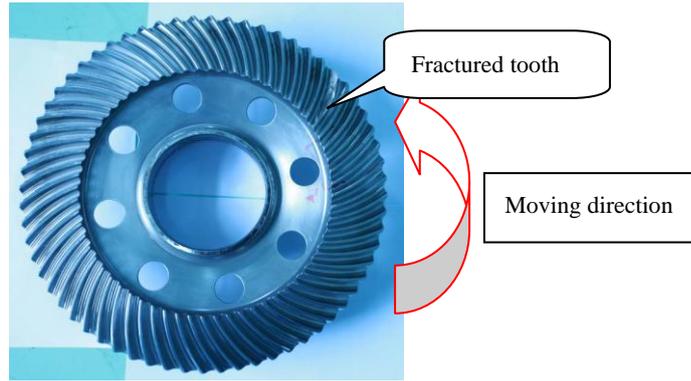
The appearance of the failed gear is shown in Fig.1. A tooth fractured at the dedendum round angle. According to the propagation steps, it can be assumed that the crack initiated from the working face at the dedendum round angle. The source is a linear source. Obvious beach marks can be seen. The fatigue region almost accounts for 80% of the whole fracture surface, shown in Fig.2. At the working face of other teeth, black regions can be seen, as shown in Fig.3. After acid erosion, these regions still present black. These regions have coarse wear trace and the machining trace of these regions is not more serious than that of other regions, so it can be assumed that the damage of these regions is burning damage during service. At the addendum top of the teeth, wear and collision traces can be seen, shown in Fig.5.

Fig.1 Macro appearance of the failed gear

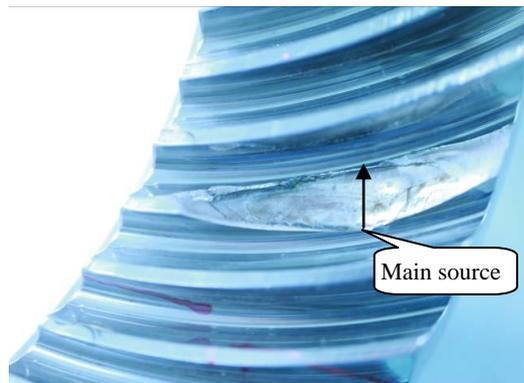
Fig.2 Macro appearance of the fractured tooth

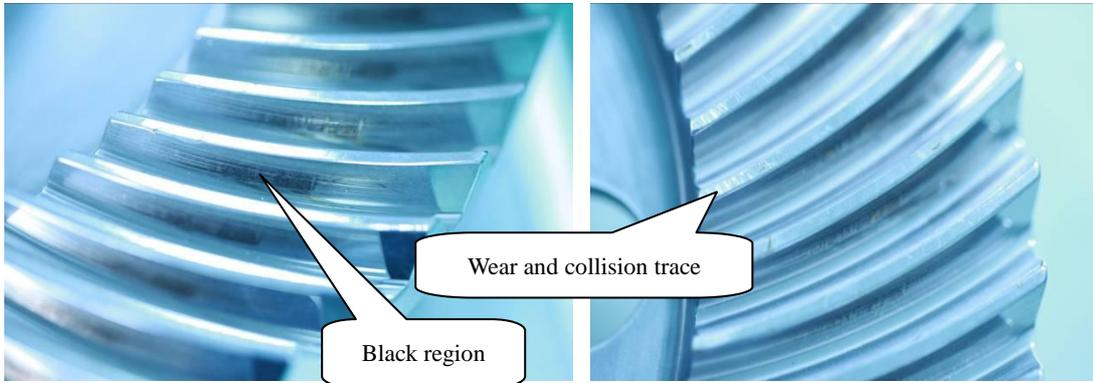
Fig.3 Wear trace at working face of other teeth

Fig.4 Wear and collision trace at addendum top

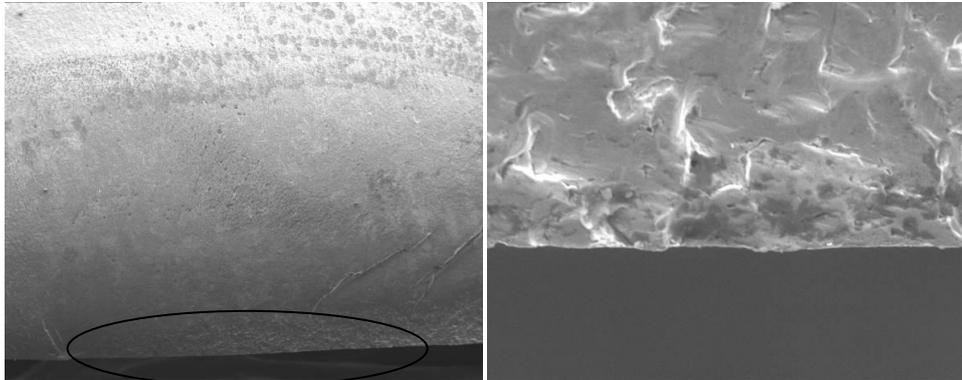
Micro observation shows that there exists obvious wear at the source region. No other damage is found at the source region, shown in Fig.3. Machining trace can be found at the lateral face near the source, shown in Fig.4. Because of serious wear of the fracture surface, the depth of the machining trace at the source region cannot be accurately measured. Fatigue striations can be seen at the propagation region, shown in Fig.5. The fast fracture region is covered with dimples, shown in Fig.6.

Fig.5 Low-magnification appearance of the main source region

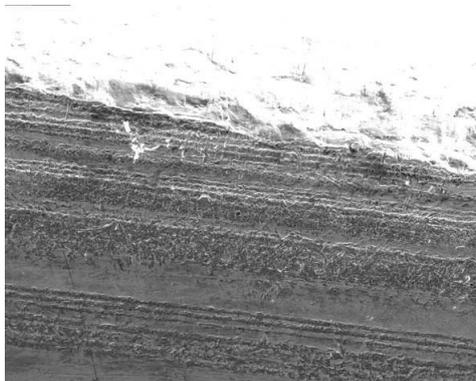
Fig.6 Machining trace near the main source

The gear failed by fatigue fracture. The crack initiated from the working face of the dedendum round angle. The working face round angle of the gear teeth is smaller than required, resulting in stress raisers, which is the main cause for the fatigue fracture of the gear. It is recommended that the manufacturing processes of the dedendum round angle should be concisely controlled.

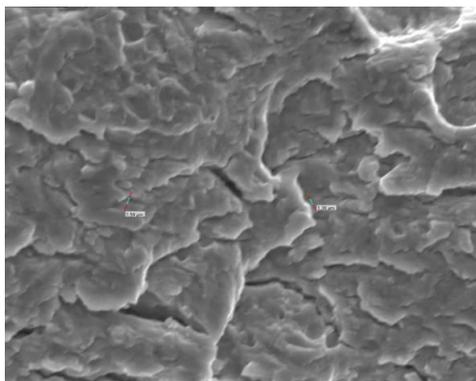
Fig.7 Fatigue striations at the early propagation region

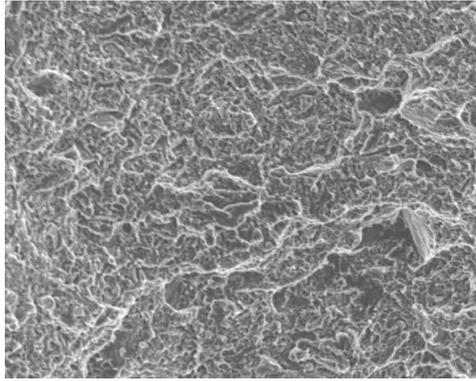
Fig.8 Dimples at the last fracture region

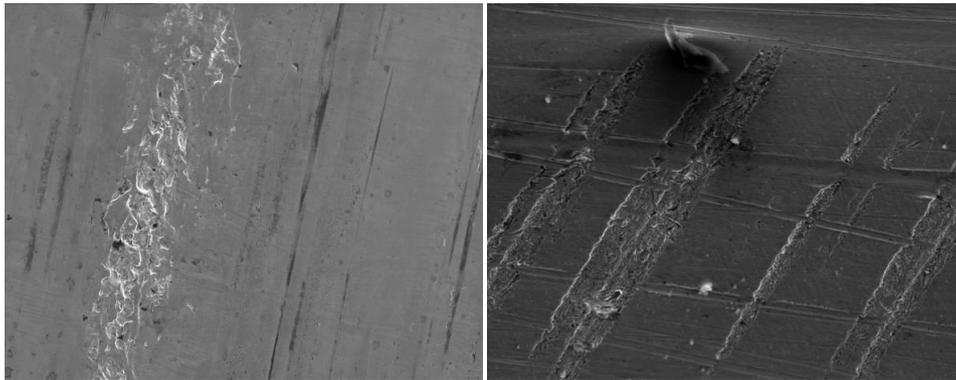
The black regions at the working face of other teeth present shelling-off feature due to serious wear, shown in Fig.7. EDS analysis results show that the oxygen content of these regions is about 4.7%. At the working face near the top and at the top of some teeth, parallel wear trace can be seen, shown in Fig.7. During normal service, the top of the teeth of the output gear wouldn't be in contact with the bottom of the teeth of input gear. According to the

parallel wear trace at the top of teeth, it can be assumed that axial float had happened to the gear. The parallel wear trace is shallow, short, and parallel, so it can be assumed that they formed a short time ago. Namely, they occurred after the tooth fractured. The direction of the working face wear trace of the teeth is the same as that of the top wear of the teeth, so it can also be assumed that they are also related to the axial float.

Fig.9 Appearance of black region of working face Fig.10 Parallel wear trace at the working face near the tooth top

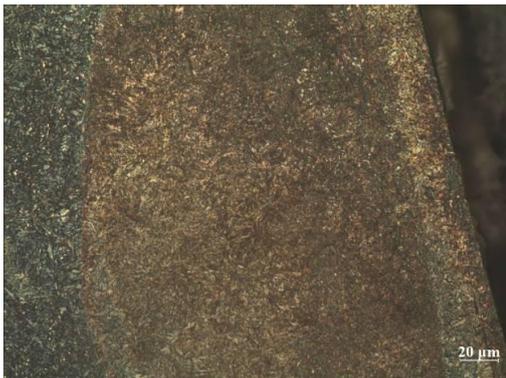
Metallographic specimens perpendicular to the burn tooth face were cut down from the teeth near the fractured tooth. A burn surface layer can be seen, composed of needle-shaped martensite and residual austenite(Fig.7). The core region is composed of lath-shaped martensite and residual austenite, shown in Fig.9. The number of the inclusions in the gear tooth is relatively small.

Fig.11 High-magnification burn structure near the surface Fig.12 Microstructure of core region of gear tooth

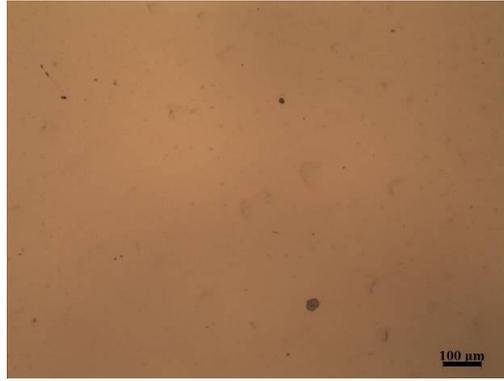
Fig.13 Inclusions in gear tooth

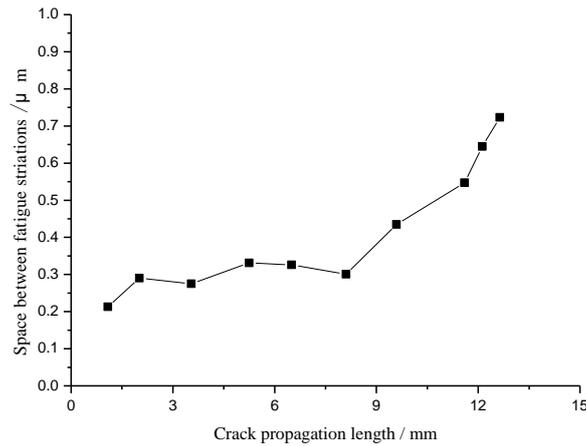
In order to work out the crack propagation life, quantitative analysis on the fracture surface was carried out by using the width of fatigue striations as a key parameter. Fatigue striations can be seen at the area 1.084mm to 12.64mm away from the source. The space between the striations in the extension region was measured as fatigue propagation rate. By curve fitting, the relationship between crack propagation rate and crack length was obtained, shown in Fig.10. The results show crack propagation rate increased with the rise of crack length. Then fatigue propagation life was obtained by listing trapezoidal method. The results show the fatigue propagation life is 33432 cycles.

Fig.10 Relationship between crack propagation rate and crack length
