Björn Palmberg, Mats-Olof Olsson, Per-Olof Boman and Anders F. Blom

Structures Department  
The Aeronautical Research Institute of Sweden (FFA)  
P.O. Box 11021, S-161 11 Bromma, Sweden

The Swedish fighter aircraft 37, Viggen, designed some 25 years ago on a safe life basis, has been re-assessed in terms of a damage tolerance evaluation. In particular, four versions of the main wing attachment frame and some components in the fin have been subjected to both detailed analyses and damage tolerance testing.

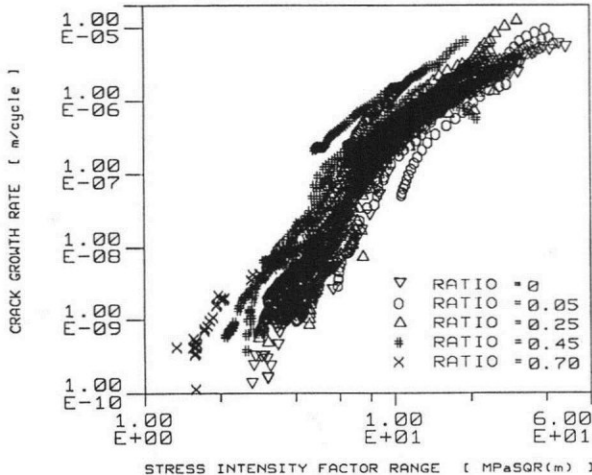
Figure 12. Fatigue crack growth rate data for a 7075 type of aluminium alloy. Ratio is equal to R, stress ratio.

All available fracture mechanics and crack growth data for the aluminium alloys and the high strength steels involved have been critically reviewed and collected in a data base for easy access. Complementary testing on coupon specimen level was performed to derive constant amplitude fatigue crack growth data in cases where data were lacking. Figure 12 illustrates the collected data for one of the relevant aluminium alloys.

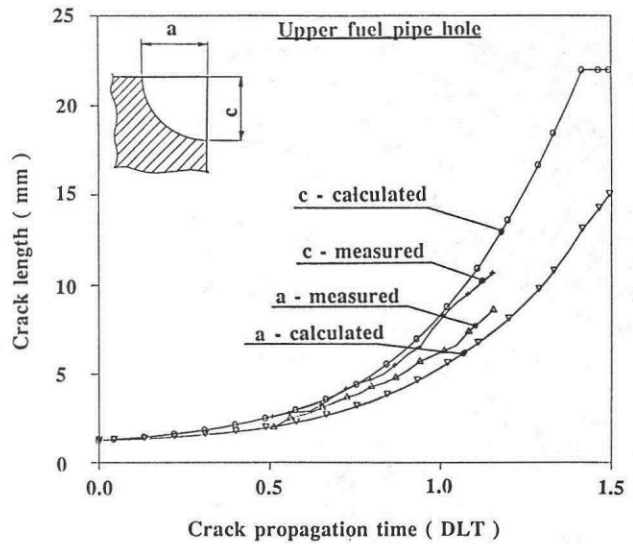
Figure 16. Comparison between predicted and measured crack length as function of time (design lifetimes)

Crack growth was monitored both visually and by means of various NDI- techniques, primarily eddy current. Firstly, cracks started to grow from defects introduced at the two fuel pipe holes. This growth is easily observed visually and has therefore been very useful in verifying the analytical crack growth predictions. A comparison of predicted and experimentally observed crack growth at the small fuel pipe hole is shown in Figure 16.

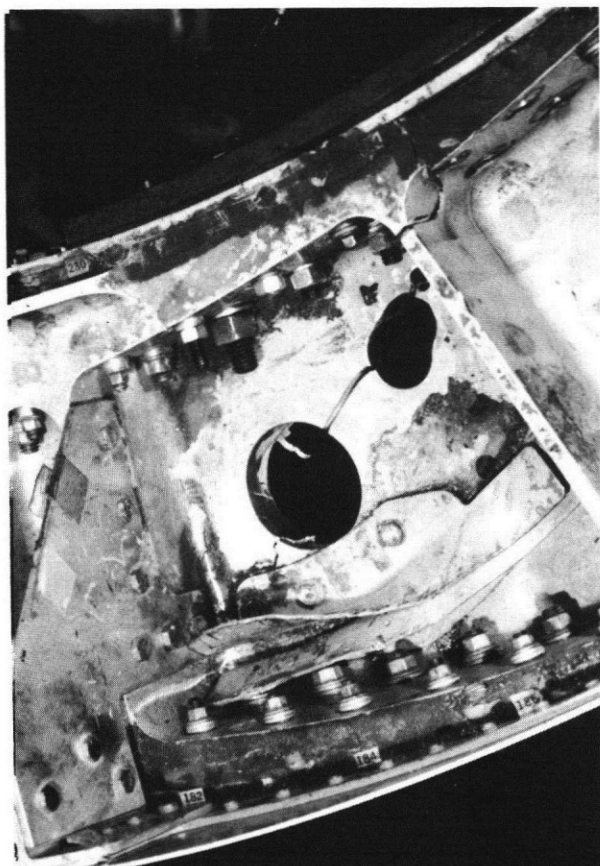
Figure 17. Final failure at the fuel pipe holes

Later on, after approximately 12500 simulated flight hours, these cracks resulted in final failure of the frame, as shown in Figure 17. After some 4000 simulated flight hours, crack growth was observed at one of the wing bolt holes. This is, according to numerical predictions, one of the most critical locations in the frame. However, as discussed further below, the predictions for this location are assumed to be overly conservative as friction between the interference fitted bushing and the frame forging was disregarded.

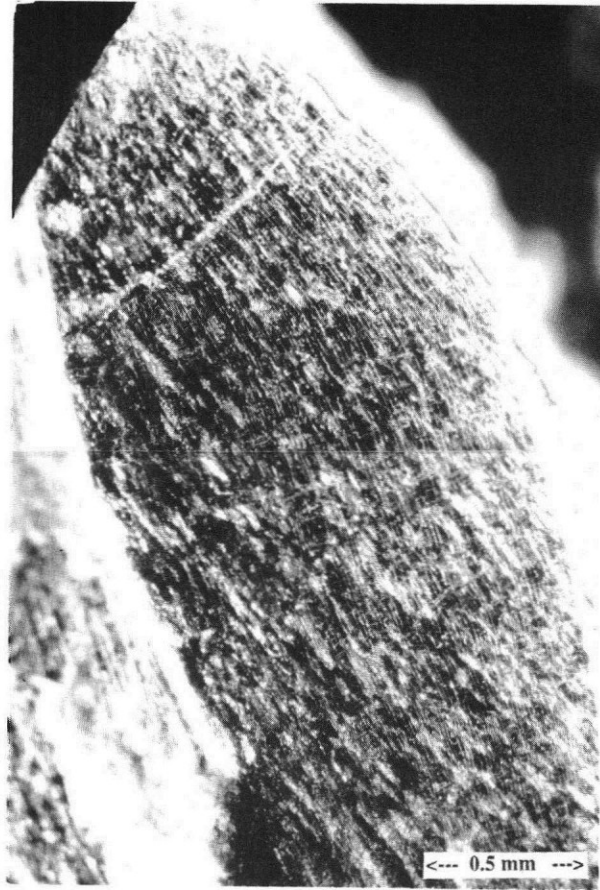
Figure 20. Crack surface of flaw No 3

Fractographic results clearly reveal the entire crack growth process for both crack number 3, Figure 20, and crack number 4, Figure 21.

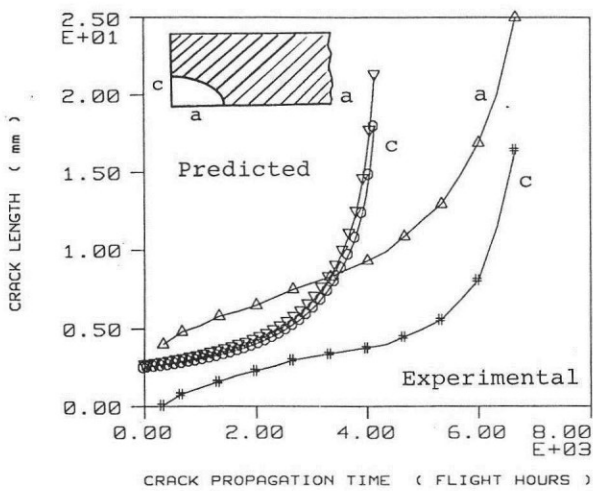
Figure 22. Comparison of measured and predicted crack propagation for flaw No 4.

The fin will during real flights see a random sequence in which the peculiarity of the test sequence does not exist. Thus, actual crack growth would be somewhere between the extreme results obtained in the testing. For the most conservative case, crack number 4, a comparison between experimental and predicted crack growth is shown in Figure 22.
