RTM COMPOSITE LUGS FOR HIGH LOAD TRANSFER APPLICATIONS

Markus Wallin*, Olli Saarela*, Barnaby Law**, Tommi Liehu***
 *Helsinki University of Technology, **Airbus, ***Patria Aerostructures

Abstract

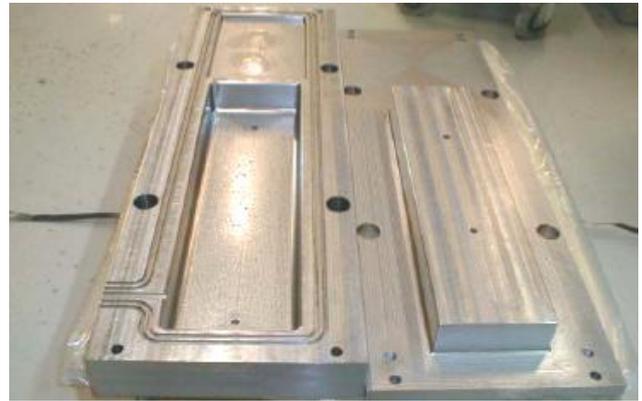
The injection mould used for the RTM lug is presented in Fig. 8. The mould material is steel. The outer lug parts with flanges are made in one end of the mould and the flat middle lug part is made in the other end of the mould. Injection channels are positioned around the mould. All lug parts are injected and cured in one cycle.

The mould was mounted in a press and heated with resistance thermal element. Injection temperature of the mould was 120 °C and the initial curing was done at 160 °C. The free standing post-cure was done at 180 °C. The injection pressure for lug parts was 2.5 bars.

Fig. 8. Tooling for the lug parts.

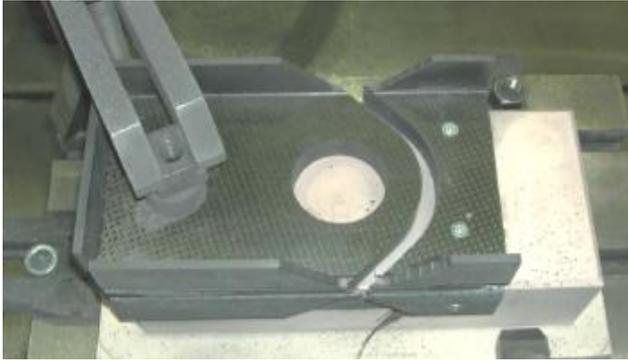
After injection the box was cut into two producing both left and right outer lug parts. The outer lug parts were bonded together with the middle lug part (Fig. 9) and the final shape was machined as shown in Fig. 10.

Fig. 10. Machining of the lug shape.

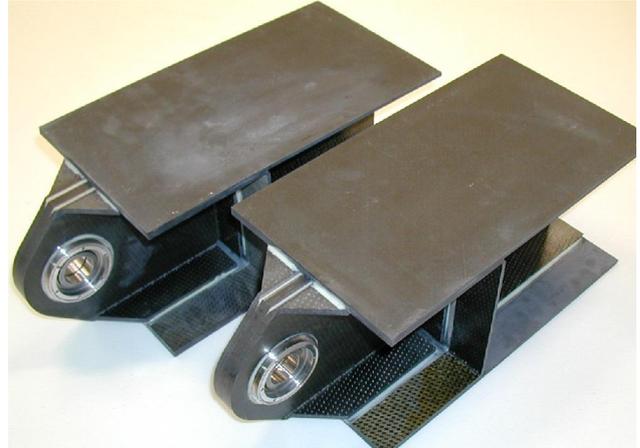
Fig. 11. Finished test specimens.

Altogether five different specimens were manufactured and tested with various configurations: with and without bearing, with bolted joint and bonded joint and after an impact damage. The specimen configurations are presented in Table 3. As an example two specimens with bearings are presented in Fig. 11.

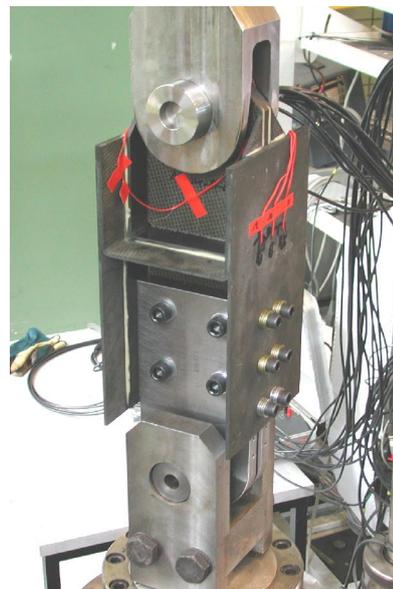
The test arrangement is shown in Fig 12. All specimens were tested in uniaxial static loading. The direction of the loading was a straight tension. The test fixture was attached to the specimen using four M16 and twelve M12 bolts. Two out of five specimens were equipped with strain gauges. The positions of the strain gauges are presented in Fig. 13.

Fig. 12. Test arrangement.

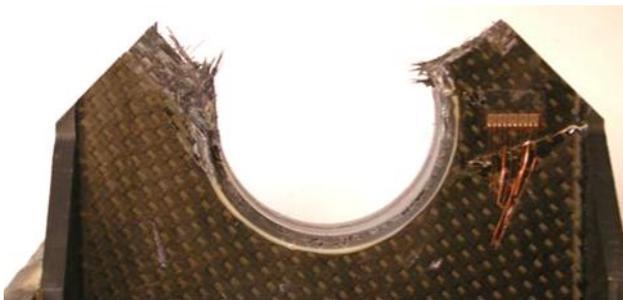
The failure mode was a tensile failure in the lug area as presented in Figs. 20 and 21. In the lug area the bondline between the outer lug and middle lug parts was failed. The maximum load was 397 kN i.e. significantly higher than with the first lug specimen.

Fig.20. Failure of the second lug specimen

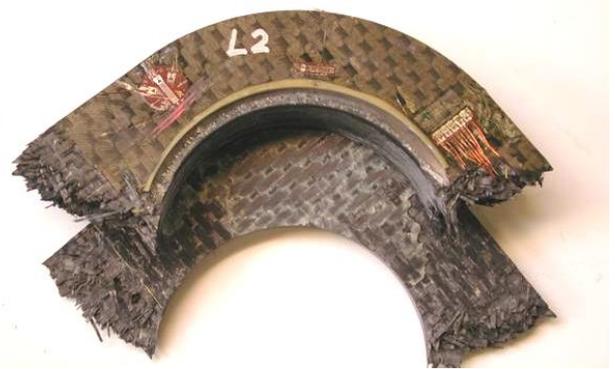
Fig. 21. Debonded parts of the second lug specimen.

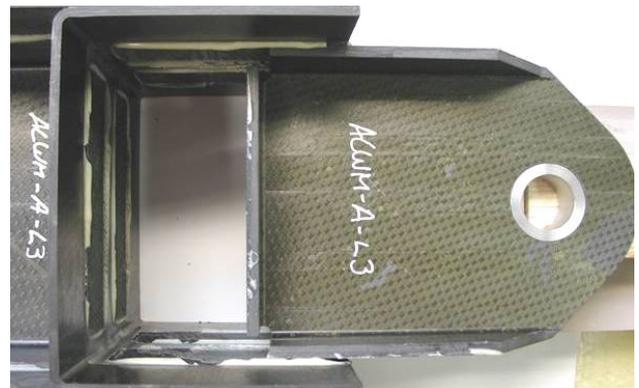
The specimen 3 with the bonded joint failed in the same way as the first specimen. The lug was detached from the surrounding structure. The failure load was 240 kN and some laminate damage was observed in the lug flanges. Otherwise the lug was undamaged. The failed specimen is presented in Fig. 22.

Fig. 22. Failure of the third specimen.

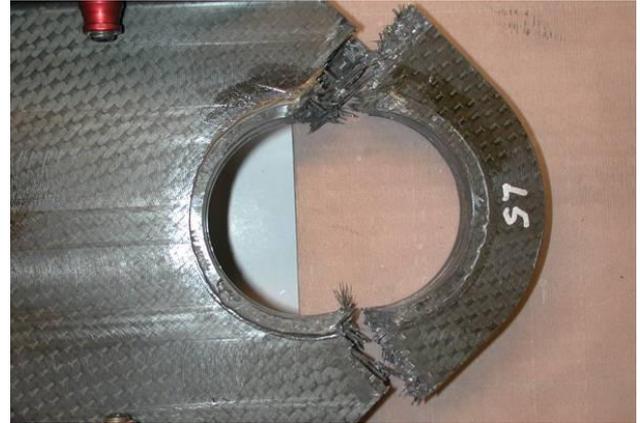
Fig. 25. Failure of the fifth specimen.

The specimen was tested directly to failure. The failure load was 400 kN and the failure mode was the same as in the second specimen. The tested specimen is presented in Fig. 25. Similarly a debonding between the outer lug and middle lug parts is observed as shown in Fig. 26. The impact damage had no effect on the specimen behaviour.

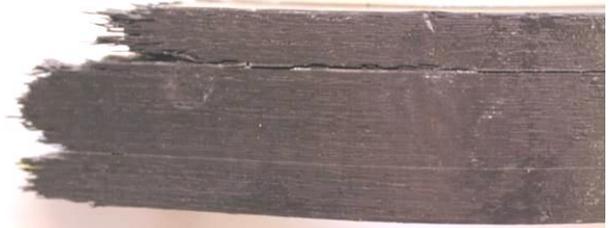
Fig. 26. Partially debonded parts of the fifth specimen.
