# ENGINEERING FAILURE MODES AND FRACTURE CHARACTERISTICS OF SINGLE CRYSTAL SUPERALLOY BLADES

## Abstract

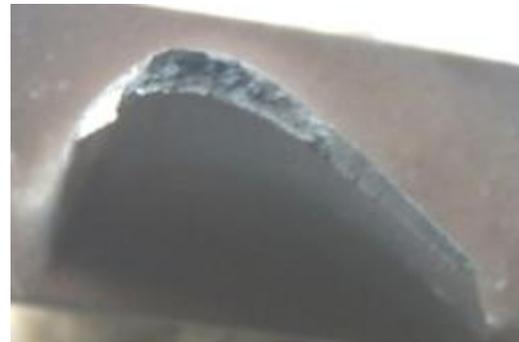
Fig.3 Macro feature of fracture surface of SC blade by creep

the blades because of creep elongation. The first phenomenon is more common than the second. The fracture surfaces of the blades caused by creep elongation can often be divided into two parts: creep cracking section and fast fracture section, shown in Fig.3. The creep cracking section was more seriously oxidized, and was nearly perpendicular to the main axis of the blades. In addition, it was covered with many small square-shaped facets, shown in Fig.4. The fast fracture section was flat, and extended in the 45° direction from the main axis. Local shear dimples can be found at the fast fracture section. The microstructure near fracture surface presented rafting feature, shown in Fig.5.

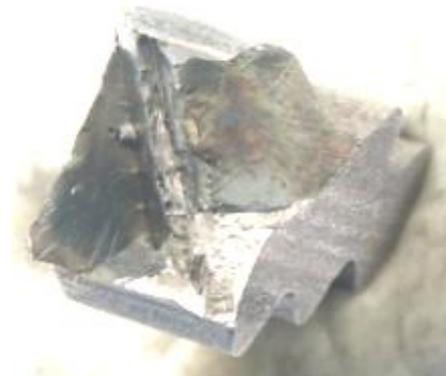
Fig.6 Fatigue fracture surface consisting of smooth facets

During service, other than centrifugal load, SC turbine blades are also under the effect of vibration stress and impact load of gas flow, so fatigue failure is also a common failure mode. Fatigue cracks may occur in rabbets, blade roots, blade bodies or blade tips. The fatigue fracture surfaces of SC blades present three patterns. The first pattern is that the fracture surfaces consist of intersecting smooth facets(Fig.6) and the fatigue cracks present zigzag appearance, as shown in Fig.7. The second pattern is that the fracture surfaces consist of rough surfaces caused by crack intracrystalline propagation(Fig.8). The third pattern is that the fracture surface is made up of smooth facets and rough faces and the fatigue source region is rough surface (Fig.9). In microscopic view, at the smooth facets of fatigue fracture surfaces, river pattern initiating from source region and beach mark can be seen(Fig.10), but fatigue striations can rarely be seen. At the end of smooth facets, fatigue striations can sometimes be seen. The rough surfaces presented typical fatigue fracture features; beach mark and fatigue striations can be seen easily, shown in Fig.11.
