# EVALUATION ON DISCRETE SOURCE DAMAGES OF CFRP STIFFENED PANELS

**Yuichiro Aoki, Shin-ichi Takeda, Hirokazu Shoji, Sunao Sugimoto and Yutaka Iwahori**  
**Japan Aerospace Exploration Agency**  
*aoki.yuichiro@jaxa.jp; takeda.shinichi@jaxa.jp; shoji.hirokazu@jaxa.jp;*  
*sugimoto.sunao@jaxa.jp; iwahori.yutaka@jaxa.jp*

*Engine debris penetration tests were conducted to evaluate the large notch damage and residual strength of composite stiffened panel. The damage mechanism was examined by progressive failure analysis based on Hashin's failure criteria and cohesive zone model. The influence of delamination on the progressing notched damage path and initial failure load of the panel are investigated. The results reveal that typical damage path is characterized by fiber breakage perpendicular to the crack tips to be followed by skin/stringer interface damage. The numerical model has a potential capability to predict the debris penetration and residual strength of the damaged panel.*

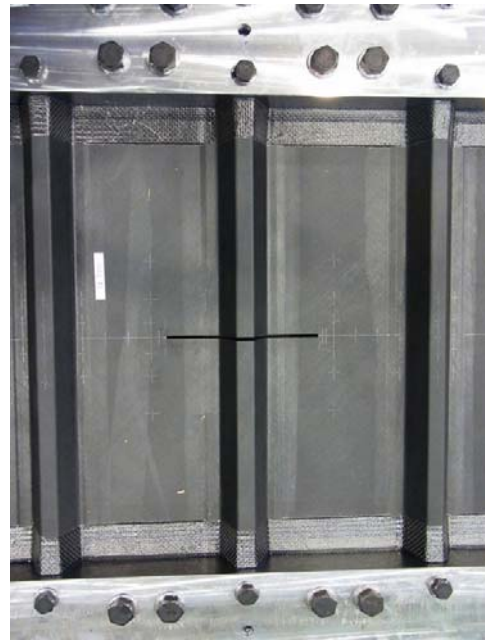
Fig. 2 Notched panel

Size of test panel is 900 mm long x 750 mm width and their skin thickness is 2 mm. The layup of the panel and stringer is quasi-isotropic with fiber fraction of  $[0^\circ / 90^\circ / \pm 45^\circ = 25\% / 25\% / 50\%]$ . The panels are fabricated in different material systems and fabrication processes; a unidirectional prepreg material with an autoclave method and dry fabrics with VaRTM (Vacuum-assisted resin transfer molding) process. Detailed specification of the panel is shown in Fig. 1 and Table 1. Total of two panels are prepared for each fabrication method. One panel is applied to both blade impact test and subsequent tensile strength test. The other one is machined to make an artificially ideal 200mm long two-bay crack at middle of the panel for the comparison of failure behavior under tensile load as shown in Fig. 2.

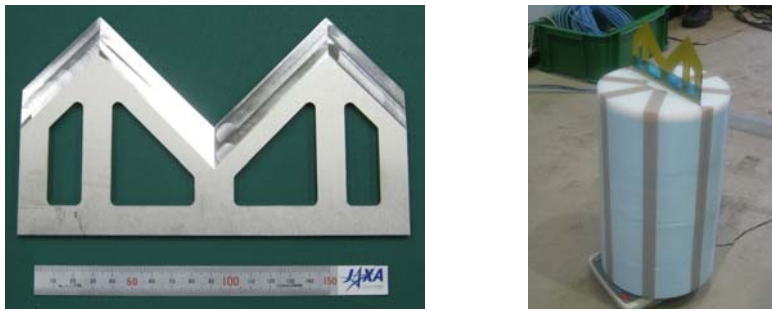
The blade penetration tests were conducted by a pneumatic high velocity impact testing machine in JAXA Chofu Aerospace Center (Fig. 3). Two composite panels mentioned above were impacted by Ti-6Al-4V titanium projectile shown as Fig. 4. The projectile is designed to simulate an uncontained fragment from a failed engine and has two sharp edges to certainly give severe penetration damage to the panel [5]. The total mass of the projectile is 195 g and target velocity is 200m/sec. The projectile is mounted in the front of sabot (Fig. 4), which will support the projectile in the barrel of the impact machine. The orientation of the projectile is controlled by careful design of the sabot. The major axis of the blade is aligned to the vertical plane in the required orientation for penetration in the target.

Fig. 4 Titanium projectile (Left: Overview, Right: Blade/sabot combination)

projectile completely separates from the sabot. A short distance of projectile free flight, typically 2 m, ensures that the orientation does not change and the projectile reaches the target at the required location.
