# FATIGUE PROPERTIES OF ADDITIVELY MANUFACTURED TOOL STEEL

## Abstract

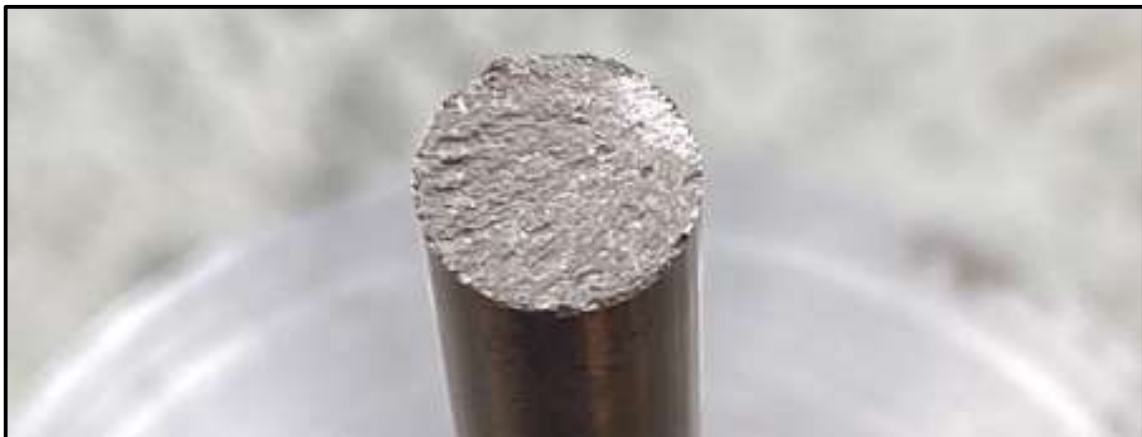
Specimen 18, which was fatigue tested at a Stress Amplitude of 527 MPa (~80% of the YS), failed after 2 879 cycles. The fracture surface of Specimen 18 displays stress raisers (see Figure 4), and it appears that crack initiation did occur near the surface (see Figure 5a). There are no beach marks on the specimens investigated, to suggest a smooth, ductile failure and so a brittle failure was deduced.

Figure 4 – Fractured surface of Specimen 18
