O. Gökgöl  
Messerschmitt-Bölkow-Blohm  
Unternehmensbereich Hamburg

This study discusses the crack-free and cracked life of the fuselage including the fin box of the Airbus A 300 B and the problems involved.

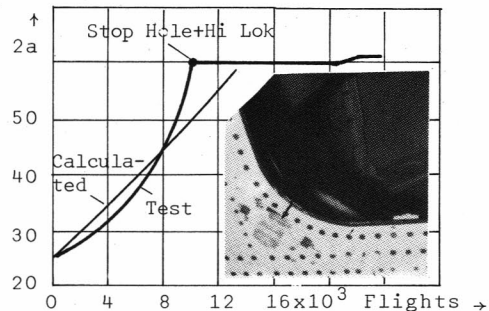
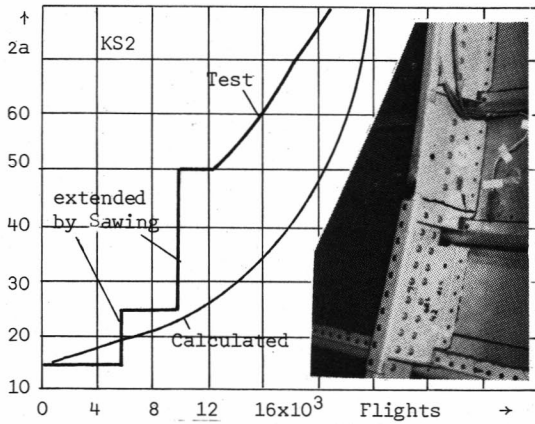
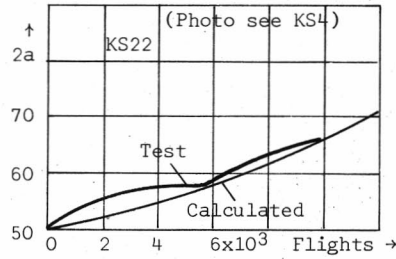
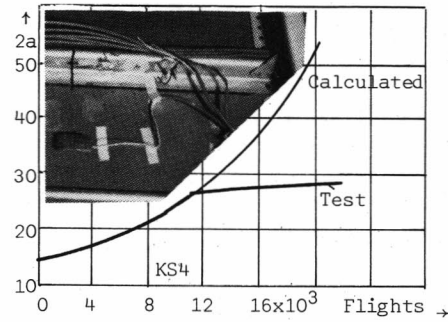
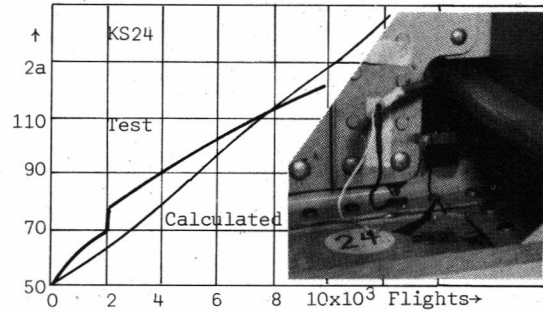
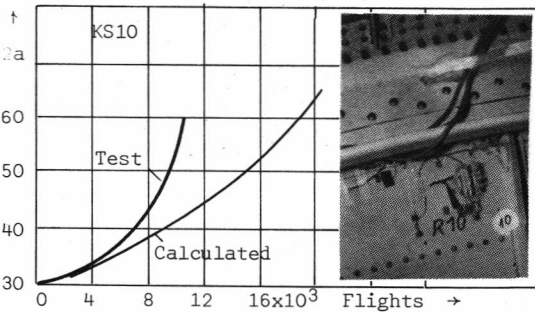
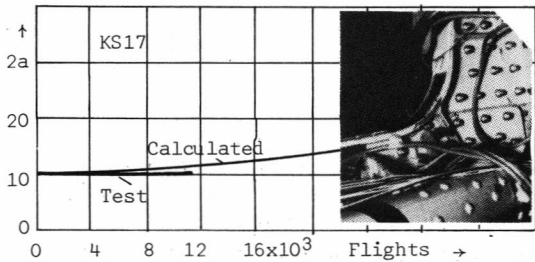
Figure 24. Propagation of Artificial Cracks in the Rear Fuselage Test

The following figures show by extract the comparison of the determination of crack propagation by way of calculation (without taking lateral contraction into consideration) and test of 35 artificial cracks in the rear fuselage test.

- KS1: Crack in cargo door corner
- KS2: Skin crack under separated frame
- KS4: Skin crack under separated stringer
- KS10: Skin crack in pressurized bulkhead under biaxial stress
- KS17: Corner fitting in horizontal stabilizer cutout on fuselage
- KS20: Connection fin box-fuselage
- KS22: Skin crack in fin box under separated stringer
- KS24: Skin crack in fin box under separated spar

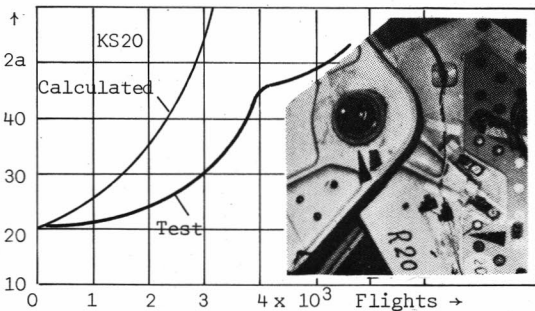
Figure 25. Biaxially Loaded Skin Cracks

The comparison of all crack propagation calculations and the test results showed that in the case of a biaxial stress in the field (a-both stresses positive) the stress intensity factor in the crack propagation calculation must be reduced as a function of the intensity of the 2nd stress by about 15% in order to achieve a certain degree of conformity with the test results. Even in a single-directional loaded field the stress intensity and thereby also the crack propagation rates are overestimated when the crack occurs in the immediate vicinity of a parallel installed stiffener (KS2; KS24). These transverse stiffener components apparently prevent locally the lateral contraction, so that the crack cannot open completely and thereby the stress intensity at the crack peak cannot be built up fully.

On the other hand a relevant increase in stress intensity and crack propagation rates could be observed for that case when the 2nd stress direction parallel to the crack was negative and amounted to 50% of the 1st positive stress (Fig. 25b). In the latter case the crack propagation determined by test could only then be simulated by calculation if the stress intensity factor in the calculation was increased by 40%. The negligence of the compressive stress directioned parallel to the crack in connection to the tensile stress acting vertically to the crack would cause a substantial under-rating of crack propagation. If you compare the correction factors mentioned in this connection with the information of future literature, the statement is allowed, that the literature factors which are given for the consideration of biaxial stresses will be substantially smaller for both cases than the above given values(7).

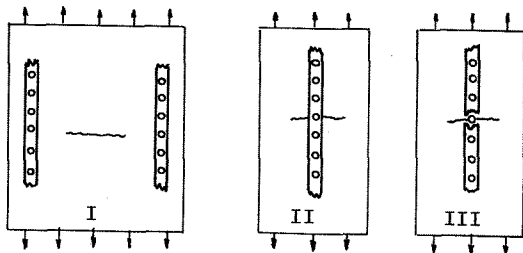
Figure 26. 3 Main Types of Skin Cracks in a Reinforced Field

Service life tests of major assemblies and full scale tests confirmed anew that the load introductions not only cause a minor crack-free service life than the undisturbed structure or a continuous riveting but also that cracks occurring at the fitting runouts (last rivet row) propagate substantially faster than in a continuous riveting.

This phenomenon can be traced back to the influence of the stiffener on the stress intensity. In general a distinction is made between 3 types of crack:

Type III includes cracks occurring at a fitting runout.
