Huey D. Carden*
NASA Langley Research Center
Hampton, VA

Abstract

Failure behavior results are presented from crash dynamics research using concepts of aircraft elements and substructure not necessarily designed or optimized for energy absorption or crash loading considerations. To achieve desired new designs which incorporate improved energy absorption capabilities often requires an understanding of how more conventional designs behave under crash loadings. Experimental and analytical data are presented which indicate some general trends in the failure behavior of a class of composite structures which include individual fuselage frames, skeleton subfloors with stringers and floor beams but without skin covering, and subfloors with skin added to the frame-stringer arrangement. Although the behavior is complex, a strong similarity in the static/dynamic failure behavior among these structures is illustrated through photographs of the experimental results and through analytical data of generic composite structural models. It is believed that the similarity in behavior is giving the designer and dynamists much information about what to expect in the crash behavior of these structures

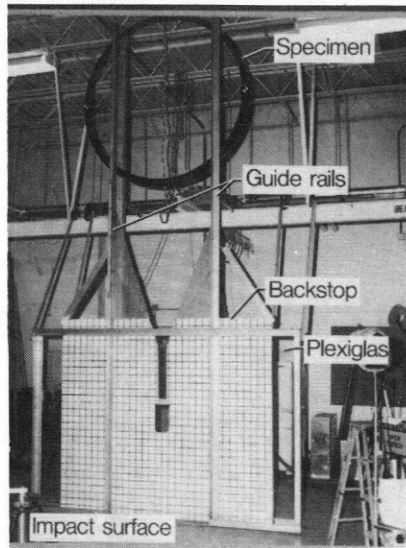
Figure 6. - Composite Z-frame in drop apparatus.

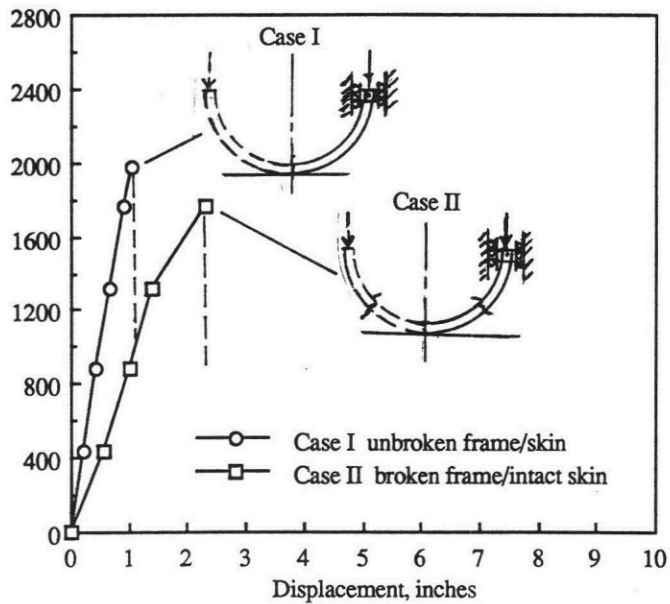
(a) Load-displacement.

Furthermore, a comparison of the analytical cases (figure 12(a)) with the actual static load-deflection of the Z-section (figure 11(b)) indicates very similar load-deflection behavior patterns as discussed above. Although the Z-frame had no skin, if the ends jam together (as they did in several cases), the boundary is effectively between the skin stiffened case and a guided boundary. Thus, the predicted maximum moment location in the simple beam-frame model at about 50 degrees (See figure 12(b)) agrees well with the 54 and 58 degree failure locations in the experiment with the Z-section frame.

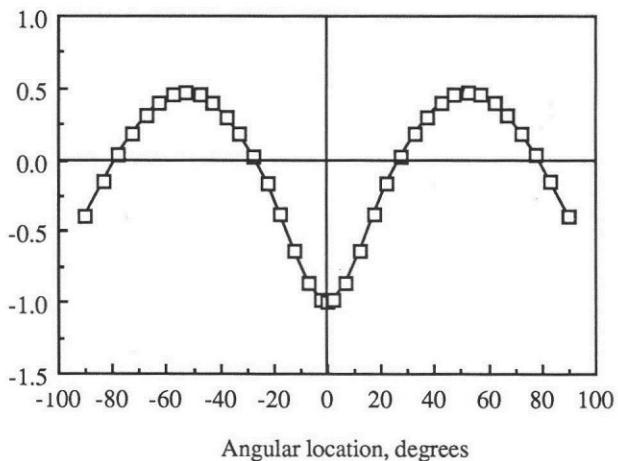
(b) Case I---Normalized moment (Prior to failure).

An examination of the normalized distribution of the bending moment on the frame shown in figure 12(b) provides insight and a better understanding of the failure/behavior. Maximum moments are indicated (just prior to failure) to be at the 0 degree location and between $\pm 50-60$ degrees from the bottom contact area. The locations correlate well with the failure locations in the experiment with the Z-frame.

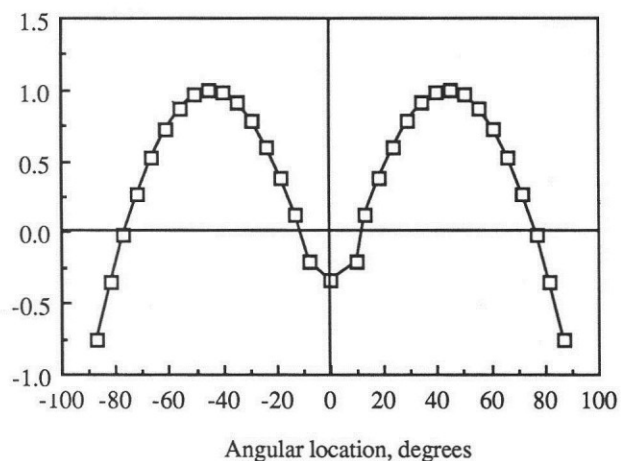
(c) Case II---Normalized moment (Broken frame-intact skin).

Normalized bending moment distribution on the broken frame is presented in Figure 12(c). As may be noted, the distribution is quite similar to the initial model results in figure 12(b). The failure location is at the maximum bending moment location predicted to be about ± 45 degrees which is somewhat lower than the same location shown in the initial model of the unbroken frame. The agreement between the predicted behavior by the two models, however, is still considered good. The effect of diameter on the moment distribution of the frame was assessed with a model having a 75 inch diameter (twice the initial diameter). The distribution was identical to the smaller diameter results, however, the loads producing the moments differed between the two models (as expected). Moment in terms of geometry and load for a point loaded ring²⁸ shows that the maximum moment will occur at the same angle for different values of diameter.

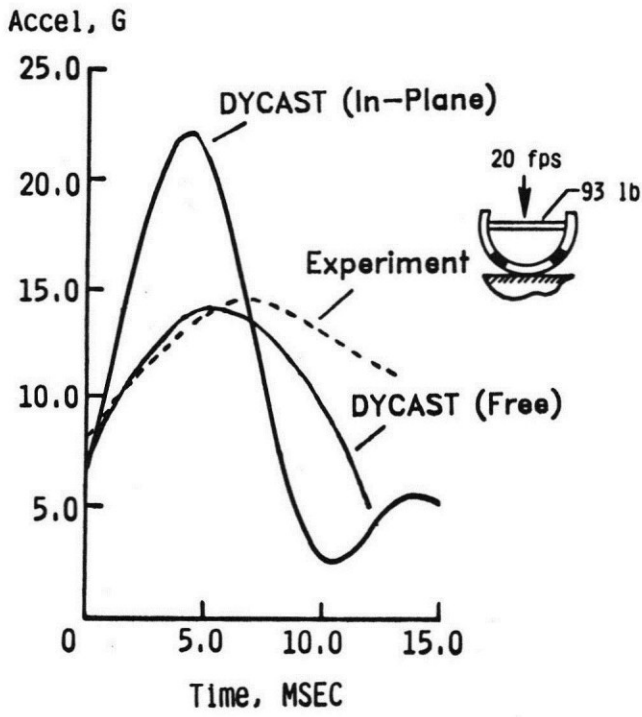
(c) Experimental and analytical accelerations.

Dynamics analytical studies.- Experimental and analytical model results for the composite Z-frame subjected to a 20 ft/s impact are shown in Figure 13(c). The first 15 milliseconds of the experimental acceleration of the floor and analytical predictions are shown. In one analysis, in-plane deformations were constrained to the plane of the frame whereas in the other, the frame was free to twist and bend out-of-plane. As noted in the figure, agreement between the "free" model and the experiment is good for the initial peak load. Later the agreement is less because the backstop and clear fence in the experiment, which was not modeled, began to provide support to the twisting and bending frame. The in-plane model results are about 60% higher when compared to the experiment and the free model results. Such results emphasize the importance of knowing and modeling the experimental boundary conditions to understand the dynamic and static behavior of structures under crash loadings. Unfortunately, mixed boundary conditions often exist or occur in the experiments.

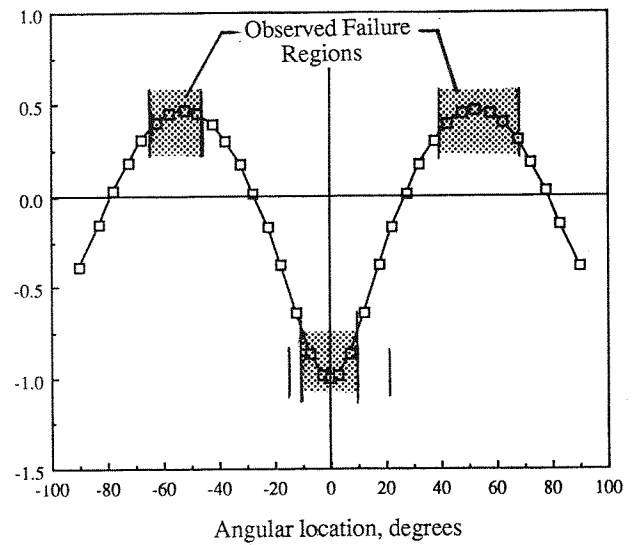
(a) Normalized moment distribution.

The response behavior determined during the studies of full-scale aircraft sections, fuselage frames, and subfloors are summarized in figure 18. Normalized moment distribution on a representative frame of the various specimens are shown in Figure 18(a). Figure 18(b) shows the failure locations which were noted from static and dynamic tests. The visual impression is quite striking among the various specimens. The structures all share in common the generally circular or cylindrical shape, the normal loading situations, and what appears to be a similar pattern of failure behavior. Analytical models of frame structures under vertical loads have moment distributions which have maximums at the point of loading and at approximately 45 to 50 degrees (depending on boundary conditions) around the circumference from the ground contact point. Failures of the structures were noted at these same locations. Such observations may help dynamists gain a clearer understanding of what to expect from such structures in crash loading situations, may guide designers of new structures to account for the vertical crash loads, and allow increased energy absorption to be included in the new designs. Additionally, the observations may help analysts to model the aircraft structures more adequately for predicting the failure responses and behavior under crash situations. The latter task is a difficult and challenging one, not only for composite structures but for metal structures as well. Studies are currently underway to improve the analysis capabilities of current codes and to add composite elements to finite element libraries such as the DYCAST program. In addition, new analysis approaches are being explored through grants to universities as an extension of NASA Langley Research Center's in-house efforts.

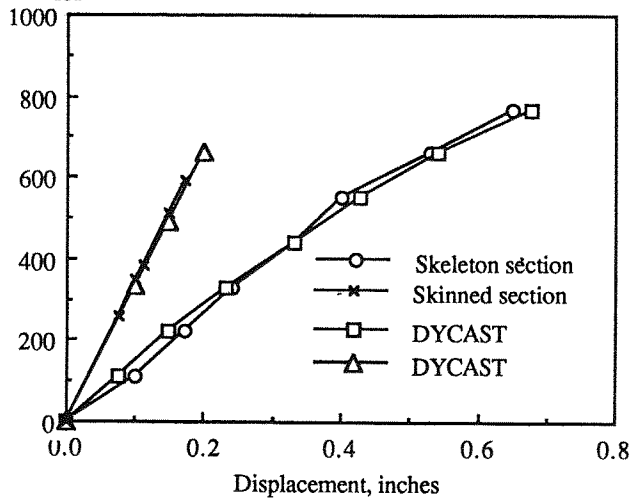
Figure 17. - Comparison of experimental and analytical stiffness of composite skeleton and skinned subfloors.

Analytical studies.-The contribution of the skin to the stiffness of the section with the nonsymmetrical frames is illustrated in figure 17. Static load-deflection data for the unskinned subfloor and the skinned subfloor along with the DYCAST predictions are shown in the figure. It can be noted that the subfloor stiffness (with skin) is approximately three times the stiffness of the skeleton subfloor, thus the skin's contribution to the structure is to maintain in-plane deflections of the non-symmetrical Z-section and prevent any substantial twisting of the frames. Out-of-plane bending and twist were allowed in the skeleton subfloor predictions.

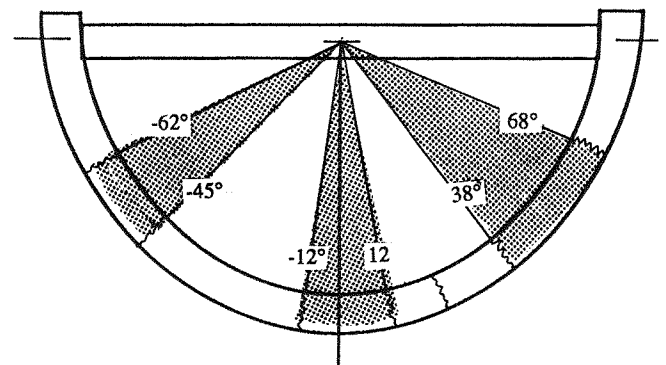
(b) Failure locations.

Figure 18. - Comparison of non-dimensional analytical moment distribution predicted by finite element frame model and observed failure locations on metal and composite fuselage components and structures.
