THE FRETTING DAMAGE AND EFFECT OF TEMPERATURE IN
TYPICAL JOINT OF AIRCRAFT CONSTRUCTION

ICAS-92-5.2R

T.Z.Tian
Shenyang Aircraft Institute
Shenyang, Liaoning, P. R. CHINA

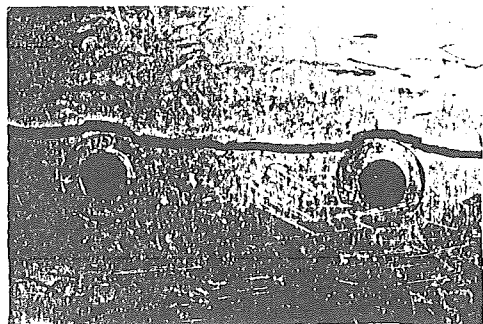
Figure 1 bolt connect joint

Bolt joints: Because of higher clamping pressure, the bolted joints can transmit load by static friction between the washers and the sheets. Fretting fatigue cracks initiated at the edge of contact between the washers and the sheets. Figure 1 clearly shows an example where the fretting scar circumscribes the fastener hole and where the fatigue crack has been influenced more by the fretting than by the geometric stress concentration of the hole itself. It also can be seen that the fretting fatigue crack initiated not at the point of geometric stress concentration of edge of hole, but somewhat higher up the side of that circumscribes the fastener hole where fretting can override the geometric stress concentration presented. The fatigue strength of this type of joints is the highest.

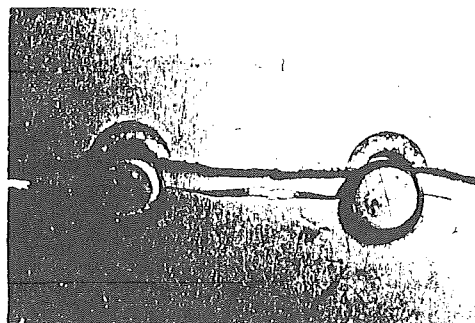
Figure 2 set-head rivet joint

Figures 1-3 and table 1 shows cases of fretting fatigue in typical joints of aluminium alloy aircraft skin stringer attachments. It is clear that cracks initiated in the places where fretting had taken place and led to the failure of fretting fatigue. Different types of joints caused different modes of transmitting load so that the places of cracks changed, which results in the difference of the fatigue strength
