BIRD IMPACT RESISTANCE OF THE SMALL TRANSPORT AIRCRAFT
Experience Gathered from Tests and Structural Changes

Ing. Ludvík BEDŘICH - Strength Department, LET a.s. Kunovice, Czech Republic

Ing. Vlastimil MERTL - Institute of Aerospace Eng., Technical University of Brno, Czech Republic

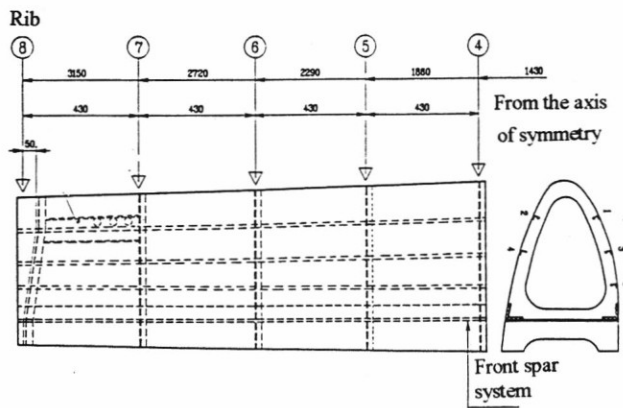
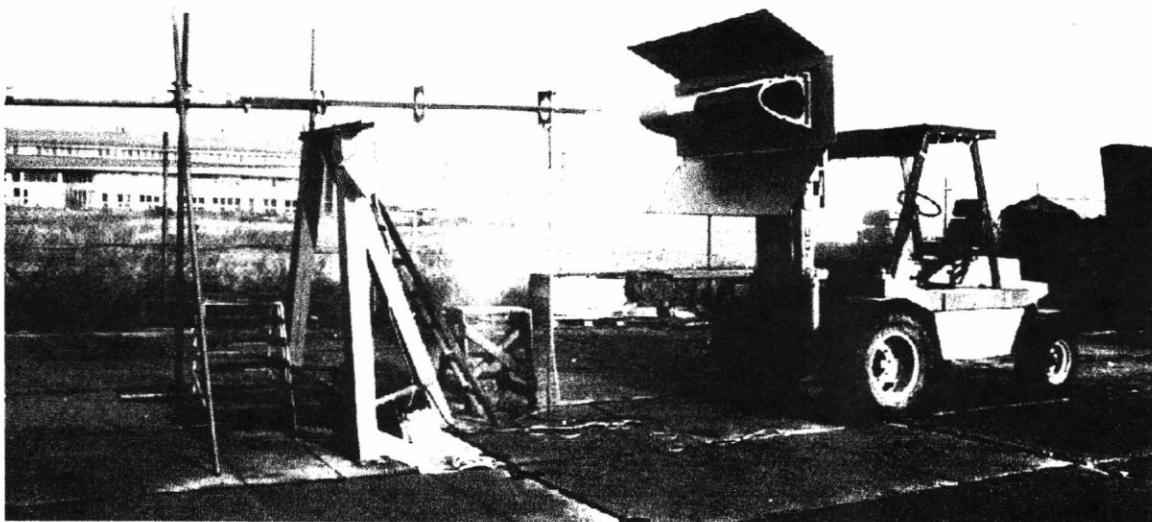
FIGURE 2 - Wing Specimen and its Attachment

By no means can the tightness of the tank be jeopardised by loose rivet joints or defective beams or webs of the foremost spar. Damage to the wing's leading box does not prevent completion of the flight and is thus admissible. Wing specimens were used in the tests. The shots were fired at the centre of the leading edges between ribs or close to them. A wing specimen and its attachment are depicted in Figure 2. The original structure and its state following the test are shown in Figure 3. Damage was inflicted onto the wing's leading edge and the front spar's web. Other structural variants that were tested but did not conform to the requirements are shown in Figure 4. Figure 5 shows the final variant, which had minor damage evident on its leading edges. Its spar remained unharmed. This variant was applied on the aeroplane.
