PATCH REPAIR OF CRACKS IN THE UPPER LONGERON OF AN F-16 AIRCRAFT OF THE ROYAL NETHERLANDS AIR FORCE (RNLAf)

W.G.J. 't Hart, J.A.M. Boogers

National Aerospace Laboratory (NLR), the Netherlands, hart@nlr.nl

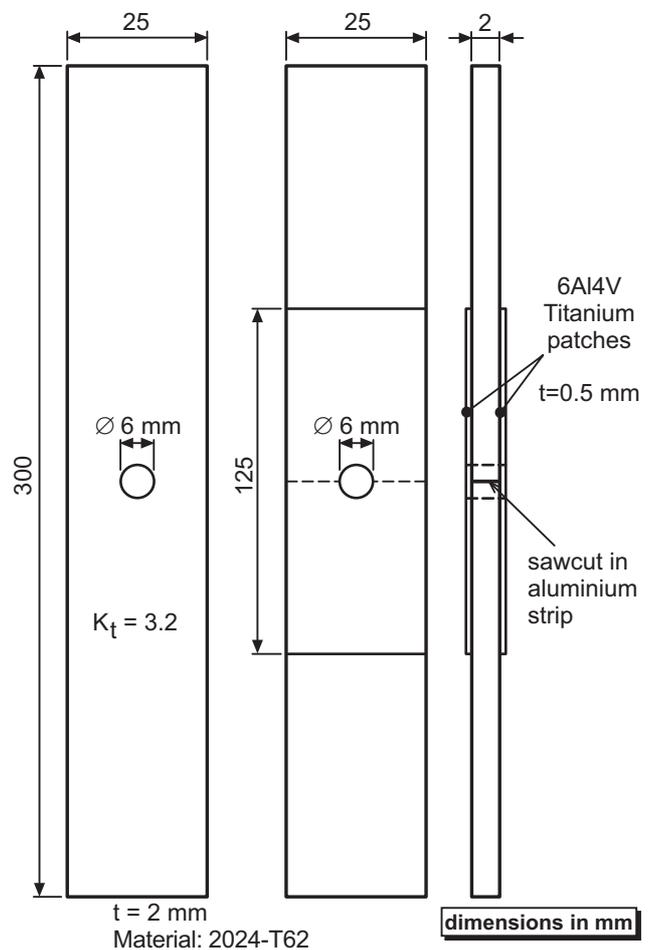
Fig. 5 Fatigue specimens for flight simulation and fatigue testing

In order to assess the performance of the patch repair, limited fatigue tests were performed on notched 25 mm wide aluminium strips with and without a patch repair, figure 5. Two open hole specimens and two patch repair specimens were prepared. A fastener of 6 mm in diameter was installed in the central hole of the repaired coupon specimen. The fastener was torqued at 3 Nm, simulating the panel attachment to the longeron flange. However, load transfer occurs exclusively through the bonded Titanium patches.

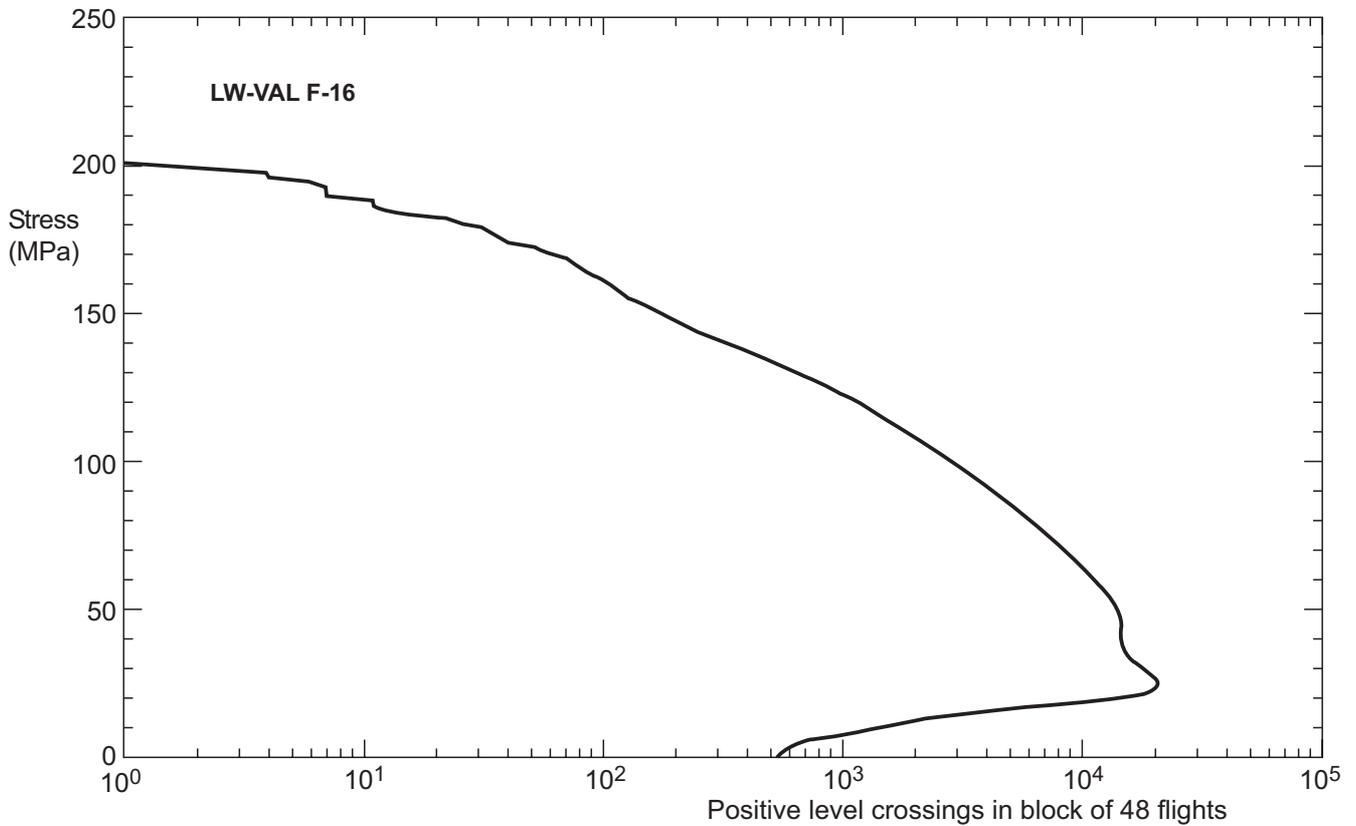
Fig. 6 Stress and cumulative level crossings of 100%-LW-VAL F-16

However, no directly usable sequence for the fatigue testing machine was available. Measurements on F-16 aircraft of the RNLAf showed a more or less similar shape of the forward fuselage and the wing root bending spectrum. Therefore the LW-VAL F-16 load sequence was selected, this being representative for the wing root bending moment for a severe EPAF** usage, figure 6. For ease of testing the negative stress levels in the sequence were set to zero. To obtain a reasonable testing time for the specimens with the central hole, the fatigue tests were executed at 130 % of the LW-VAL load sequence. This means that the maximum gross stress in the specimens was 268.5 MPa. According to GD-16 PR8150 [4] the maximum spectrum stress for longeron 16B1111 is 196.77 MPa (28.11 ksi).

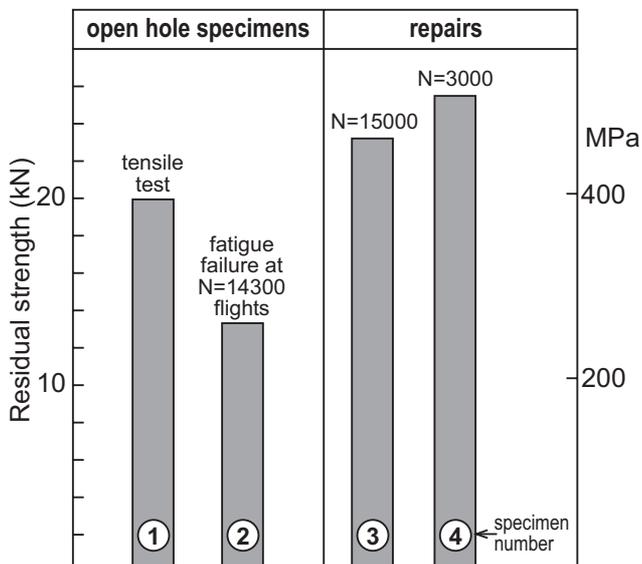
Fig. 7 Test results of experimental programme

Figure 7 gives the test results. The static failure load of the undamaged open hole specimen was 19.9 kN, specimen 1. Fatigue testing at 130 % LW-VAL resulted in a life of 14300 flights, specimen 2. Specimen 3 demonstrated that the repair survived 15000 flights after which a residual strength of 23.1 kN was obtained. NDI before residual strength testing showed local delamination at the edges of the titanium patches. Specimen 4 did not show signs of debonding after testing for 3000 flights. The residual strength was 25.3 kN. Figure 8 shows the failed repair specimens. Both specimens showed tensile failure of the

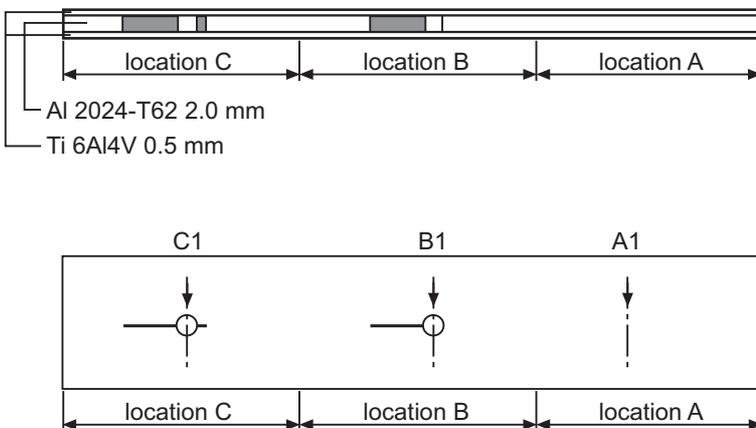
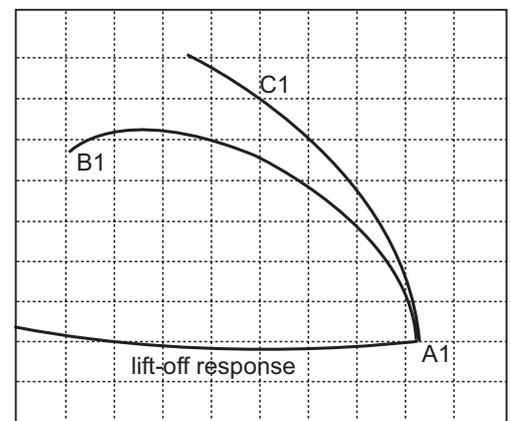
Fig. 11 Calibration standard for Eddy Current detection of crack growth from the drilled-off hole at the tip of the longitudinal crack

For crack detection the Nortec-19e^{II} Eddy Current scope was used with a Nortec PR/1 kHz – 100 kHz/A pencil probe. The test frequency was 15 kHz. A calibration standard was made to monitor possible crack propagation from the stop-drilled holes. The reference signals are shown in figure 11.

- Location A: Defect free area
- Location B: 4 mm diameter hole + 10 mm EDM notch
- Location C: 2 mm EDM notch + 4 mm diameter hole + 10 mm EDM notch

- Response A1: Scan over defect-free substrate
- Response B1: Scan over hole with a one-sided EDM notch
- Response C1: Scan over hole with a two-sided EDM notch
