FATIGUE INITIATION AND CRACK GROWTH BEHAVIOUR IN GLARE FROM THE AIRBUS MEGALINER BARREL TEST

R.J.H. Wanhill, T. Hattenberg, P.H. de Haan
National Aerospace Laboratory NLR, Amsterdam, The Netherlands

Abstract

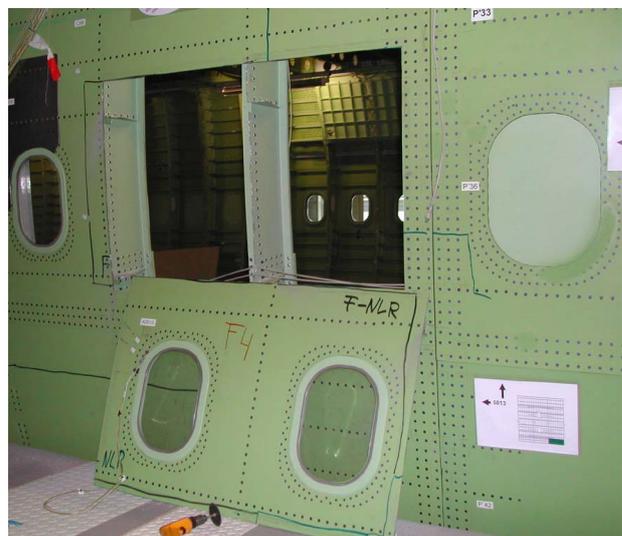
Fig.1. GLARE window area cut from the MLB

starboard windows, midway along the MLB. The basic structure is a GLARE 3-7/6-0.3/0.4 skin fastened to die forged 7175-T73 aluminium window frames by press fit 3/16" (4.76mm) Hi-Loks. The GLARE code means seven 2024-T3 aluminium layers 0.3mm thick (five inner layers) or 0.4mm thick (two outer layers), interleaved with six glass fibre layers.

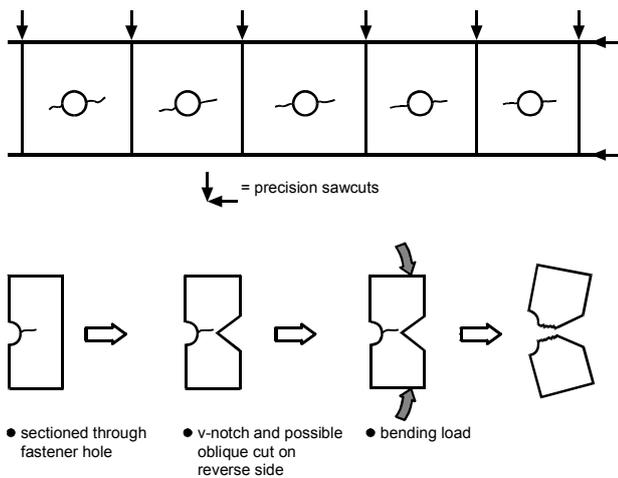
The NDI-indicated fastener holes were opened up for optical fractography using the procedure shown in figure 3. This verified the NDI for all GLARE fastener holes with maximum crack lengths $\geq 0.24\text{mm}$. Also, there were only 4 false calls for a total number of 216 inspected fastener holes. These results demonstrate that our NDI capability will detect most cracks in GLARE during teardown.

Fig.3. Procedure for opening up cracks.
