EFFECTS OF REPLACEMENT OF A DYNAMIC CRASH TEST WITH A QUASI DYNAMIC ONE. TEST OF PW-5 WORLD CLASS GLIDER

Piotr Czarnocki, Tadeusz Wiącek, Waldemar Wingralek
Warsaw University of Technology

This paper presents the results of a comparative studies carried out to investigate a possibility of replacing a dynamic crash test with quasi dynamic one in a case of glass-epoxy structure. In a case of gliders, general practice is that the fuselage is subjected to the required static load and the extend of the damage in the longitudinal direction is judged. Such procedure is relatively simple and inexpensive and for these reasons often applied however the relationship between the amount of energy absorbed in dynamic crash and that absorbed in a quasi dynamic one is not well known. To obtain necessary information preliminary investigations with the use of coupons and sub-components were carried out. The results showed that in the both cases the failure modes in macro scale were similar, (the same deformation modes) but in micro scale a pronounced difference occurred with the respect to the damage modes and the energy absorption mechanisms. The quasi dynamic loading resulted in the damage cause

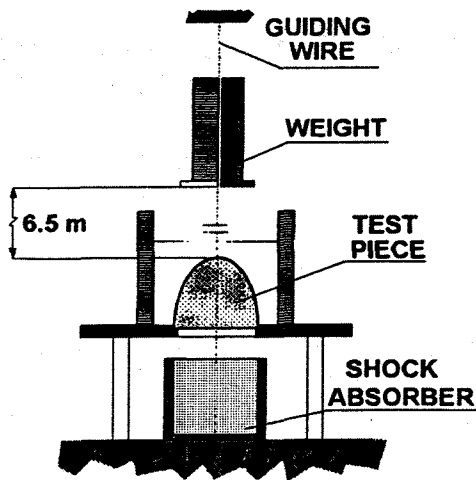
Fig.4. Dynamic test of the sub component.

The sub-components were loaded in compression with the cross head speed of 1.5 mm/s until a size of the damage zone reached 80 mm. The dynamic loading was produced by dropping a weight of 8.8 kg, Fig.4. The estimated contact velocity was about 11.3 m/s.
