## BUCKLING BEHAVIOUR OF LARGE GLARE FUSELAGE SHELLS UNDER COMPRESSION AND SHEAR LOADING

Peter HORST

Daimler-Benz Aerospace Airbus GmbH, Hamburg, Germany  
Structural Repair Engineering  
Kreetslag 10, 21129 Hamburg

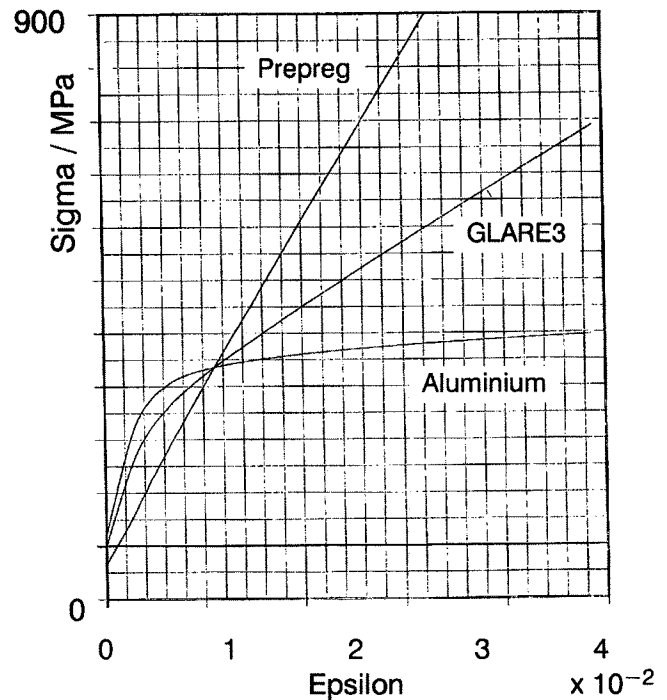
Fig. 2 : Stress-Strain-Relation of Glare Material and Components of GLARE3 3/2 Lay-Up

The calculation of the buckling behaviour needs some information about the elasto-plastic stress-strain relationship. As a first conservative guess this has been done for GLARE® – exactly in the same way as for monolithic aluminium – based on the Ramberg-Osgood equation. The Young's modulus of the prepreg has been regarded as constant. A curing temperature of 125°C has been adopted due to ref. 2. The difference of the operational temperature and the curing temperature result in a certain initial stress and strain state of the aluminium and glass layers, which has to be included in the calculation as a certain offset of the curves (see figure 2). The figure shows that GLARE exhibits a considerable hardening effect also beyond the yield strength.

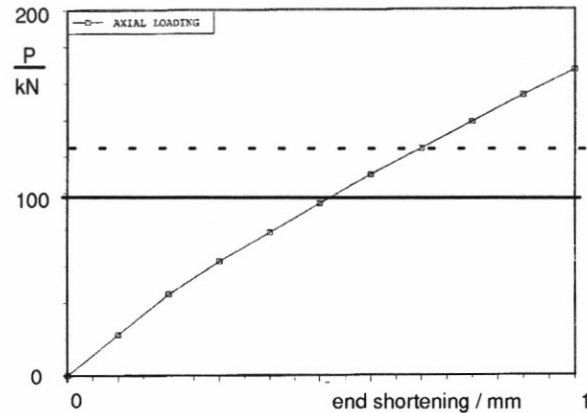
Figure 27: Load-Displacement Curve for Compressive Loading

The basic buckling behaviour of the panel under pure compression as shown in figure 26 is indicated in figure 27. Two points are crucial in this case: the non-linearity after only a low loading of about 40 kN, the fact that the compressive loading in the case of the combined loadcase is about 122 kN (indicated by the dotted line). The first point may easily be explained by the fact that local buckling occurs in the two upper shear fields. This actually does not alter the overall stability of the panel. The second point is mainly interesting with regard to the combined loading case, since it seems to be interesting to use the related value of the end shortening for the combined loadcase.

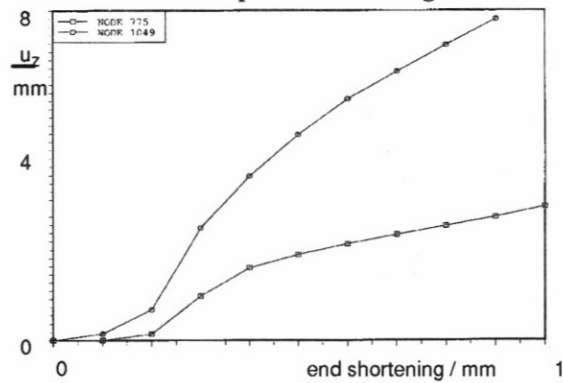
Figure 28: Deflection over End-Shortening

Figure 28 gives a good summary of the buckling behaviour, the deflection  $u_z$  is plotted versus the end shortening for two discrete nodes: the middle of the upper

shear field (node 775) and the edge of the window frame (node 1049)
