# ***Reduction of Development Costs of Full Composite Aero-Structure :A Proposal from a Research Sector***

***ICAS Biennial Workshop – 2011, Sept. 5, 2011  
Stockholm, Sweden***

***Takashi Ishikawa***

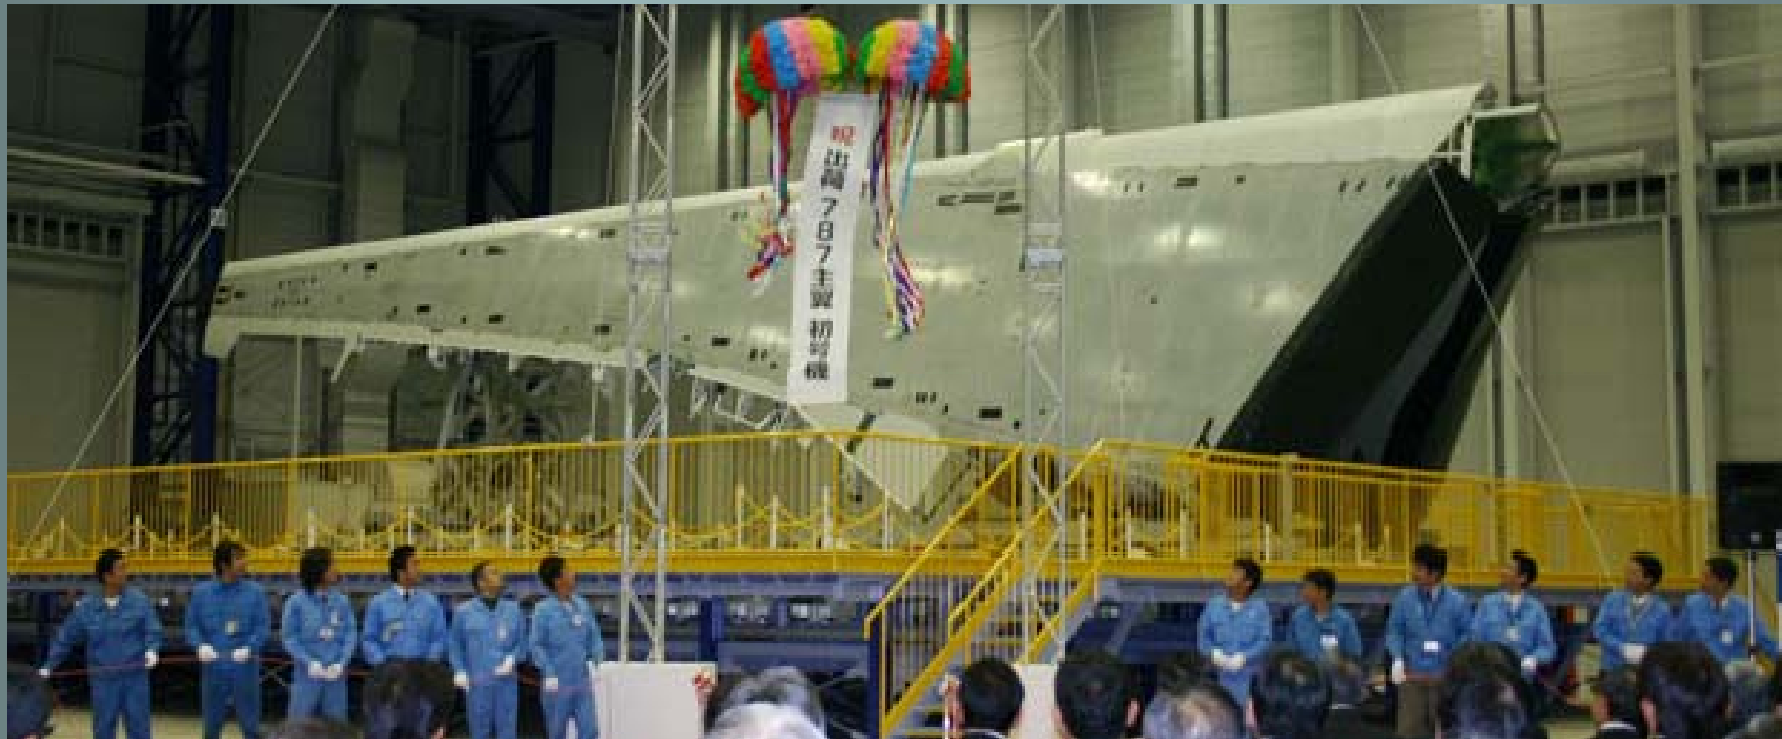
# Picture of B-787 Main Wing at Roll-out Ceremony at MHI O-e Plant

**Using Toughened Epoxy Prepreg:  
Auto tape lay-up machines are used  
in lamination process of wing skin**

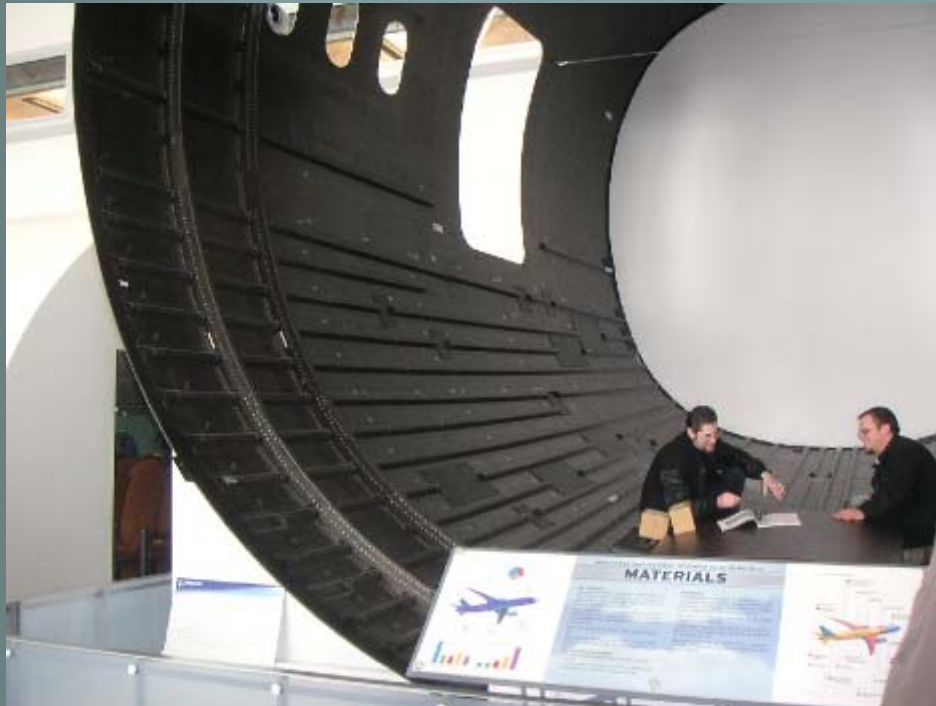
# Picture of Full Composite Fuselage of B-787

**Demo Parts:**  
In the production,  
Work share by  
Kawasaki Heavy  
Ind. (KHI), Japan  
and Alenia, Italy.

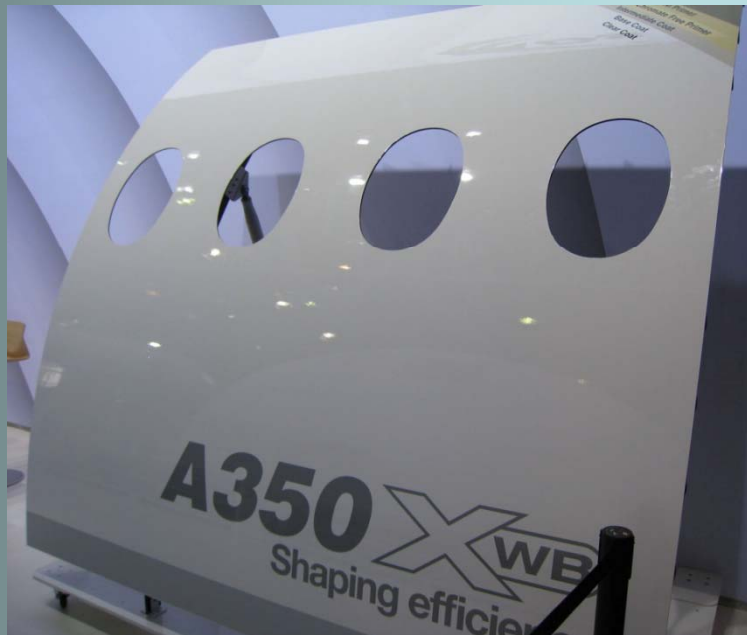
# Full Composite Fuselage of A350 XWB

above: Upper Panel, below: Demo Parts of Side Panel

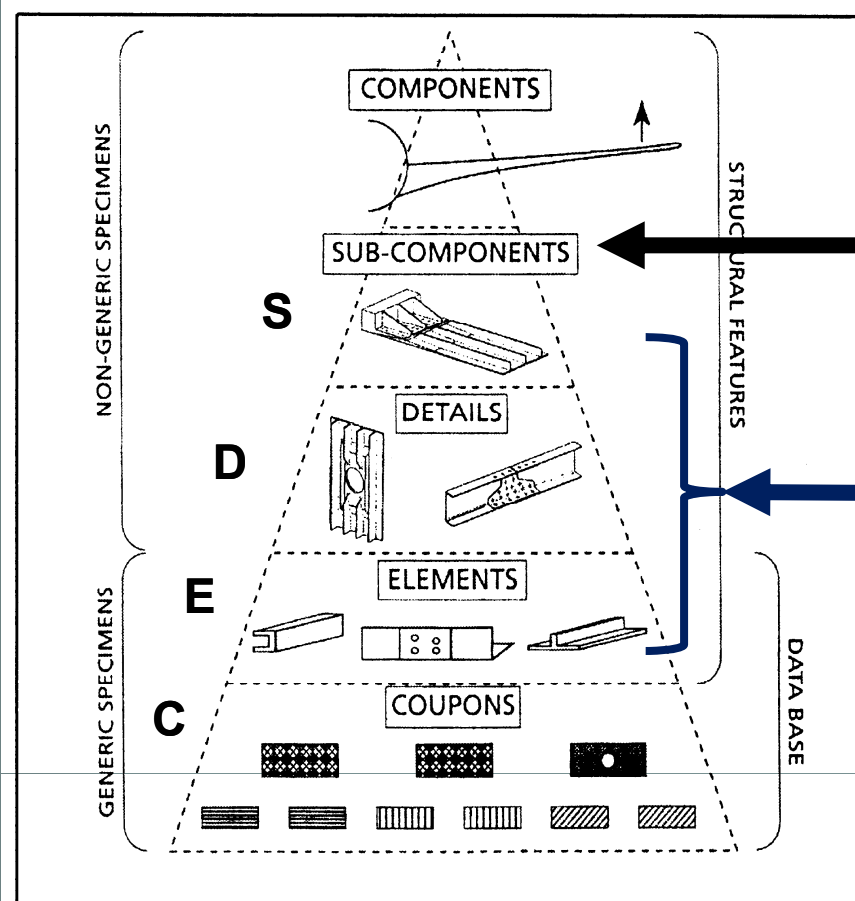
# Established Procedure of Type Certification of Composite Aero-Structure Building Block Approach (BBA)

BBA is considered as inevitable approach. However, as a research sector, two questions can be raised.

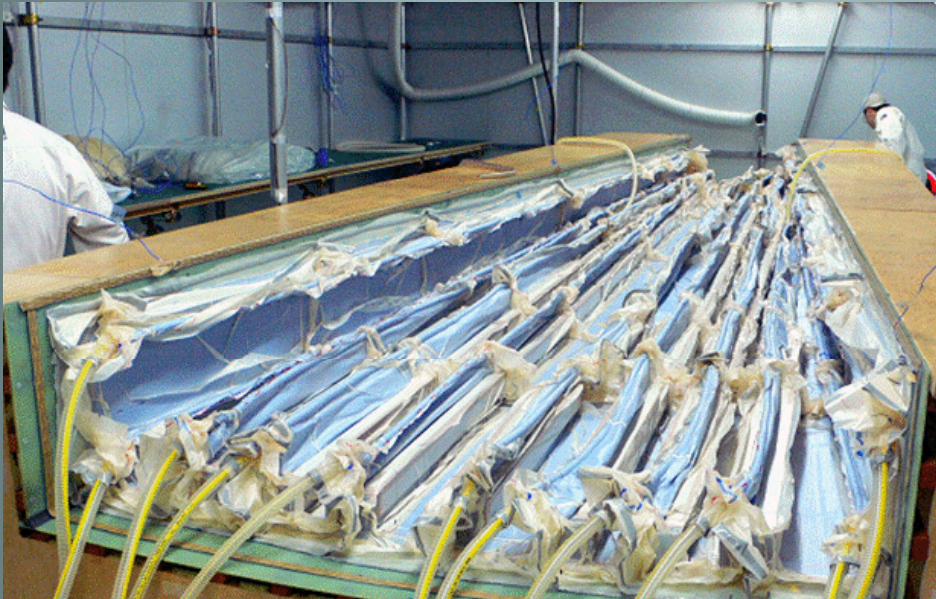
# Fabrication of 6m Full Size Panel

(Bagging and vacuuming)

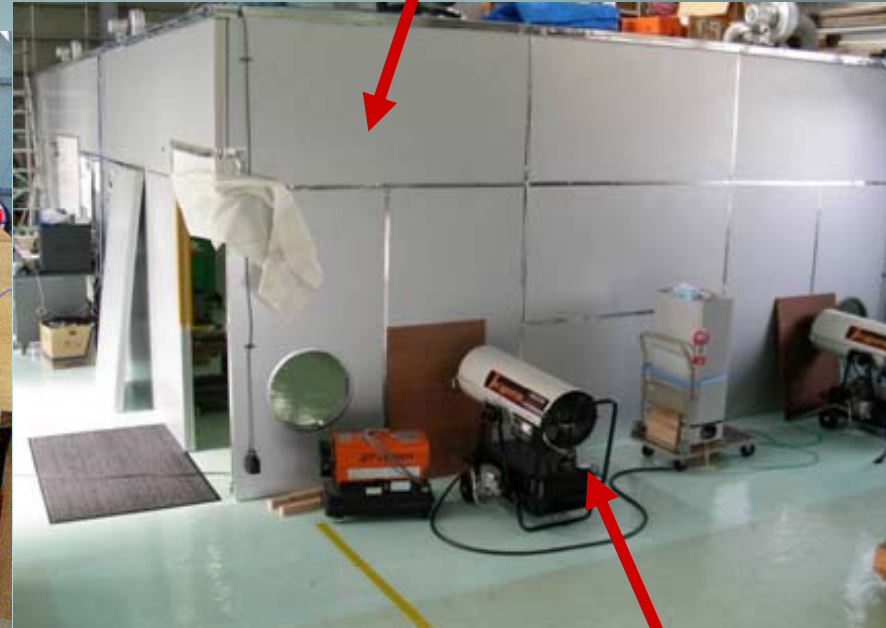
Heat Insulation Panel

Needless costly autoclave!

Fan heater blower

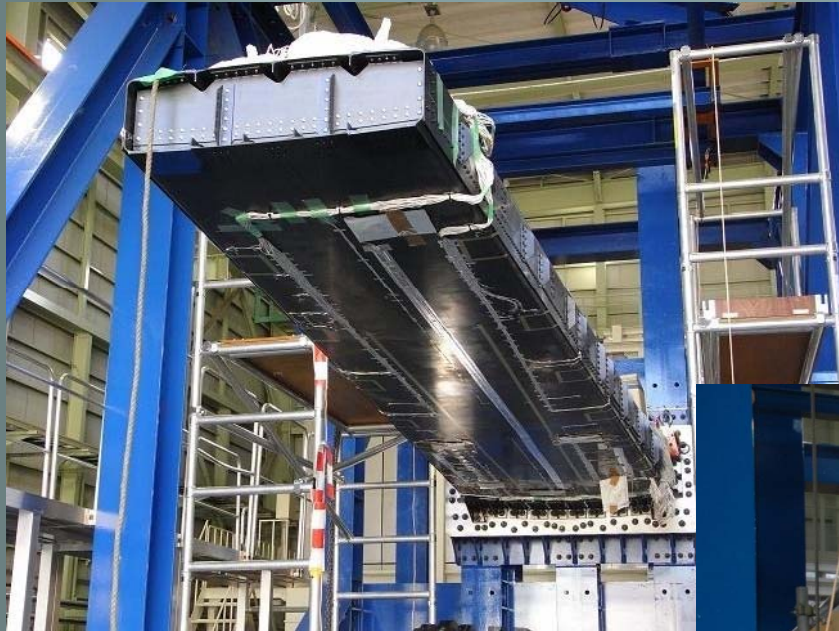
# 6m Full Size Wing Box in the Test Rig

**Photo of Static Load Test  
(100%)**

**Two life fatigue test  
of this box was  
finished**

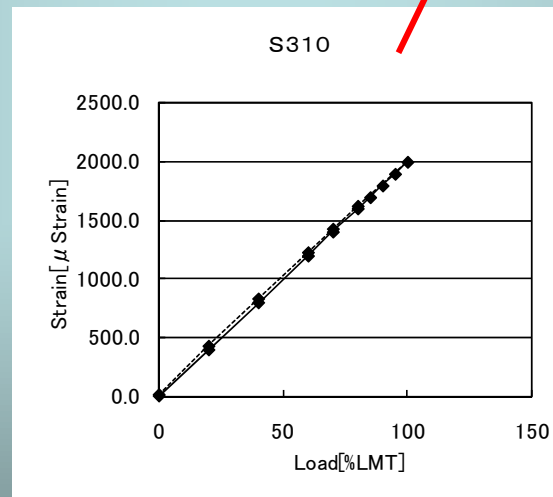
# Comparison of calculated (FEM) and experimental strain level at limit load test [at lower panel]

<b>S310</b>	<b>S134</b>
FEM	2006	2260
Measured	1990	2331
Error [%]	0.8	3.0

**Easy Work before the Progressive Failure  
: in Design Limit Load Test**

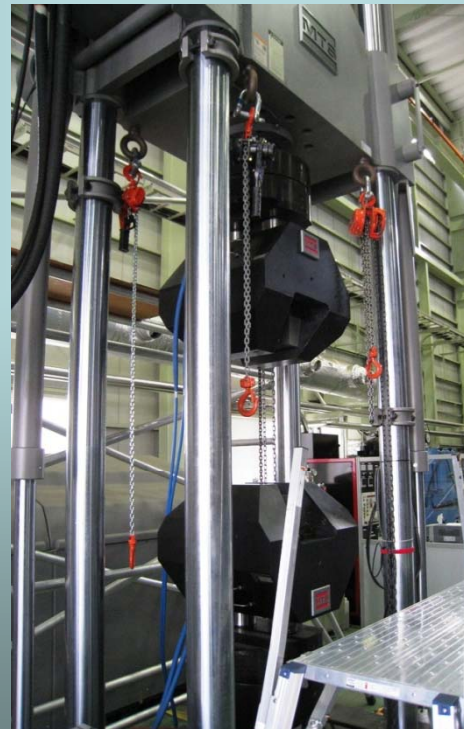
2,500kN Machine

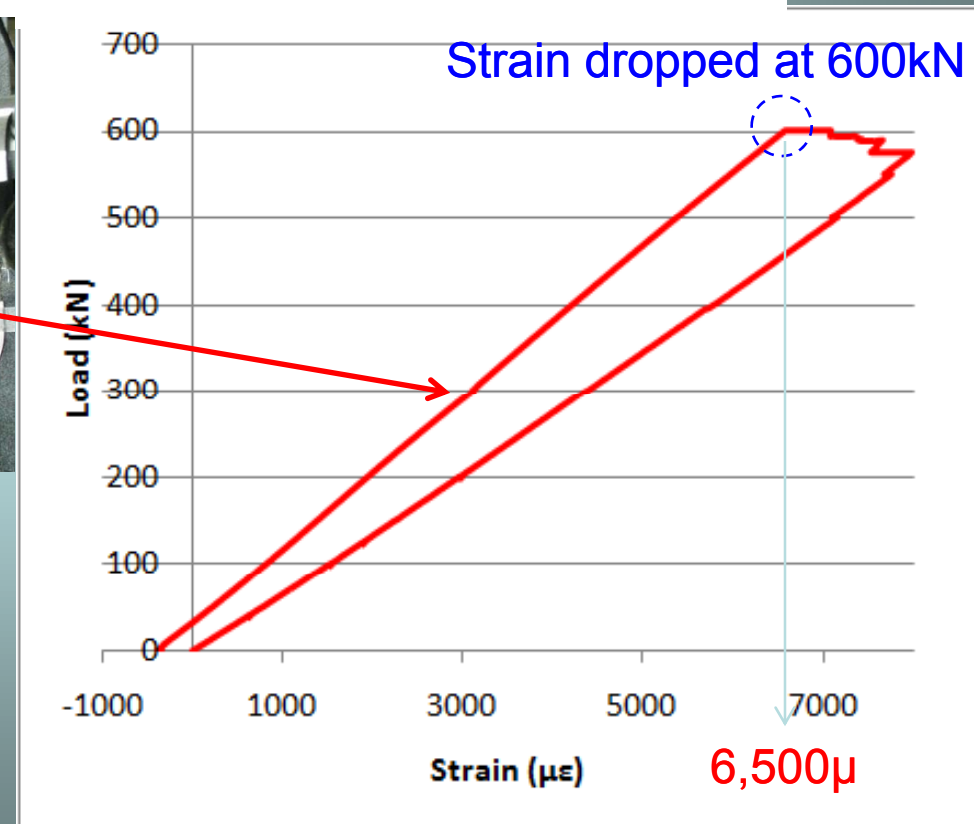
# Fatigue Test of Lower Panel: Strain Survey as the 1<sup>st</sup> Step

- Initial Adaptation of Fixture, Check of Measurement System, Comparison with Analysis
- **Bestowment of Initial Damage at Edge of Stringer Run-out**
  - ⇒ Created at 82% DLL: Peel Force by Local Bending
  - ⇒ No Detrimental Residual Deformation

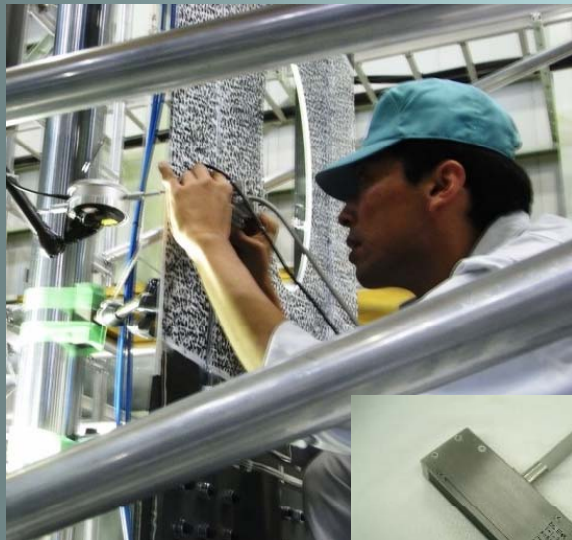
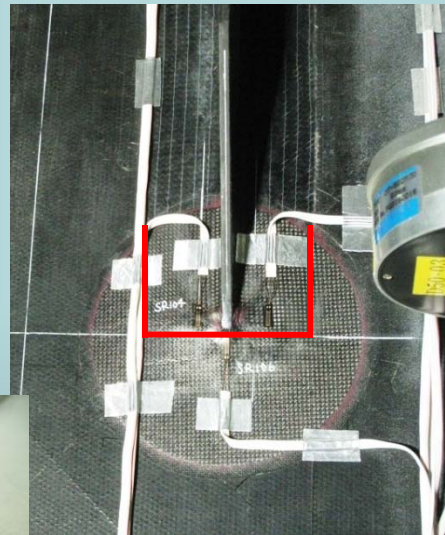
# Fatigue Test of Lower Panel: Inspection after Strain Survey

- Non-Destructive Inspection by Using Array Probe Ultrasonic C-Scan  
⇒ Small Delamination at Tip of Stringer Run-out (5mm x 2mm)

64ch x 5MHz linear  
array sensor

Disbonding (5mm x 2mm)

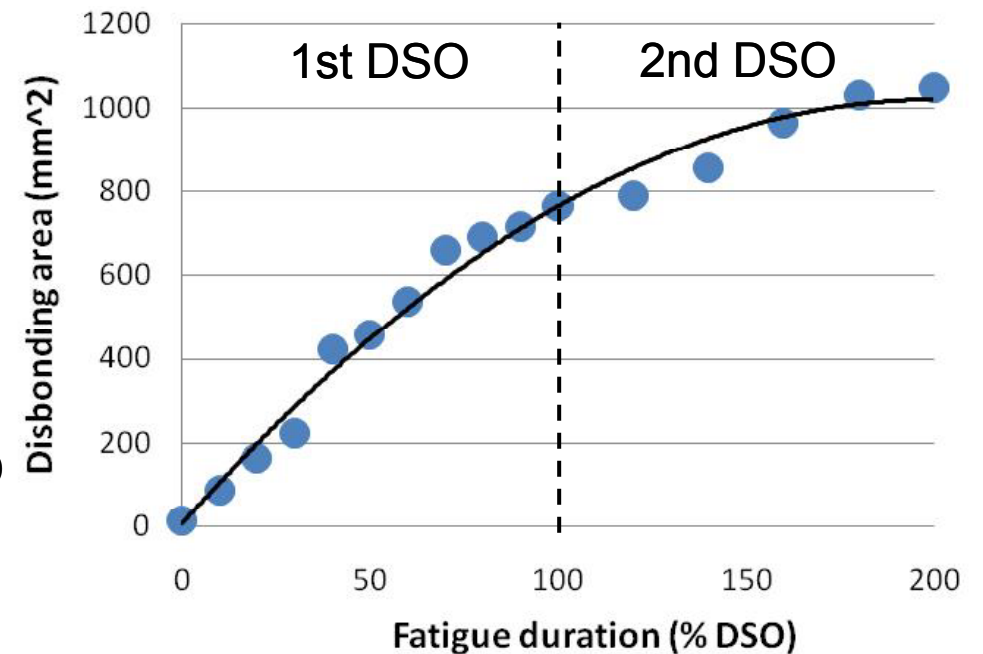
# Fatigue Test of Lower Panel: Evaluation of Delamination Growth

- Inspection Interval: at Every 4,000 Flight (every 10% of DSO)
  - By Human Eye: No Finding
  - NDI: Growth of Delamination at Stringer Run-out Tip

- Stable Growth during 1 DSO (slow growth)
- No Effect on Whole Structural Integrity at 100% DLL Test after 1 DSO

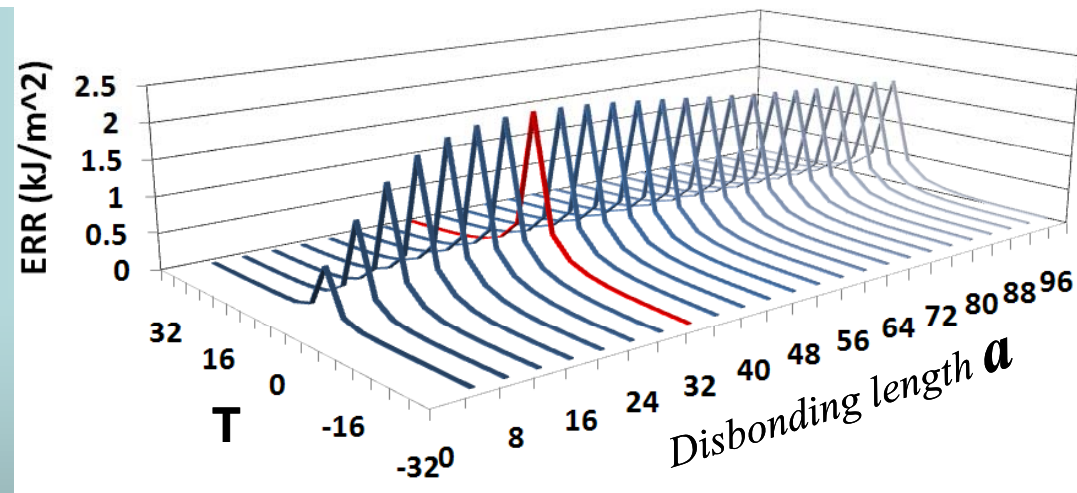
# Fatigue Test of Lower Panel: Numerical Analysis of Damage Growth

- Obtained Relationship between Delamination Length  $a$  and Energy Release Rate Distribution at Tip  $\Rightarrow$  Mode I Dominant ( $G_I \gg G_{II}, G_{III}$ )
- Energy Release Rate Distribution
  - Width-wise (T): Maximum at the Center(= below Web)
  - Length-wise (L): Increase within  $a < 32\text{mm}$   $\rightarrow$  Tend to Grow  
: Decrease over  $a > 32\text{mm}$   $\rightarrow$  Tend to Stop

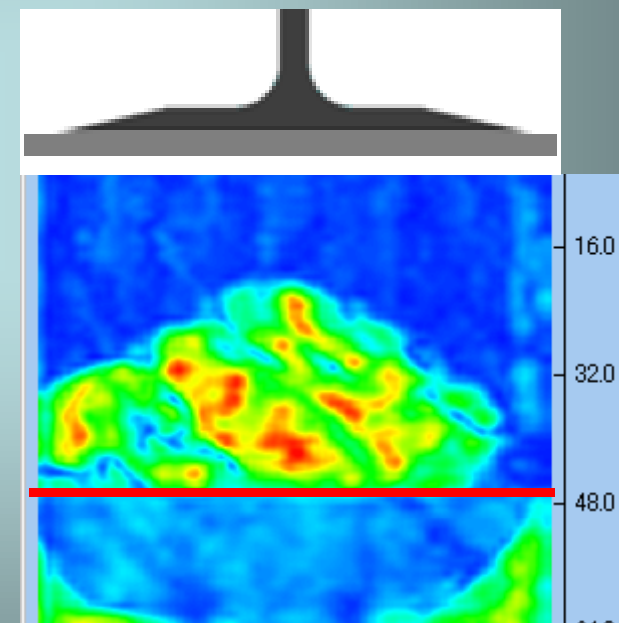
- Loading to 150% DLL, Keep for 3 Seconds
- Slight Growth of Delamination at Stringer Run-out, No Finding other Detrimental Residual Deformation or Rigidity Reduction
- No effect on Structural Integrity

After 150% DLL test

If numerical prediction is successful, this test can be eliminated.  
Current simulation level: not 100% complete, future task

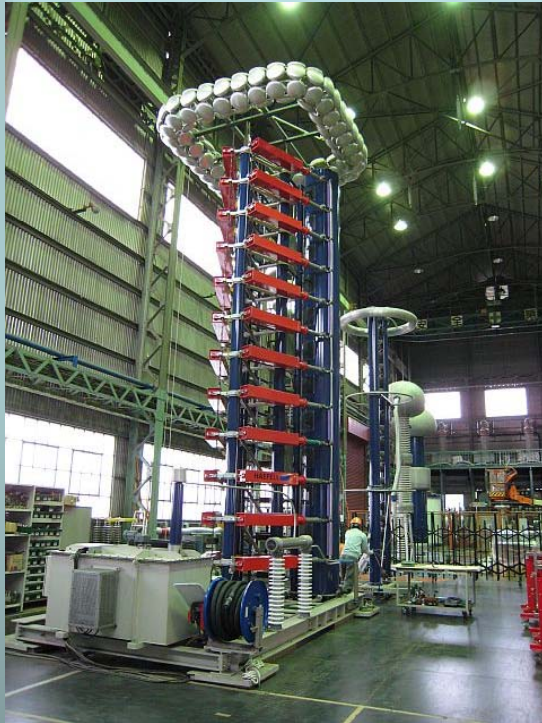
Lightening Strike to Regular Compression after Impact Specimen

**High Voltage Impulser, by HAEFELY Co.  
(Owned by Nisshin Electric Co. Ltd [Japan])**

Maximum capability: 2400kV 120kJ  
 Time Parameter for Impulse Current Pattern:  
 4/10 $\mu$ s, 8/20 $\mu$ s, 0/350 $\mu$ s  
 Maximum Current:  $\pm 40$ kA ( $\pm 20$ kA)

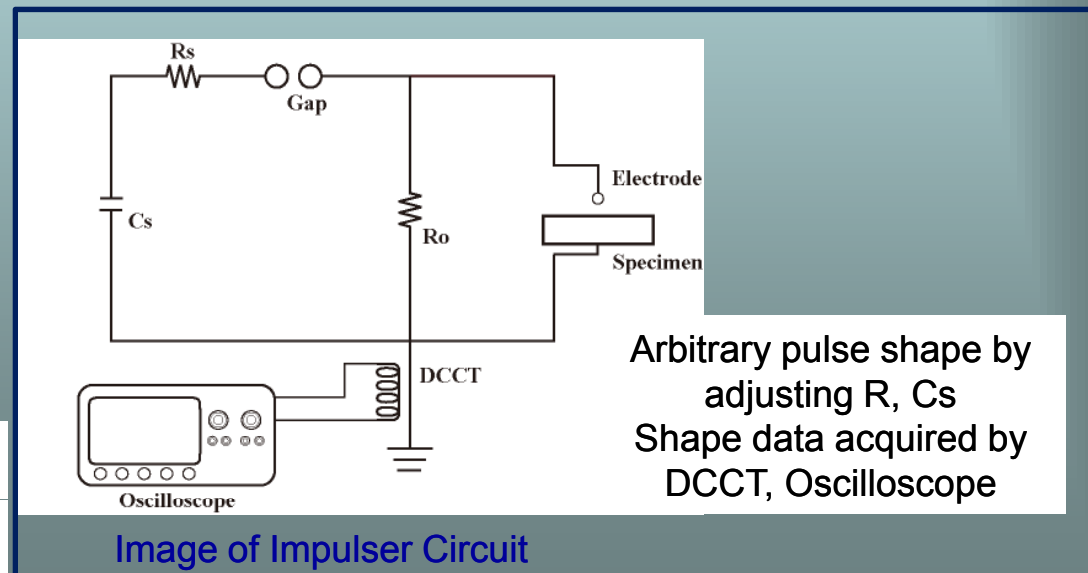
**Specimen**  
 ASTM D7131 (CAI)

IM600/133  
 [45/0/-45/90]4s (n=4)  
 t = 4.7 [mm]  
 100 × 150mm

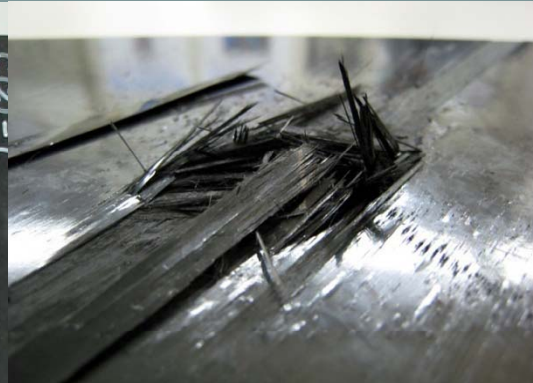
Vicinity of impulse contact point

Wave profile : 4/20 $\mu$ s  
Peak current : 40 kA  
Action Integral :  $2 \times 10^4$  [A<sup>2</sup>s]  
thickness : 4.7mm

**Estimated scenario: Created super high temperature by Joule heat due to high electric current**

**⇒ Explosive sublimation of fiber or resin**

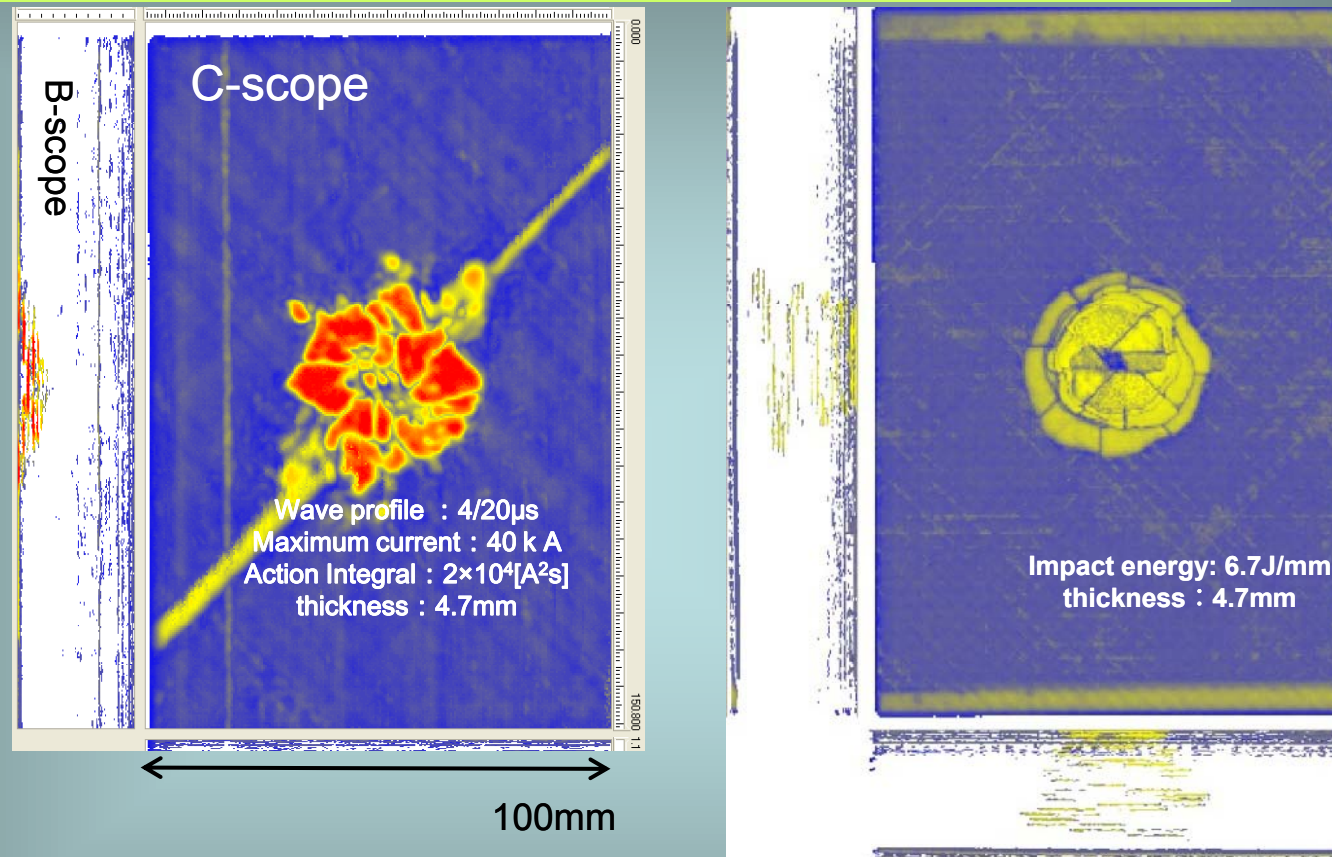
# Internal Damage Pattern by Ultrasonic C-scan

Damage by lightning	Damage by mechanical impact
Delamination	Delamination between each ply: A pair of fan-like shape	
Cause of growth	Thermal & electrical anisotropy	Mechanical anisotropy
Thickwise extent	A few plies near impulse point	Whole in the thickness

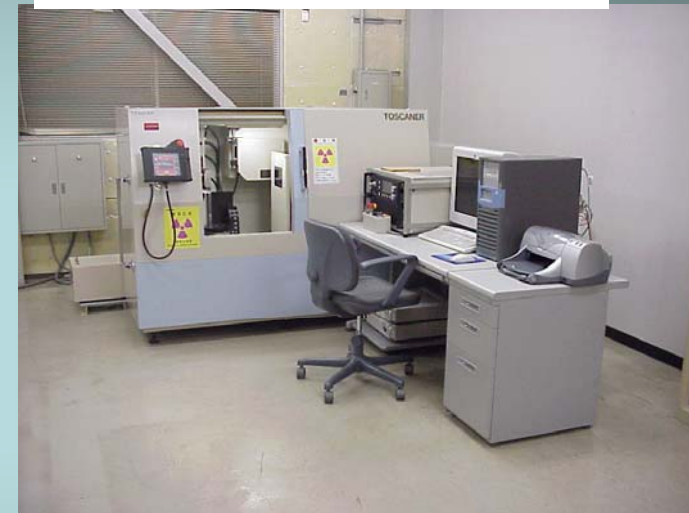
# Internal Damage Pattern by X-ray CT Scan and Actual Cutting

Pictures of cut sections
