STRUCTURAL BEHAVIOR OF DAMAGED ANISOTROPIC STIFFENED PANELS UNDER COMPRESSIVE LOADS

Giacomo Frulla*

*Politecnico di Torino, Dipartimento di Ingegneria Aeronautica e Spaziale

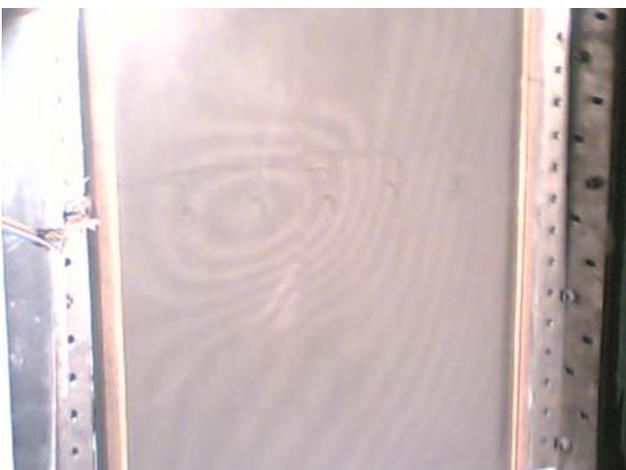
Figure 19: Load level ratio of 0.55
