IMPACT ON BONDED REPAIRS TO CFRP LAMINATES UNDER LOAD

Keywords: *Carbon composite, bonded repair, scarf joint, impact*

Abstract

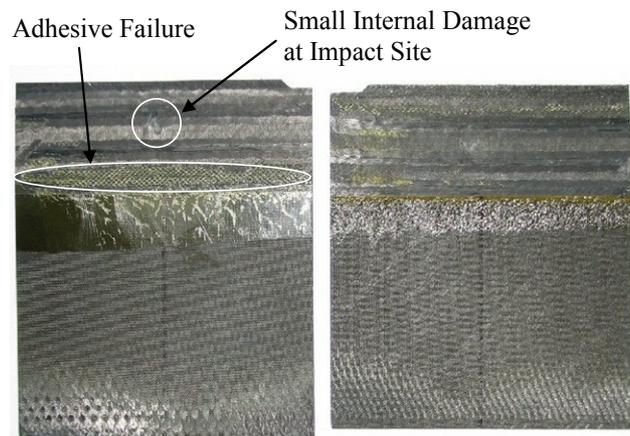
Fig. 7. Failed scarf joint specimen (3000 $\mu\epsilon$ prestrain) showing adhesive failure around the tip of the scarf joint on the underside (left) and subsequent adherand failure. A small direct impact damage at the impactor site can also be seen (circled).

although the impact velocity was lower (see Table 1). The failure is presumed to have been caused by adhesive failure around the tip of the scarf joint remote from the impact, as shown in Figure 7. This would be a point of maximum combined stresses under bending induced by the impact. Once initiated, the disbond can be seen to have traversed into the composite substrate itself.

In addition to the bondline damage, a small direct impact damage can also be seen, as shown in Figure 7. The size of this damage is almost identical to that of the other specimen impacted at the same level of prestrain as indicated by the C-scan.
