MULTI-DISCIPLINARY INSTALLATION OF THE EAGLE'S EYE

Peter L. Hoogendijk
National Aerospace Laboratory NLR

Abstract

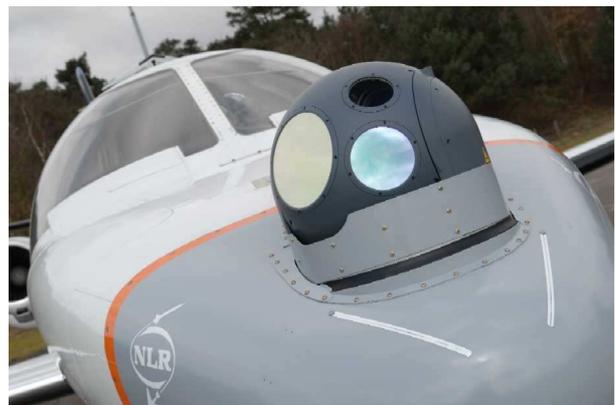
Fig. 1 Final and certified situation of camera installed on Cessna Citation 2

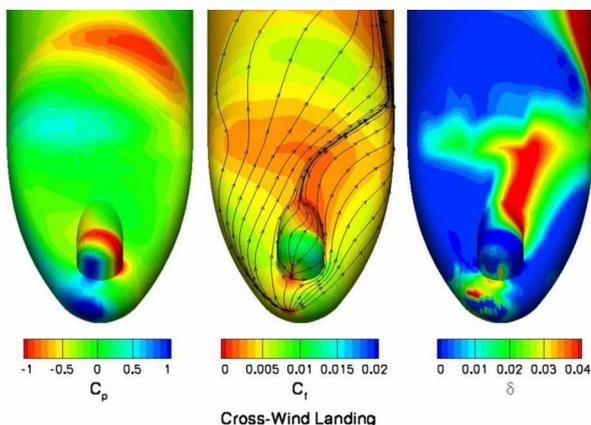
Fig. 2 Results of Surface Pressure Coefficient (C_p), Skin Friction Coefficient (C_f) and Boundary Layer Momentum-loss Thickness (δ) for the Cross Wind landing configuration.

The following flight conditions had been researched by use of the CFD method, representing the critical conditions to be expected during flight:

1. Stall ($V = 91$ kCAS, $\alpha = 12^\circ$, $\beta = 0^\circ$)
2. Cross-wind landing ($V = 118$ kCAS, $\alpha = 6^\circ$, $\beta = 16^\circ$)
3. High Speed flight ($V = 262$ kCAS, $\alpha = -0.3^\circ$, $\beta = 0^\circ$)
4. High Speed flight with sideslip ($V = 262$ kCAS, $\alpha = -0.4^\circ$, $\beta = 10^\circ$)
5. Dive ($V = 393$ kCAS, $\alpha = -0.8^\circ$, $\beta = 0^\circ$)

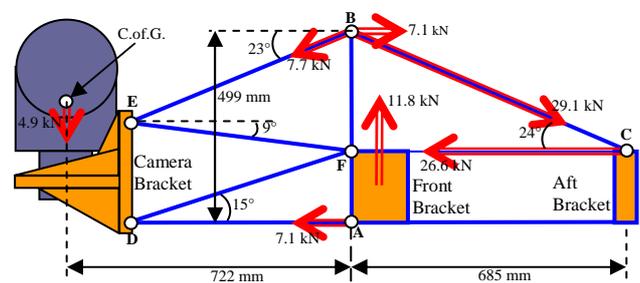
Fig. 3 Overview of load and forces

Vertical gust load (see Fig. 3)

Using the design dimensions and the vertical gust condition as shown in Table 1, being 4874 N, gave a load of 7052.2 N on tube DA. Because of the interconnection between the forward and aft brackets via the upper rods BC at an angle of 24°, the vertical load is calculated, being 11823 N, acting on forward and aft bracket. With this calculated load, the loads on BC and CF can be calculated. Calculations revealed loads as follows: on support rod BC 29068 N, on support rod CF 26555 N and on support rod BE 7662 N.

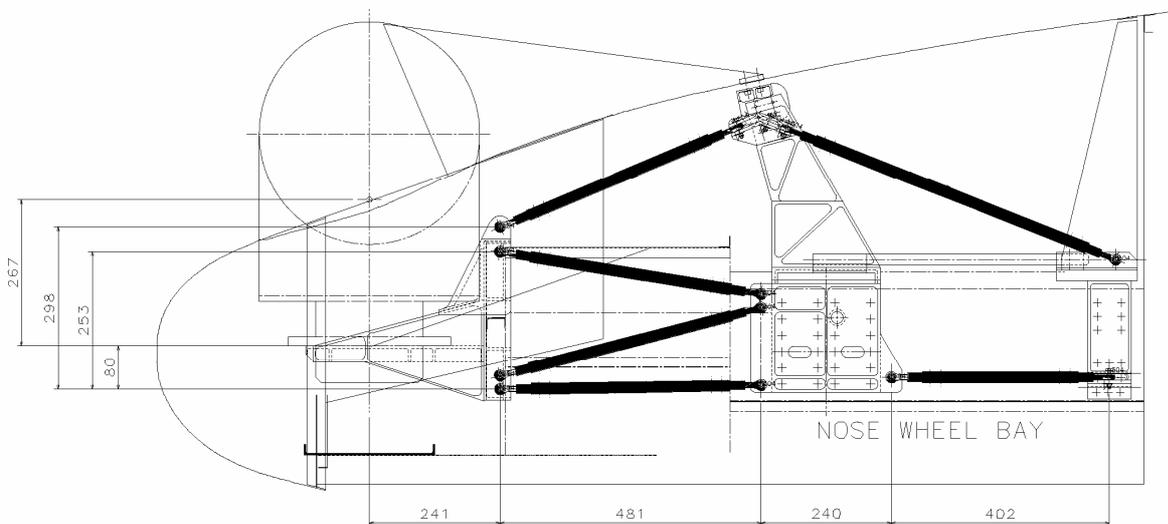
Fig. 4 Drawing of the brackets and frame construction

The camera was mounted on an aluminum bracket. The loads introduced by the camera were transmitted from the camera installation bracket to a tube frame, which was installed symmetrically on both sides of the nose gear wheel bay. Via the tube frame the loads would be transmitted to (in total four) brackets which were riveted onto both vertical sides of the nose gear wheel bay structure. The camera bracket itself was hanging, by use of in total 8 tubes, which were attached onto the camera bracket and the forward nose wheel bay bracket (see Fig. 4). For accommodating the camera in the aircraft nose area, a 410 mm (16.15”) diameter hole was made in the upper side of a new nose and radome assembly.

A single direction curved plate strengthened with ribs, strips along edges, L-profiles and a base plate, was installed behind the camera.
