IMAGE-BASED STRUCTURAL HEALTH MONITORING OF COMPOSITE STRUCTURES

T. Uhl*, **M. Szwedo****, **P. Hellstein***, **L. Pieczonka***

Keywords: *composites, structural health monitoring (SHM), pulsed thermography, vibrothermography, shearography, laser Doppler vibrometer (LDV)*

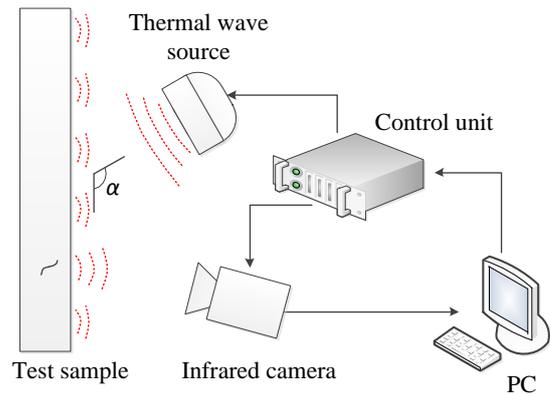
Figure. 1. Experimental arrangement of pulsed thermography

Pulsed thermography belongs to the family of active thermographic techniques with external excitation. It is schematically presented in Figure 1. The experimental setup consists in: (1) a thermal wave source, which may be a halogen, flash or infrared lamp, (2) an infrared camera, (3) a control unit that allows to synchronize and trigger a measurement and (4) a personal computer with data processing software. If thermal source is located on the same side of a tested component as infrared camera the arrangement is called the reflection mode, if it is located on the opposite side the arrangement is called the transmission mode.

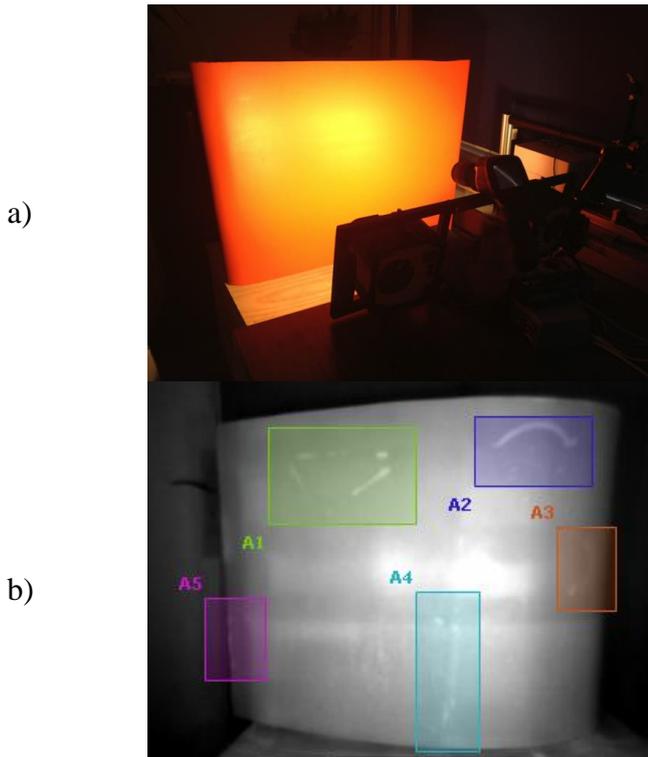
Figure 2 Test rig with pulsed thermography measurement system (a) and test result with highlighted areas containing defects (b).

In this study, pulsed thermography measurements were performed on a prepared section of wind turbine blade with the dimensions 94×70 cm. Artificial defects were manufactured in the blade by removing the skin of the blade and creating disbonds between the skin and the internal stiffeners. After that the blade has been restored to its initial state using standard production methods. Pulse thermography measurement consists of two stages – heating and cooling. The heating process was performed with use of two high-power 2 kW lamps delivering the energy for 10 seconds, with 40 seconds of cooling phase afterwards. The test system was placed 50 cm from the inspected turbine blade. Because of the small distance to the object, a wide-angle lens has been mounted on infrared camera, which increased its field of view. The resultant thermographic image acquired during the measurement with post-processing applied in ThermoAnalysis software [11] is presented in Figure 2. The defect localizations are marked with rectangular overlays. Areas A1, A2 and A3 present inhomogeneity, which has been initially prepared. Areas A4 and A5 present internal structure defects that have not been prepared during manufacturing process, but have occurred during exploitation of the blade and have not been previously known.

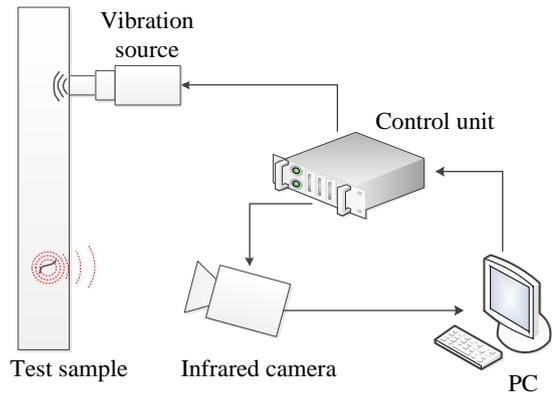
Figure 3. Experimental arrangement of vibrothermography.

Vibrothermography, also referred to as ultrasonic thermography or thermosonics, is an active thermographic approach with internal excitation [12]. It is schematically depicted in Figure 3. The experimental setup consists in: (1) an ultrasonic vibration source, (2) an infrared camera, (3) a control unit that drives the transducer and allows to synchronize and trigger a measurement and (4) a personal computer with data processing software. Ultrasonic vibration source is typically an ultrasonic welding setup that consists in a piezoceramic stack based converter and a waveguide composed of a booster and a sonotrode. Such setup allows for high power, narrowband frequency operation. Vibrothermography is very well suited for materials with intermediate thermal diffusivity values (the ratio of thermal conductivity to mass density and specific heat capacity of a material) as for example carbon fiber reinforced polymer (CFRP) composites [12-14].

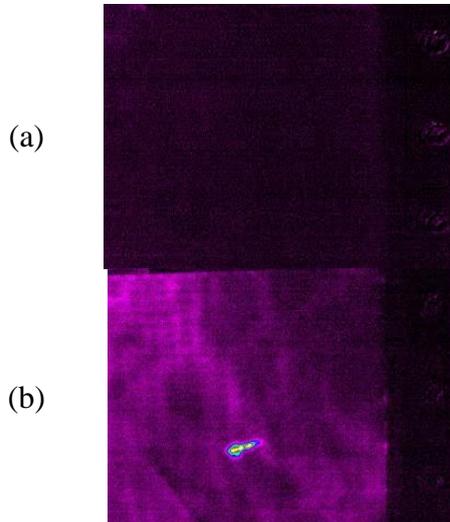
Figure. 4. Experimental arrangement of vibrothermography.

Figure 4a presents the thermal image acquired before applying ultrasonic excitation. The initial temperature distribution on the sample was subtracted from the image therefore only the camera detector noise can be seen in

the image. Figure 4b presents the thermal image acquired 3 seconds after applying ultrasonic excitation. The damaged area can be clearly identified as a bright spot in the image.

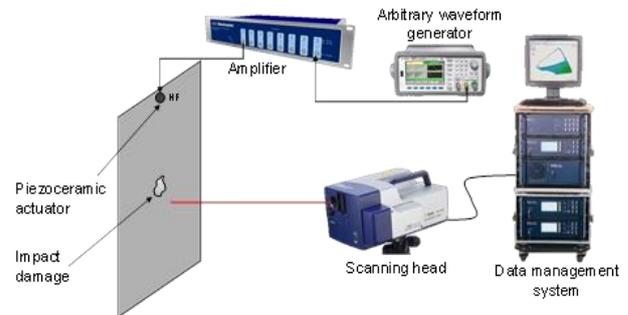
Figure. 5. Experimental arrangement of scanning laser Doppler vibrometer (LDV) measurements.

Experiments with LDV imaging were performed using the experimental setup shown schematically in Figure 5.

For LDV measurements the plate was suspended using elastic cords to simulate free-free boundary conditions. The excitation was applied by a surface-bonded *Noliac CMAP* stack actuator driven by the *EC Systems PAQG* signal amplifier. A *Polytec PSV-400* scanning laser vibrometer was used for non-contact measurements of vibration responses at 2345 points on a 35×67 measurement grid. Excitation signal was a wave packet of 8 cycles 100 kHz wave in a Hanning window.
