STRENGTH ESTIMATION METHOD FOR UNDAMAGED, DAMAGED AND REPAIRED HONEYCOMB STRUCTURES

Mr V. Urinovsky, Research Student
 Mr D. P. Coldbeck, Lecturer (Aircraft Structures)
 Mr L. Smrcek, Senior Lecturer (Aircraft Design)
 Department of Aerospace Engineering,
 University of Glasgow,
 Glasgow, Scotland

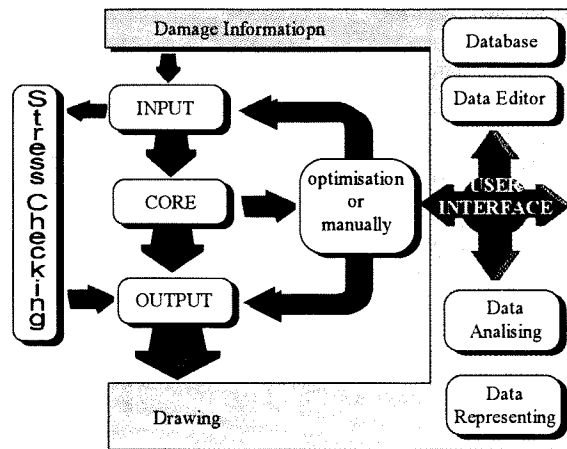
Figure 10 Macro-Algorithm

The programme has been written in modular form so as to be easily adaptable to meet the needs of a variety of users. Figure 10 shows the macro algorithm in diagrammatic form.
