# THE DYNAMIC BEHAVIOR OF FUNCTIONALLY GRADED PLATES UNDER THE IMPACT LOADING

Xiao-Qiong Zhang; Wei-Guo Guo; Jian-jun Wang

School of Aeronautics, Northwest Polytechnical University, Xi'an 710072, P.R. China

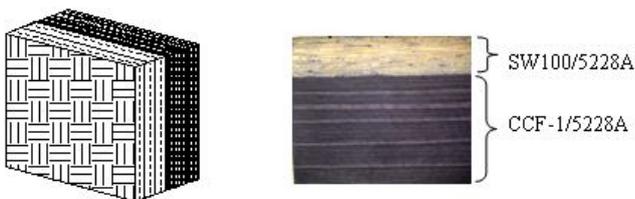
The functionally graded composite plates are represented in Fig.1. Its impact panel is made of glass fiber woven composites SW100/5228A and backplane is produced by carbon fiber CCF-1/5228A, and then solidified them together. The size of all laminated plates were 200mm\*150mm\*8.7mm. The thickness of glass fiber layer accounted for total thickness 5%, 10%, 15%, 20%, 25% and 30%. The configuration of samples were showed in table1.

Fig. 1. Functionally graded plate of SW100/5228A and CCF-1/5228A
