Experimental Investigations on Tensile Properties of Aluminum Honeycomb Sandwich Structures with Single-sided Repairing

Tensile properties of single-sided panel repair (SP) and panel/core repair (SPC) of aluminum alloy honeycomb sandwich structure (AAHSS) used in civil aircraft were researched by experiments and compared with that of AAHSS without repair. Firstly, a clamp suitable for testing the tensile properties of wide-wall panels with different thicknesses was designed. Then, the failure behavior, the strain and deformation characteristics of SP and SPC structures were firstly studied by digital image correlation (DIC) technology. The results showed that the debonding of the patch and the fracture near the root were the main failure modes of the SP structure, and the strength recovery rate was 101%. A summary was that the repairing method for this configuration could effectively improve the bearing capacity of the original structure, and the adhesive performance was more stable. For SPC structure, debonding of the patch was the primary failure mode with only a 94% strength recovery rate. Besides, the strain concentration of both repairing structures was located in the substra

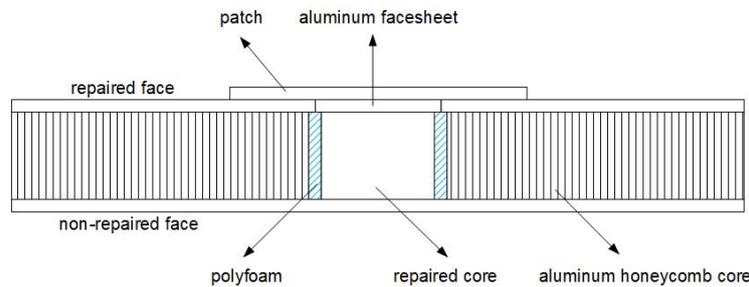
The configuration of the SPC structure is shown in Figure 1. Firstly, the damaged part of the aluminum facesheet and honeycomb core (only the damaged part of the aluminum facesheet for single-sided panel repair) were completely removed from the substrate. Then, polyfoam was used to bond the repaired core and aluminum honeycomb core. Lastly, a small circle aluminum facesheet was glued onto the surface of the repaired core, and the patch was stick onto the entire repair area. The patch-attached side was called the repaired face, while another flat side was called the non-repaired face.

Figure 1 – The repairing method of SPC structure

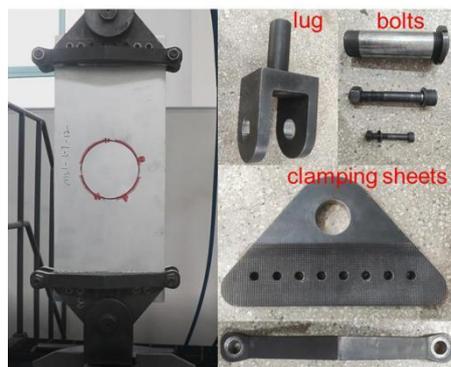
The tests were carried out on the MTS Model 311.31 hydraulic servo fatigue testing machine, while the loading rate was 1mm/min. The clamp width ranges of the fatigue testing machine is between 90~130mm, so a directly clamping scheme was not adopted in the tensile tests of large size repaired structures under a large fracture load level. Aiming at testing the tensile properties of wide-wall panels with 250mm width and different thicknesses, a clamp was designed according to the manual [28]. The designed load was 30t, and the safety factor was 2. The clamp consisted of lugs, clamping sheets with hobbing teeth, and M10, M18, M38 bolts of grade 12.9, as shown in Figure 2, and the clamp was made of No.45 steel. The main design idea of the clamp was to increase the friction between the inner clamp and the ends of specimens by applying a large preload on the clamp by bolts, which to simulate the loading of the machine clamp more realistically. The load applied by the testing machine was transferred to the specimen mainly through friction, and the bolts bear little or no shear load in the loading process. Uneven loading and severe stress concentration caused by the hole at patch were prevented effectively, which may result in section fracture near the ends. The even distribution of load in the working section can be verified by back-to-back strain data and DIC technology, respectively.

Figure 2 – The clamping scheme of the sample

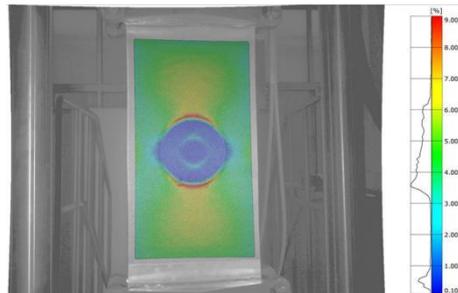
Figure 3 showed the results measured by DIC technology. The full-field strain and displacement distribution can be observed directly, and all the result information of a point during the loading process can also be output directly by the computer. For the traditional method, the arrangement and numbering of gauges were drawn in Figure 4. The numbering in parentheses (e.g. (1-3), (2-2)) indicated that the strain gauges were attached to the non-repaired face of the specimen, others attached to the repaired face. The strain gauges numbered 1-1, 1-2, and 1-3 were set to demonstrate the loading uniformity of the fixture designed in section 2.2.

Figure 3 – Full-field longitudinal strain plot as measured by DIC

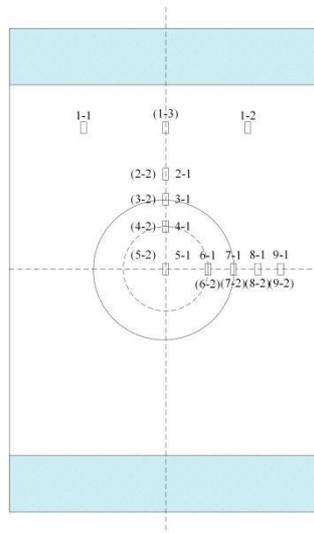
Figure 4 – Distribution of strain measurement

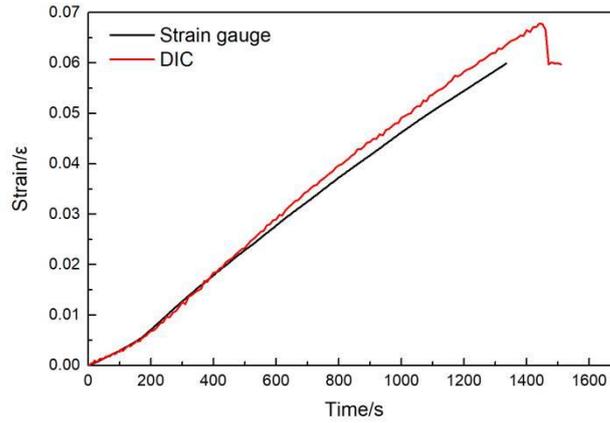
For the same point on the surface of the specimen, the strain-time curve of gauge numbered (1-1) was in good agreement with that measured by DIC, as shown in Figure 5, which makes valid points about the relative convenience and value of DIC over traditional strain gages.

Figure 5 – Comparison between the results of DIC technology and strain gauges

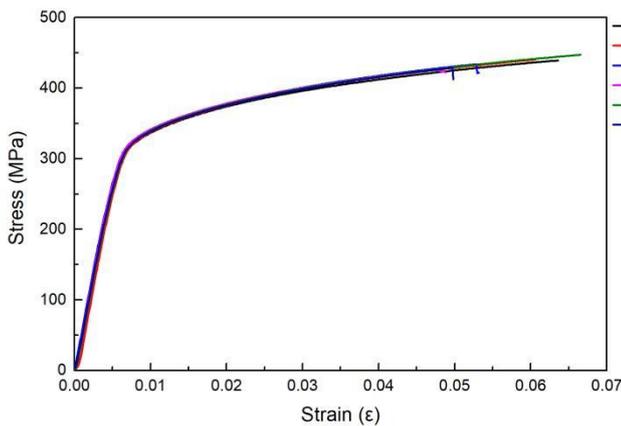
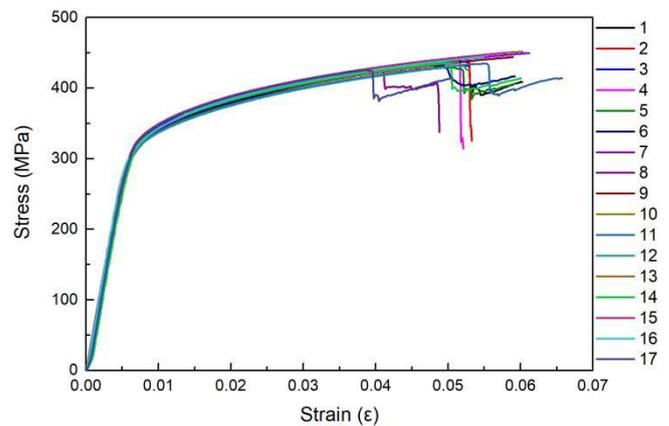
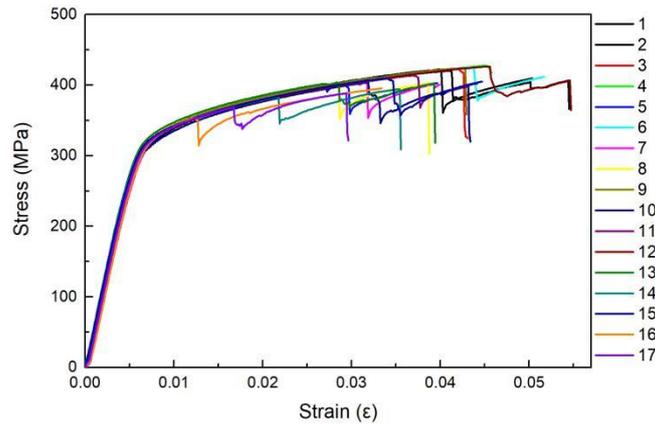
The stress-strain curves of NS, SP, and SPC structures are shown in Figure 6. The average strain in the working section of the specimen increased linearly during the initial loading stage. When the tensile yield strength of the aluminum alloy material (about 330MPa) was reached, the slope decreased obviously and the load increased slowly. For non-destructive specimens, failure occurred when the average strain of the specimen was higher than 0.045ε (Figure 6(a)). For SP structure, failure may occur when the strain was higher than 0.035ε (Figure 6(b)), and the dispersion coefficient of debonding strain was 11.49%, which indicated the adhesive performance was stable. For the SPC structure, the debonding failure occurred randomly once the applying load was over the critical yield point (Figure 6(c)), and the dispersion coefficient of debonding strain was 30.41%, which can prove the quality of bonding between the substrate and patch was poor. The failure strain level of SP and SPC structures depended on the adhesive quality, such as initial defects, bonding area, and adhesive thickness. In addition, more initial defects such as air bubbles and weak bonding may exist in the seam of the honeycomb of SPC structures, so it is easier to produce debonding failure than the SP structures at a low load level.

(a) Non-destructive specimens(NS)

(b) Specimens with single-sided panel repair(SP)

(c) Specimens with panel/core repair(SPC)

Figure 6 – The stress-strain curves of three type specimens

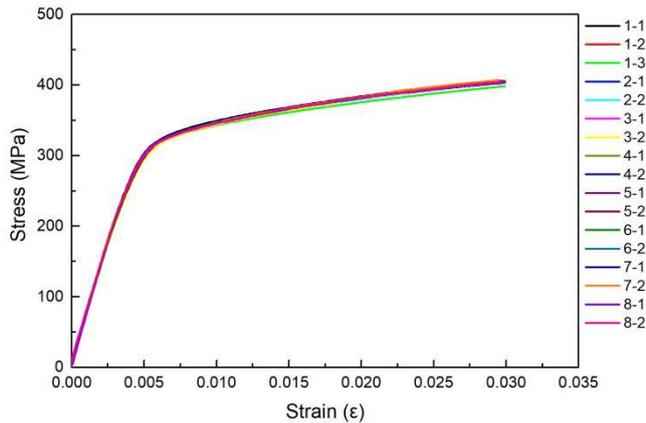
For NS structures, the longitudinal strain's growth trend at different positions of both faces was the same during the loading process, as shown in Figure 10. The strain was 0.006ϵ when the panel's average strength reached the yield strength (330MPa) of the aluminum alloy material, after that the strain increased sharply. The strain distribution characteristics of the SP and SPC repairing structures were very different from NS structure. However, the strain distribution characteristics of the SP and SPC repairing structures measured by gauges and DIC technology were almost the same, which means that the effect of the polyfoam used in the honeycomb seam was very small and can be ignored. Besides, different failure modes had almost no effect on the strain distribution characteristics during loading. Therefore, typical specimens were selected below to analyze the full-field strain and deformation characteristics of the metal honeycomb repairing structure under tensile load.

Figure 10 – The strain-stress curves of NS structure

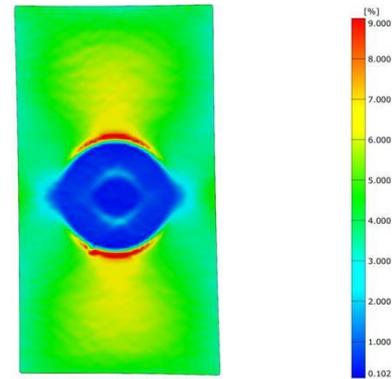
Figure 11 – The longitudinal strain distribution of repaired face

The typical specimen SP-13 with the failure mode B was selected. At the beginning of loading (about 60kN), the strain of the patch in the repairing area was slightly smaller than that of the substrate, and the low strain area of the patch was circular. As the load increased, the low strain area of the patch changed from a circle to an eye shape, as shown in Figure 11. At this time, the substrate on both sides of the patch was also in a low strain state due to the reinforcing effect of the patch, indicating that the patch can restrain the damaged area from being deformed and damaged. In addition, the maximum strain was located on the substrate near the upper and lower edges of the patch. The area of the strain concentration decreased as the load increased. The shape of the strain concentration area became a red crescent shape surrounding the patch when the specimen was about to fail. This was the weak place where the repairing specimen was most easily damaged under tensile load and was the stress concentration area on the entire structure of the repairing face. In addition to bearing the tensile load, it also borne the peeling stress applied by the adhesive layer.

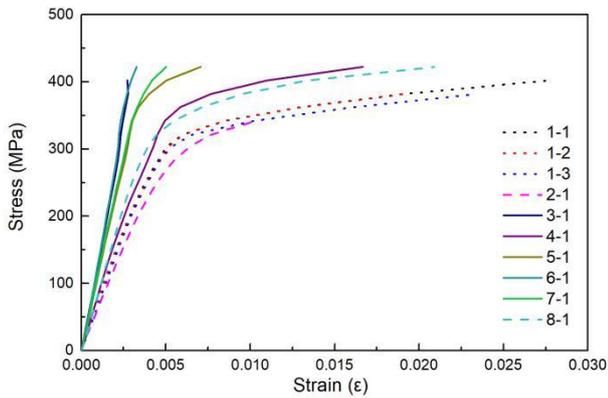
The stress-strain curves recorded by strain gauges of the repairing face are shown in Figure 12. The strain on the substrate of the repairing surface was represented by the dot line, and the strain on the patch was noted by the solid line. It can be seen that the strain on the substrate increased faster as the load increased, which was significantly higher than the strain on the patch. However, 4-1 gauge in strain-load curves was significantly higher than the strain at the other locations of the patch, and slightly smaller than the strain on the substrate. The phenomenon was consistent with the result measured by DIC technology. As shown in Figure 13, the local strain distribution nephogram of patch at the later stage of loading was recorded by DIC technology, and the crescent-shaped red area was the place corresponding to 4-1 gauge. The load transferring in the repairing area was very complicated, where involved the transmission path of load at the overlap of the substrate, the patch and the repairing panel. The cross-sectional area of the three overlaps was the smallest, so the strain here was the largest.

Figure 12 – The strain-load curves of repaired face

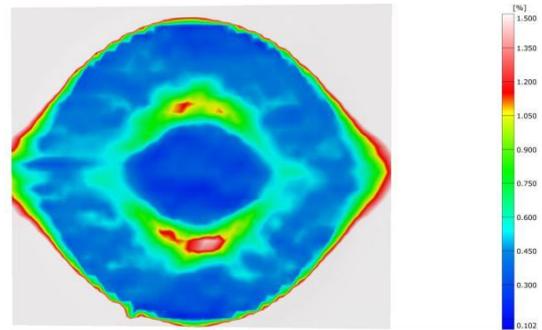
Figure 13 – Local longitudinal strain distribution in reinforcing face

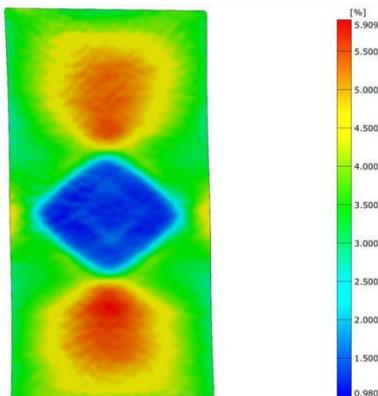
The typical specimen SP-11 with the failure mode B was selected to analyze the strain distribution characteristics, which were basically the same as the strain distribution characteristics of the repaired face. The difference was the shape of the low strain area like a diamond, as shown in Figure 14. At the beginning of the load process, the highest strain of the substrate was near the four corners of the rhombus on the non-repaired face. The low strain in the repairing area on the non-repaired face was evident before the failure load, and the location of strain concentration occurred on the substrate near the longitudinal upper and lower edges of the repaired area.

Figure 14 – The longitudinal strain distribution of non-repaired face

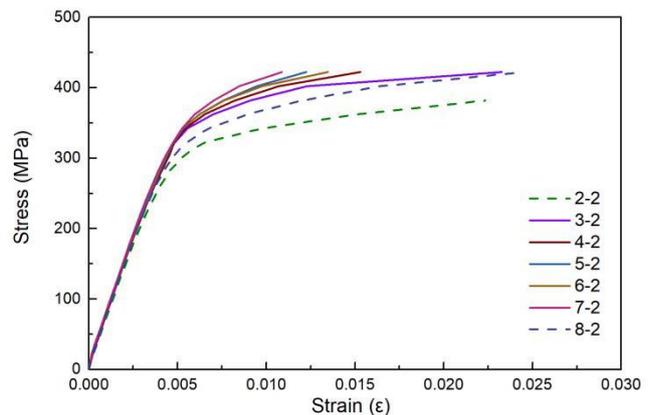
Figure 15 – The strain-load curves of non-repaired face

The stress-strain curves of the non-repaired face recorded by strain gauges are shown in Figure 15. When the load was at a low level, the strain in the non-repaired area at different positions increased linearly and the growth slope was almost the same. When the load increased to about 65kN, the strain corresponding to the repairing area began to be smaller than that of the substrate, which was especially obvious when the specimen was about to fail. In addition, the strain in the repairing area of the non-repaired face increased from the center of reinforcing area to the edge of that, which was consistent with the results of DIC technology. The local strain distribution nephogram of the non-repaired face was shown in Figure 16. It can also be seen that the strain in the area where was the overlap of the substrate, the patch and the repairing panel was higher than the surrounding area in the repairing area. This phenomenon occurred in the SP and the SPC repairing structures. Therefore, for a metal honeycomb one-side repair structure of this thickness, the structural characteristics of the repair surface can also affect the strain distribution of the non-repair surface.

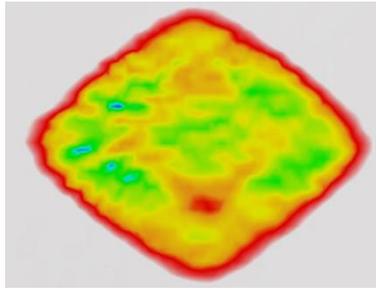
Figure 16 – Local longitudinal strain distribution in non-repaired face

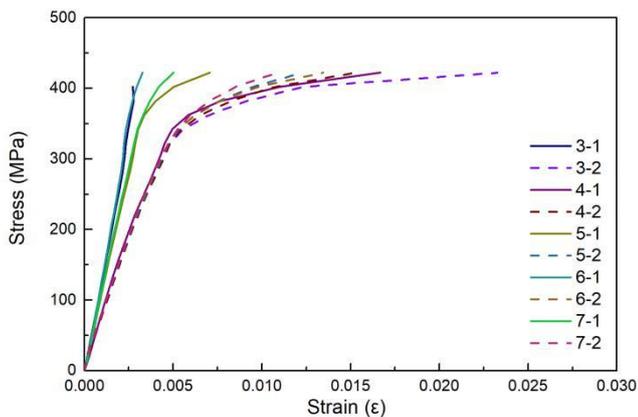
The stress-strain curves of the gauges at the patch on the repaired face and non-repaired face were shown in Figure 17. It can be observed that, except for the 4-X strain gauges, the strain in the repaired area of the repaired face was significantly lower than that of the non-repaired face.

Figure 17 – Strain comparative of repaired face and non-repaired face on patch

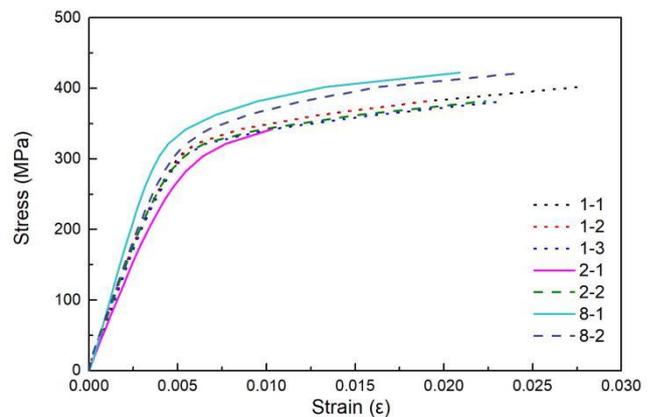
The stress-strain curves of the strain gauges on the repaired face and the non-repaired face on the substrate were shown in Figure 18. It can be concluded that the strain measured by the back-to-back strain gauges on repaired face and non-repaired face was almost the same throughout the loading process.

Figure 18 – Strain comparative of repaired face and non-repaired face on the substrate
