Richard A. Pride  
NASA Langley Research Center  
Hampton, Virginia, USA

### Abstract

Interim results from a number of ongoing, long-term environmental effects programs for composite materials are reported. The flight service experience is evaluated for 142 composite aircraft components after more than five years and one million successful component flight hours. Ground-based outdoor exposures of composite material coupons after 3 years of exposure at five sites have reached equilibrium levels of moisture pickup which are predictable. Solar ultraviolet-induced material loss is discussed for these same exposures. No significant degradation has been observed in residual strength for either stressed or unstressed specimens, or for exposures to aviation fuels and fluids.

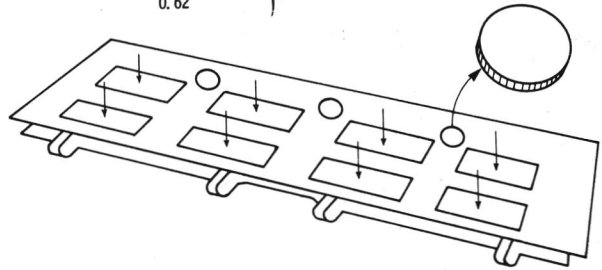
T300-5209 GRAPHITE-EPOXY AFTER THREE YEARS SERVICE WITH LUFTHANSA  
RESIDUAL MOISTURE  
0.63 PERCENT  
0.66  
0.62 } AV = 0.64 PERCENT

Figure 3.- Spoiler moisture levels determined from plugs.

After several years of unsuccessfully attempting to determine the moisture absorbed by the graphite-epoxy spoilers in service, a technique of cutting plugs from near the trailing edge was developed (fig. 3). The eight rectangular areas shown with an arrow in the center of each represent the whiffletree loading areas for static strength tests. Since failures always have initiated near the leading edge at one of the center hinges, it has been determined that three plugs of 6.4 cm (2.5 in.) diameter could be cut from the region behind the loading areas without influencing the failure load. These plugs, which consist of aluminum honeycomb core, two graphite-epoxy face sheets, two layers of epoxy film adhesive and two exterior coats of polyurethane paint, have about 90 percent of their weight in the composite faces, including the paint and adhesive. A good determination of the moisture level in the spoiler can be made by drying the plug and noting the weight change. After three years of service with Lufthansa Airlines in Germany, plugs taken from a T300-5209 graphite-epoxy spoiler indicated a moisture content of 0.64 percent, based on the composite weight.

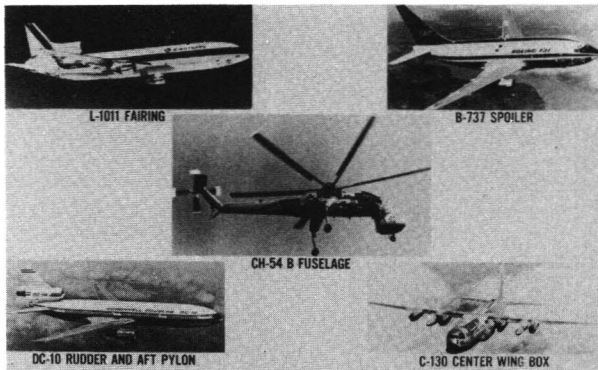
Figure 1.- Flight service evaluation of composite structural components.

A number of composite structural components have been designed, manufactured, tested, and placed in operational service on a variety of aircraft. This operational flight service is monitored periodically to evaluate the long-term experience with composite durability. The types of aircraft and composite components are shown in figure 1. The L-1011 application is six fuselage fairing panels involving two types of Kevlar-49 epoxy composite on each of three airplanes<sup>1</sup>. Three graphite-epoxy material systems are used for the spoilers on 27 Boeing 737 airplanes<sup>2</sup>. A fourth graphite-epoxy material is used in the upper, aft

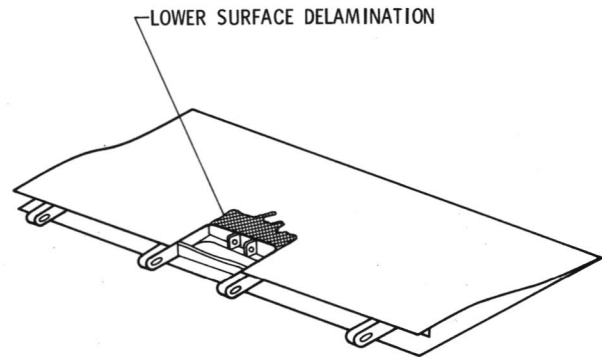
Figure 4.- General area of spoiler delamination.

Subsequent to the introduction into flight service of the graphite-epoxy-skinned spoilers, a development program was undertaken for an all-composite spoiler which included glass-epoxy honeycomb core, molded graphite-epoxy hinge fittings and leading edge spar, and thermoplastic graphite-poly-sulfone skins. It was recognized that the poly-sulfone matrix had an environmental sensitivity to phosphate-ester-based hydraulic fluids, and the laboratory testing demonstrated this in elevated temperature, stressed immersions. However, based on the room temperature experience it was believed that the material could be successfully used in flight components with only minor, intermittent exposures to hydraulic fluid leakage from the spoiler actuators. Twelve of these spoilers were fabricated and placed in service on six of the aircraft that were flying graphite-epoxy spoilers. After six months of operational flight service the two spoilers installed on Aloha Airlines were reported to have developed significant delamination of the lower surface skin directly aft of the actuator attachment fitting (fig. 4). Within a month a third spoiler was reported as starting to experience delamination, so it was decided to remove all the remaining graphite-poly-sulfone spoilers. A closeup view of the delaminated area is shown in the photograph in figure 5. This experience demonstrated the difficulty of performing adequate laboratory accelerated environmental testing and provided a good example of the necessity for flight service evaluation.

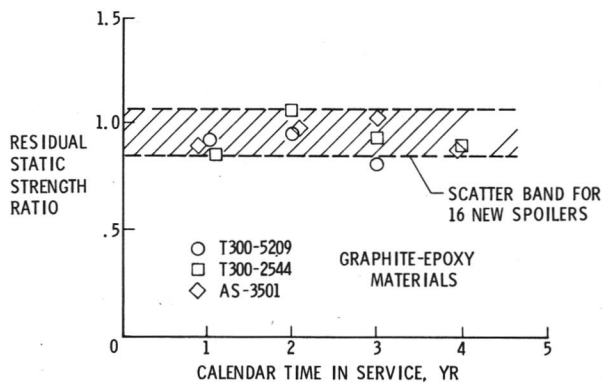
Figure 2.- Residual static strength of graphite-epoxy spoilers.

For destructive testing the spoilers are mounted in the same static test jig as was used for the initial airworthiness certification tests<sup>2</sup>. A distributed load is applied to the outer surface of the spoiler, simulating aerodynamic loads, and the magnitude is increased until failure occurs. Results of these residual static strength tests on the graphite-epoxy spoilers are shown in figure 2. The residual strengths for each material system have been divided by the failure strength of the initial certification test for each material, and the results are presented nondimensionally as a function of the time in service. A scatter band for strength tests of 16 new replicate spoilers manufactured with the T300-5209 graphite-epoxy material has been superimposed on the individual tests of spoilers removed from service. In four years of service, the scatter in strength for the individual spoilers generally falls within the width of the new spoiler strength scatter band; an indication of essentially no degradation in strength.

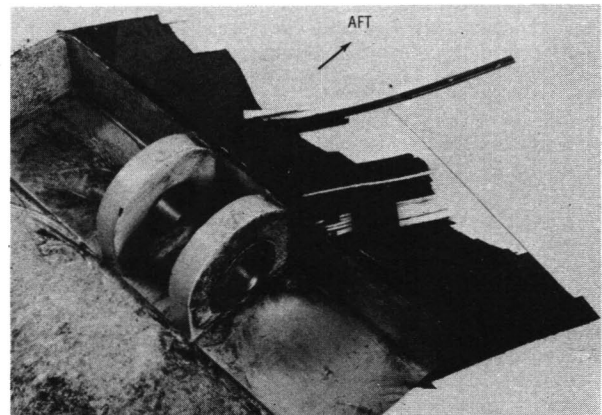
Figure 5.- Delamination of spoiler cover due to hydraulic fluid attack.

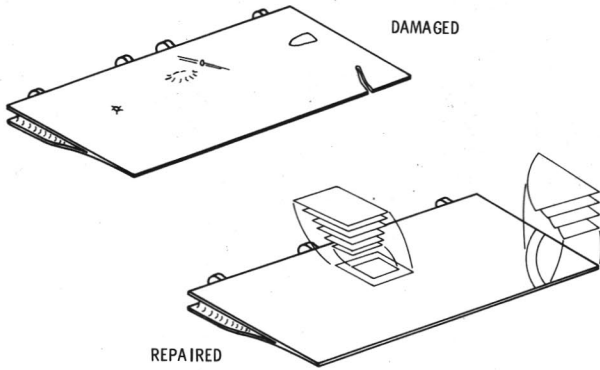
Figure 6.- Graphite-epoxy spoiler repair techniques.

There have been several instances in which the graphite-epoxy spoilers have received damage in service sufficient to require repairs. Examples of these are illustrated in figure 6. On this program, damaged spoilers are removed from the aircraft and returned to The Boeing Company for repair. Repairs are made by cutting out the damaged area, replacing honeycomb core as needed, and replacing graphite-epoxy plies on a one-for-one basis with each ply lapped over the underlying one by about 6 mm (0.25 in.). One piece of adhesive film is placed under the patch assembly and the built-up patch is cured and bonded in one cycle in an autoclave with the spoiler supported in its original assembly tooling<sup>7</sup>. The repaired spoiler is ultrasonically inspected and returned to flight service with the airline which had previously used it.

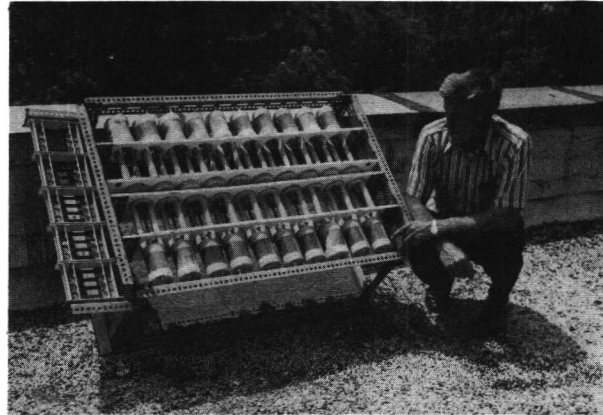
Figure 9.- Stressed exposure rack.

In addition to the unstressed exposures, three racks containing stressed tensile specimens (fig.9) are also deployed, one each at San Francisco, Seattle, and Langley. Individual specimens are mounted in fixtures which apply a constant load through a compressed helical spring. Unstressed tensile specimens are also placed in these same racks for comparison.

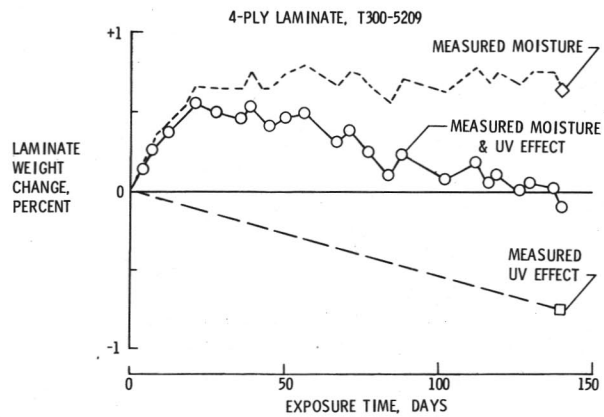
Figure 10.- Weight change in outdoor exposure; 4-ply laminate, T300-5209.

When specimens are removed and shipped to Langley periodically, they are weighed to determine weight changes associated with moisture absorption and weathering. An example of the specimen weight changes with exposure time is shown in figure 10 for a thin graphite-epoxy specimen in the unstressed rack at Langley. The solid curve in the center of the figure drawn through the circular test points is the record of the repeated weighings. The specimen initially gained weight and then began to gradually lose weight as a result of the combined effects of moisture and solar ultraviolet exposure. The exposure of this specimen was terminated after 140 days and the specimen was then dried to a fully dry condition. The weight change associated with this drying indicated the actual measured moisture level in the specimen at 140 days. Comparing the fully dry weight to the initial fully dry weight showed the measured ultraviolet effect of a weight loss after 140 days. Since the ultraviolet effect is a loss from the exposed specimen surface, it is assumed to be linear with exposure time. Corrections can then be calculated for the measured weights at intermediate times, and an interpolated moisture curve can then be plotted as shown by the upper dashed line in figure 10. This curve appears to have reached an equilibrium level of moisture absorption between 0.6 and 0.7 percent. The small fluctuations correspond to changes in the daily levels of relative humidity.

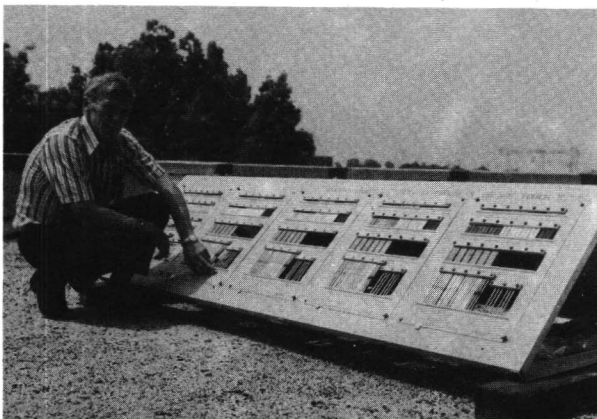
Figure 8.- Unstressed exposure rack.

As a parallel part of the flight service exposures of composite components, a number of replicate mechanical property specimens have been manufactured from the same composite material systems used in the components. These specimens have been mounted in racks which are deployed on rooftops of airline buildings at a number of airports around the world so as to receive maximum exposure to the airport ground environment. The location of six of the exposure sites is shown on the map of the world in figure 7. Each of these locations has an exposure rack with unstressed specimens as indicated in figure 8. Each of the five panels mounted in

the rack contains triplicate specimens of four graphite-epoxies, one graphite-polysulfone, and two Kevlar-49 epoxies in short beam interlaminar shear, flexure and compression configurations. After one year and three years of exposure a panel is removed from each rack and shipped to Langley Research Center for specimen testing and evaluation.

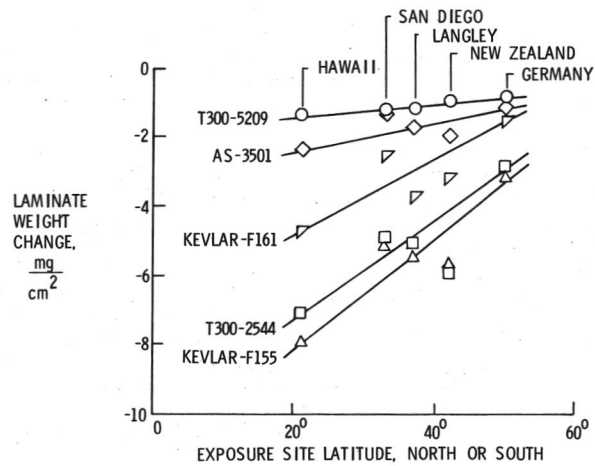
Figure 11.- Weight loss from three-years outdoor ultraviolet exposure.

The results of fully drying the flexure specimens from five exposure sites after three years of exposure provided a pattern of weight losses due to ultraviolet exposure as shown in figure 11. For any given material, the weight losses are greater for exposure sites closest to the equator. Variations in the epoxy matrices for the different material systems seem to provide a greater variation in weight loss than changes in exposure site latitude. In all cases the specimens were exposed in an as-laminated condition without any protective coating. The weight losses in three years time correspond to less than 25 percent of one ply thickness.

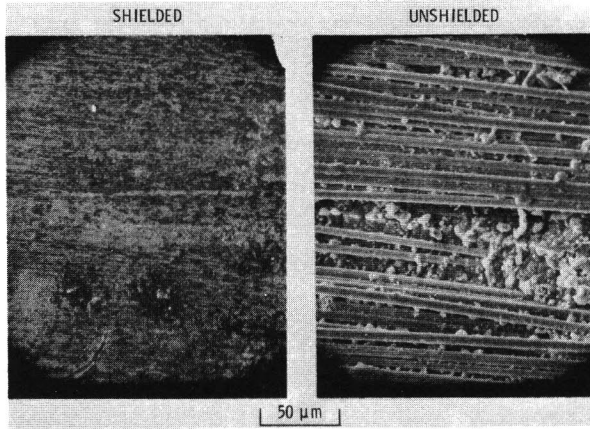
Figure 12.- Graphite-epoxy surface degradation; 3-years outdoor exposure.

Scanning electron micrographs of two areas on one of the T300-5209 graphite-epoxy specimens exposed at the Honolulu site are shown in figure 12. The left-hand area was shielded from the solar ultraviolet by the specimen mounting clamp on the exposure rack. The magnified view is essentially the original as-laminated surface, which is entirely epoxy. The right-hand area was typical of the unshielded portion of the same specimen. In this

area the epoxy matrix has been removed by the ultraviolet weathering process, exposing a layer of individual graphite fibers. Although the effect looks bad, it really is quite superficial in three years time and it can be prevented by painting the exposed specimen surface.

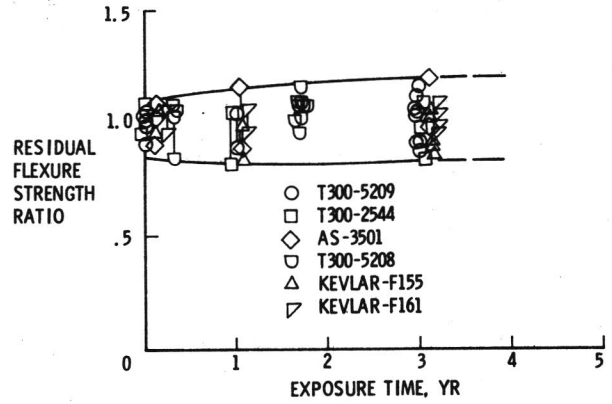
Figure 15.- Residual flexure strength after worldwide exposure.

The observed loss of material from ultraviolet exposure and pickup of moisture from the relative humidity leads to a concern for the effect on residual mechanical properties. Figure 15 shows the results of flexure strength tests performed after various exposure times at all of the worldwide exposure sites for six composite materials. The data are shown in nondimensional form obtained by dividing residual strengths by the initial as-

laminated strengths. The width of the scatter band for strength is largely a function of the scatter in triplicate tests from various exposure sites. However, it is not sufficiently greater than the scatter in the initial replicate tests to justify any conclusions. It is evident that for three years of outdoor ground-based unstressed exposure there has been no indication of degradation in flexure strength. Similar conclusions can be drawn from results of the short beam interlaminar shear and the compression tests also, after three years of unstressed outdoor exposure.

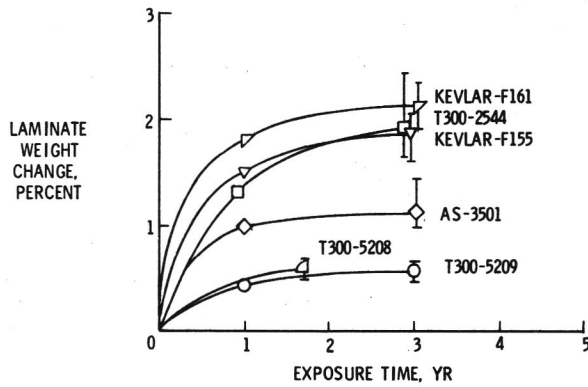
Figure 13.- Moisture pickup after worldwide exposures.

The amount of moisture absorbed by the various composite material systems is shown in figure 13. These results represent the determinations made on flexure specimens after their worldwide outdoor exposures for times up to three years. The weight gains shown have been corrected for the ultraviolet weight losses as described previously for figures 10 and 11. The scatter bands indicated for the three-year exposures contain all the data for triplicate specimens and five exposure sites. In general there is no separation of individual sites by the magnitude of absorbed moisture. The largest variable appears to be the type of epoxy matrix used in the composites. Even the Kevlar-epoxy values are in the same range as one of the graphite-epoxies. Data for T300-5208 graphite-epoxy is only shown for a 1.7-year exposure because the specimens which were made as a part of the graphite-epoxy rudder flight service program were not available to be deployed in the exposure rack panels until 1.3 years after the other specimens were deployed. However, the absorbed moisture for the T300-5208 is essentially the same as for the T300-5209 material, and both appear to be at an equilibrium level of about 0.5 percent of the laminate weight.

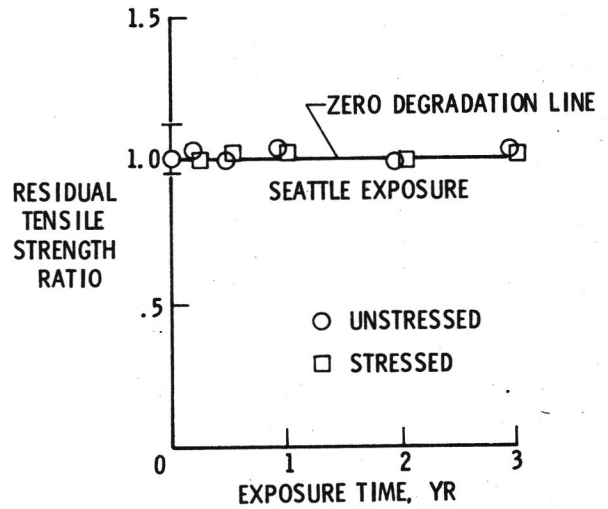
Figure 16.- Residual tensile strength after sustained stress outdoor exposures; T300-5209,  $\pm 45^\circ$  laminate stressed at 25 percent ultimate.

To consider the possible influence of constant stress during the outdoor exposure, three sets of tensile specimens have been included in the program. The first set consists of T300-5209 graphite-epoxy material laminated at  $+45^\circ$  ply orientation and stressed during exposure at 25 percent of the initial ultimate strength. Exposure and residual strength testing have been conducted in the Seattle, Washington area by The Boeing Company under NASA contract. Results shown in figure 16 indicate essentially no difference between stressed and unstressed exposure and no degradation in tensile strength for up to three years of exposure. The second and third sets of tensile specimens are T300-5208 graphite-epoxy material laminated in a  $[0^\circ, +45^\circ, 90^\circ]$  quasi-isotropic ply orientation and stressed during exposure at 40 percent of the initial ultimate strength. Exposure sites for these are located at the San Francisco airport and at Langley. Specimens have been retrieved and tested at Langley after one and three years exposure. The results shown in figure 17 indicate about the same amount of scatter as shown previously for the flexure strengths and indicate essentially no difference between stressed and unstressed exposures and no degradation in tensile strength.

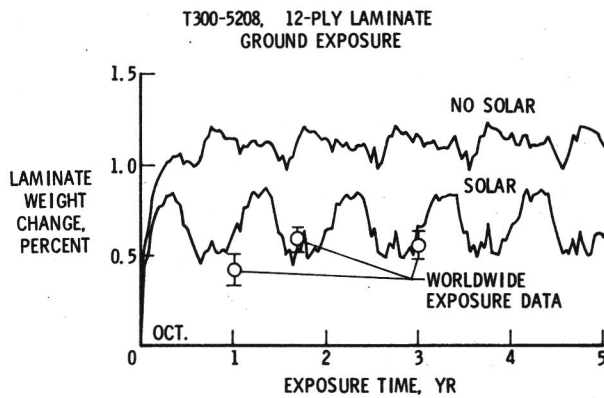
Figure 14.- Comparison of predicted and measured moisture contents; T300-5208, 12-ply laminate; ground exposure.

A comparison of the measured moisture contents for both T300-5208 and T300-5209 materials with predicted moisture contents for a 12-ply laminate of T300-5208 graphite-epoxy is shown in figure 14. The predicted moisture contents are based on calculations using the Fickian diffusion equations with varying inputs for relative humidity and temperature<sup>8</sup>. These varying inputs are taken directly from tape recordings of the weather at Langley Research Center. The predicted curve marked "No Solar" was calculated assuming that the temperature of the specimen was the same as that of the ambient air. This is a reasonable assumption for specimens exposed in shade; however, if the specimens are exposed to the Sun, they will be heated to temperatures well above the ambient air temperature on clear, sunny days. This will increase the rate of moisture diffusion and, more importantly, decrease the local relative humidity at the surface of the specimens. Inclusion of these effects in the calculations results in the lower predicted curve marked "Solar". The weather data for the year 1962 were used repetitively in the calculations, starting at the first of October to correspond with the initial deployment of the exposure racks and specimens. The experimental data points at 1, 1.7, and 3 years are taken from the overall worldwide exposure data previously discussed in figure 13 for T300-5208 and T300-5209 graphite-epoxies. The correlation between prediction and experiment is good.

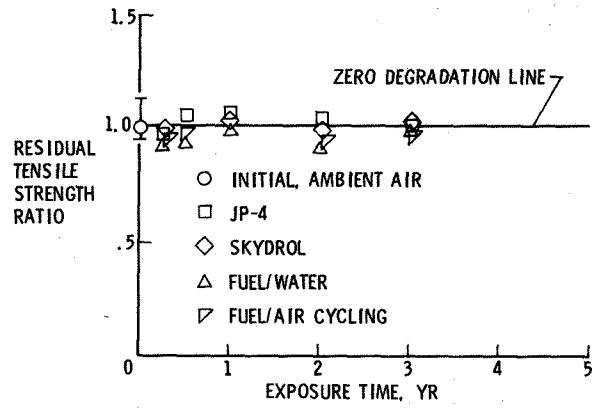
Figure 18.- Effect of fuels and fluids on strength; T300-5209, +45° tensile specimens.

Another type of environmental exposure includes the interaction of composite materials with extended exposure to aircraft fuels and hydraulic fluids. Under NASA contract The Boeing Company has conducted a series of exposures of several composite materials in JP-4 jet fuel, a commercial aviation phosphate-ester hydraulic fluid, a fuel-and-water mixture, and a fuel-and-air cyclic environment. All exposures are outdoors in an unheated shed in the Seattle area. Short beam interlaminar shear and tensile specimens are being exposed. Typical results are shown in figure 18 for T300-5209 graphite-epoxy material laminated at a  $+45^\circ$  ply orientation. The data indicate no degradation in tensile strength for up to three years exposure in any of the above environments.
