## DEVELOPMENTS IN ACCIDENT PREVENTION

**Paul Mayes**  
**School of Aviation, UNSW**  
*candpmayes@bigpond.com*

### Abstract

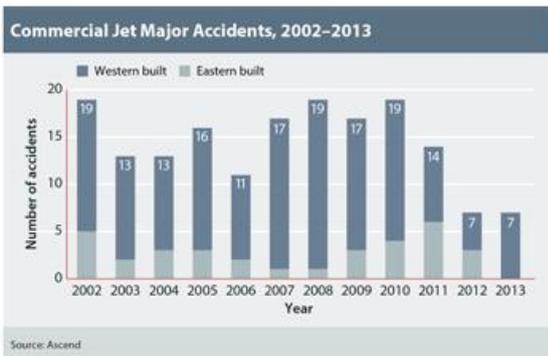
Figure 1 shows the total number of commercial jet major accidents and the number of Eastern-built aircraft accidents for commercial jets since 2002. Over the last five years, an average of 5 percent of the active commercial jet fleet was Eastern built, but they accounted for 30 percent of the major accidents over that same period.

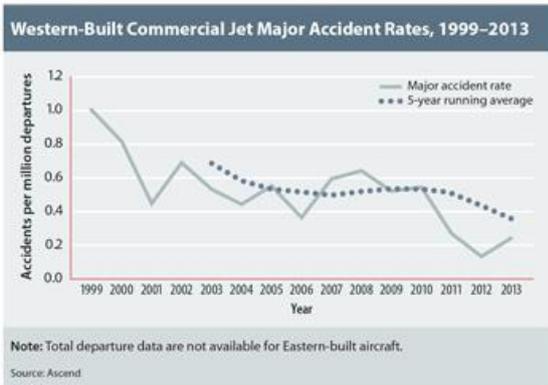
There were no Eastern-built commercial jet major accidents in 2013. Figure 2 shows the commercial jet major accident rates and the five-year running average. This rate is only for Western-built jets because, even though we know the number of major accidents for Eastern-built jets, we do not have reliable worldwide

exposure data (hours flown or departures) to calculate valid accident rates. After a decade of negligible improvement in the accident rate for commercial jets, a very positive trend of improvement that started in 2011 is evident, and the five-year running average continues to decrease.

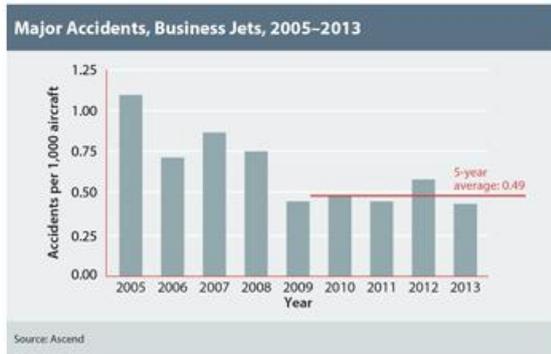
The accident rate for business jets can be calculated as the number of major accidents per 1,000 aircraft. Figure 3 uses this metric, and it shows an improvement in the business jet accident rate over the last nine years. Figure 4 shows the number of turboprop accidents since 2002. CFIT accidents continue to dominate the accident and fatality numbers for commercial turboprops. In 2013, eight of the 22 major accidents were CFIT accidents. Over the last seven years, 30 percent of the commercial turboprop major accidents have been CFIT accidents.

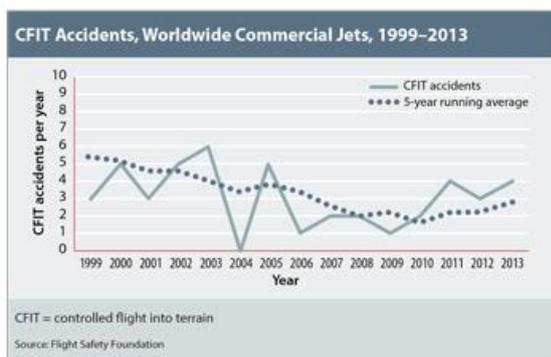
Figure 5 shows the CFIT accidents for all commercial jets since 1999. The upward trend since 2009 is quite disappointing because more than 95 percent of all commercial jets have been equipped with TAWS (terrain awareness and warning systems) since 2007. Over the previous six years, there have been 38 commercial aircraft CFIT accidents (14 turbojet, 24 turboprop). Only three of these 38 aircraft were equipped with operating TAWS. In those three aircraft, the TAWS provided 30 seconds or more of warning of the impending collision with the ground.

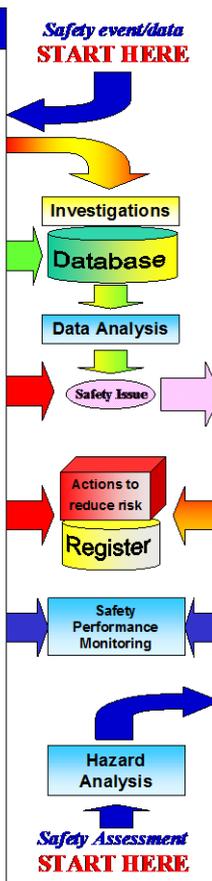
Question 2		Question 1	
What was the effectiveness of the remaining barriers between this event and the most credible accident scenario?		How did the event escalate into an accident outcome. What would have been the most credible outcome?	
Effective	Limited	Minimal	Not effective
50	102	502	2000
10	21	101	500
2	4	20	100
1

- Think how the event could have escalated into an accident outcome (see examples to the right of the ERC matrix). Typically, the escalation could be due to actions by the people involved, the way the hazard interfaces with the flight, and barrier behaviour.
- Do not filter out improbable scenarios. Question 2 will take the (low) probability into account.
- Among the scenarios with an accident outcome, pick the most credible, and select the corresponding row in the matrix.

- To assess the remaining safety margin, consider both the number and robustness of the remaining barriers between this event and the accident scenario identified in Question 1.
- Barriers, which already failed are ignored
- Select the column of choice. See section 4.2 for detailed guidance.

- Immediate action & further investigation required
- More refined Risk Assessment and/or investigation required.
- No action required. Contributes to the Safety Database.

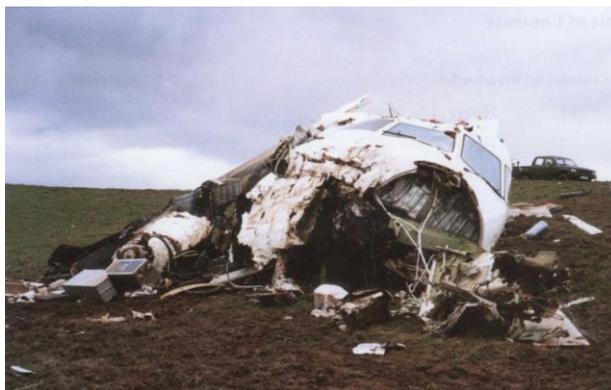
Cockpit section ZK-NEY

*At approximately 0922 hours on Friday 9 June 1995 a de Havilland DHC-8 aircraft, ZK-NEY, collided with the terrain some 16 km east of Palmerston North Aerodrome while carrying out an instrument approach. One crew member and three passengers lost their lives and two crew members and 12 passengers were seriously injured in the accident.*

*The causal factors were: the Captain not ensuring the aircraft intercepted and maintained the approach profile during the conduct of the non-precision instrument approach, the Captains perseverance with his decision to get the undercarriage lowered without discontinuing the instrument approach, the Captain’s distraction from the primary task of flying the aircraft safely during the First Officer’s endeavours to correct an undercarriage malfunction, the First Officer not executing a Quick Reference Handbook procedure in the correct sequence, and the shortness of the ground proximity warning system warning.*

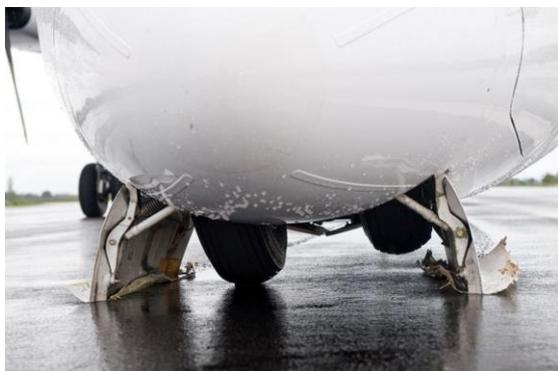
With the nose landing gear stuck in a partially extended position, light from the taxi light was likely detected by the sensor for the down-lock verification system, causing it to give a false green light.

The false green light on the verification system misled the pilots of ZK-NEB into believing that the nose landing gear was fully down and locked.

When the aircraft touched down and the pilot lowered the nose, the nose landing gear was pushed into the wheel well and the aeroplane completed the landing roll skidding on the nose landing gear doors. Damage to the aeroplane was minimal and no-one was injured.

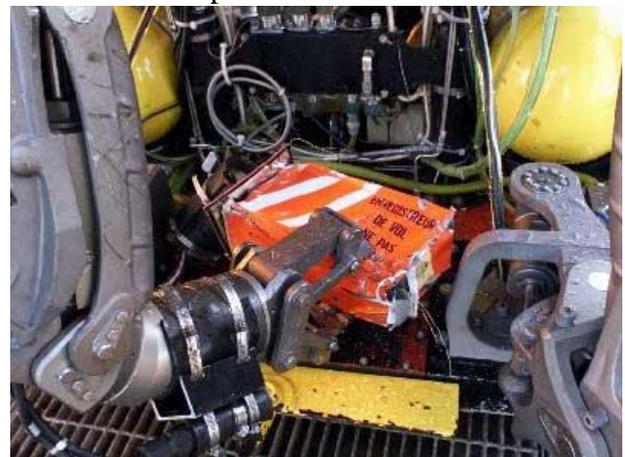
*Alaska Airlines Flight 261 CVR underwater recovery by remote vehicle.*
